Inspection Report

430 E Main St
Phoenix AZ 85024

Buy It Right Home Inspections LLC

Date: 5/15/2024	Time: 09:00 AM	Report ID: 20240515-430-E-Main-St
Property: 430 E Main St Phoenix AZ 85024	Customer: Joe Homebuyer	Real Estate Professional: Rhonda Carstensen My Home Group

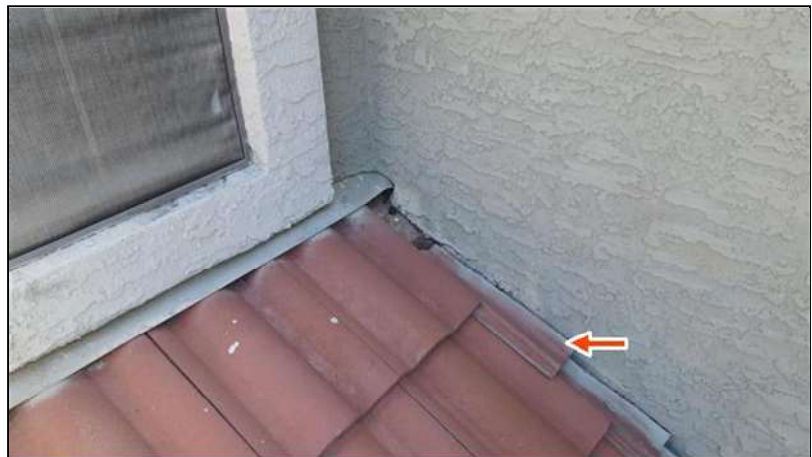
1.0 (1) Tile is out of position. If tiles are far enough out, it can allow excessive moisture or UV rays to reach the underlayment causing premature failure. Recommend repair by a qualified roofing contractor. **Images may not be all inclusive and only representative of the types of repairs required.**

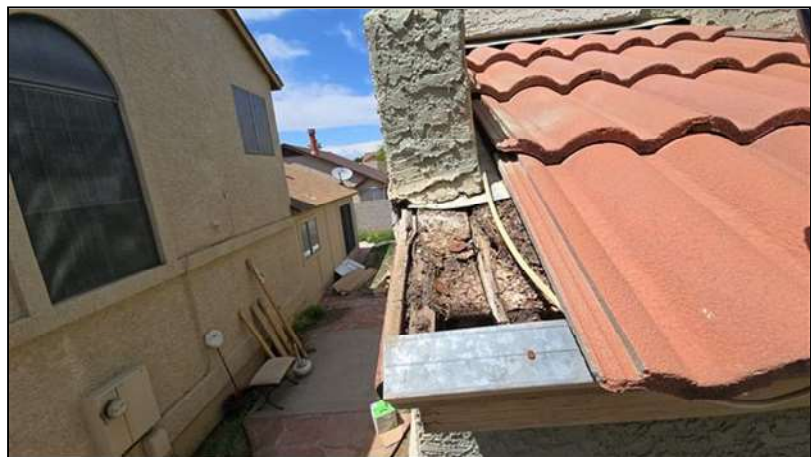
1.0 (2) Front side - one tile is missing. The underlayment and sheathing need to be replaced; Recommend repair by a qualified roofing contractor.

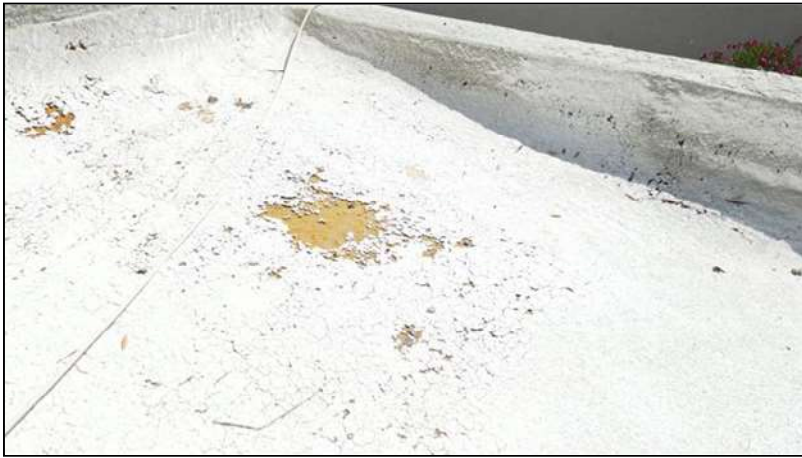
1.3 (1) The elastomeric coating is deteriorated and at the end of its useful life. Recommend areas be re-coated as required by a qualified roofing contractor.

Elastomeric coatings have a limited life span typically 5 or 10 years depending on the product used. This is a regular maintenance item that will need to be re-applied as it deteriorates.

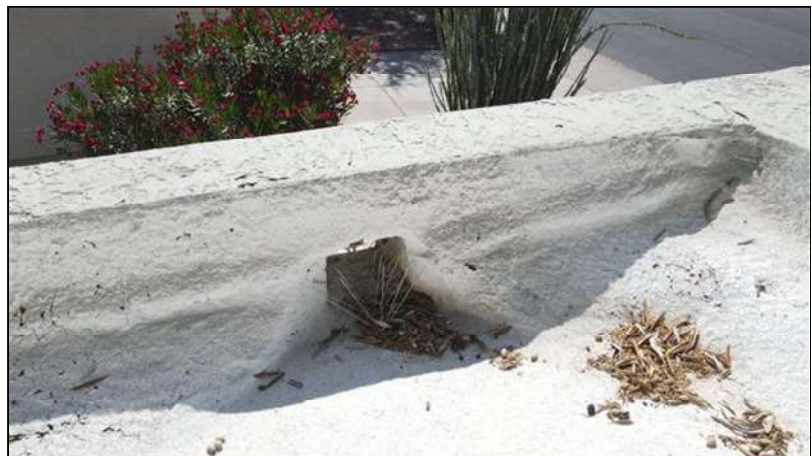
1.3 (2) Observed areas with excessive debris. Excessive debris can cause water to back up, trap moisture and cause premature failure of roof coverings. Recommend removal of debris. The bird spikes should be removed from scupper to prevent them from catching debris and building up blockage.

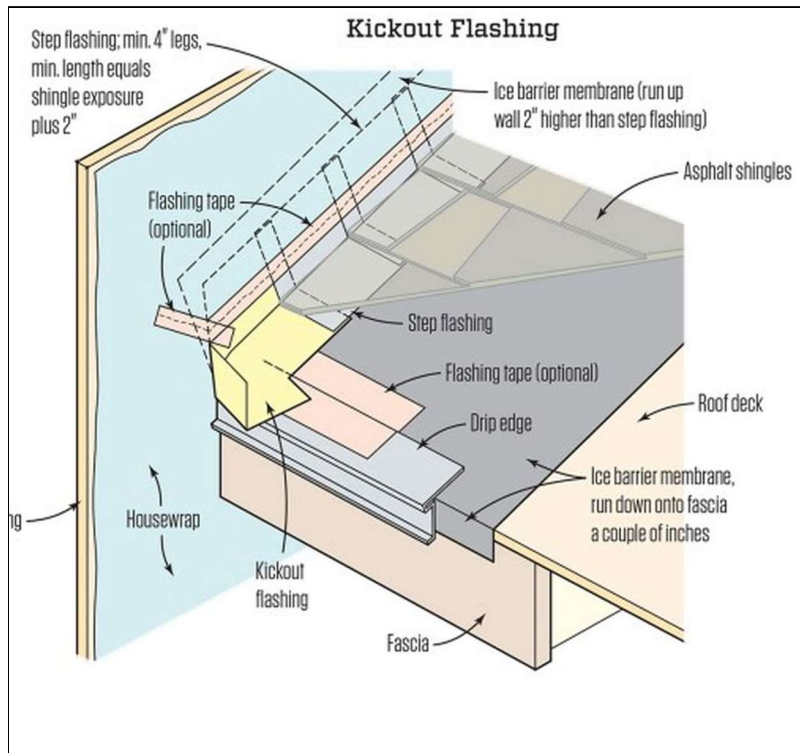
1.6 Kickout Flashing

1.6 (1) Kickout flashing is missing in multiple areas. Kickout flashing directs water flow away from the structure which can cause moisture damage. This is currently a standard construction method. Recommend kickout flashing be added.

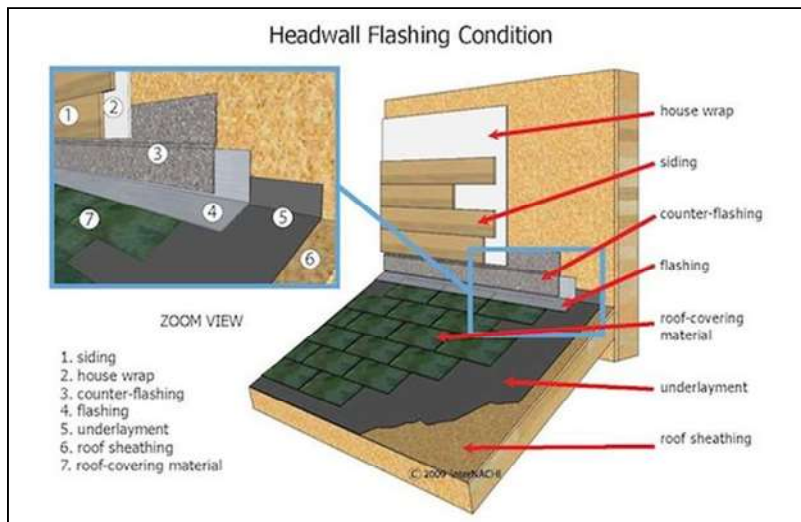
1.6 (2) The patio roof coverings were not installed to workmanlike standards. There is no flashing or counter flashing installed. Edge of roof coverings are dependant on sealant stopping moisture. This is a maintenance item as sealants will deteriorate and need repair. Properly installed flashing will require no maintenance. Recommend flashings be installed

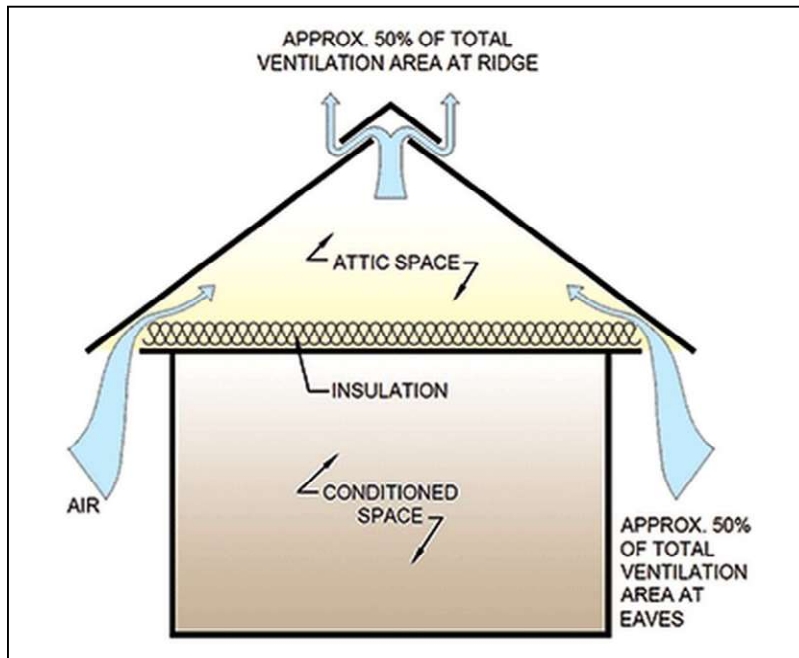
2.2 Attic Ventilation

2.2 The Installed attic ventilation does not appear adequate. The attic ventilation operates on the theory of convection. As heat rises it escapes the upper vents as the low pressure pulls cooler air in through the lower vents. Proper vent placement and ratio of upper to lower vents is critical. Improper venting could create abnormal temperatures as well as not being able to remove moisture from the attic. This could increase energy costs and allow microbial growth to more easily occur. Recommend repair.

The total square foot of the attic area to be ventilated should be 1/300. At least 40 percent and not more than 50 percent of the required venting area is provided by ventilators located in the upper portion of the attic or rafter space. Upper ventilators shall be located not more than 3 feet below the ridge or highest point of the space, measured vertically, with the balance of the ventilation provided by eave/lower vents. Where the location of wall or roof framing members conflicts with the installation of upper ventilators, installation more than 3 feet below the ridge or highest point of the space shall be permitted. The ratio and placement of vents is calculated by a qualified contractor in that field. **Recommend repair by a qualified contractor.**

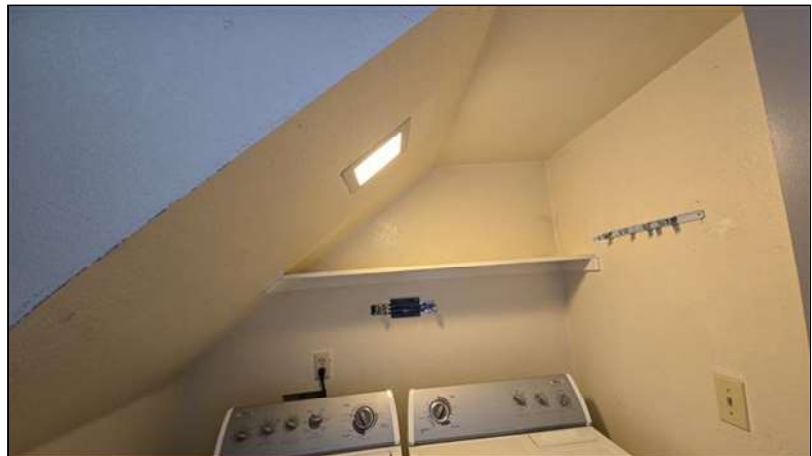
2.3 No ventilation (window or exhaust fan) for Laundry. An exhaust fan or a window is required under current building standard for proper ventilation. Excessive continuous humidity can allow microbial growth. This is for your information. Repair as necessary.

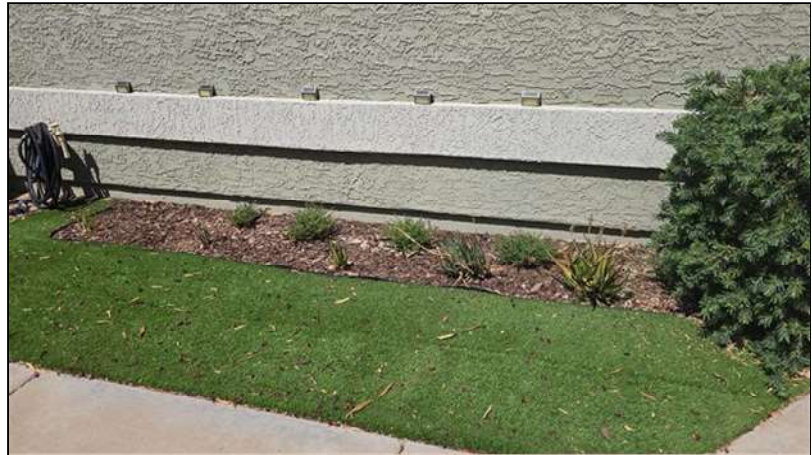
4.0 (1) Wood chips next to the home. This can attract pests such as termites. Recommend removal.

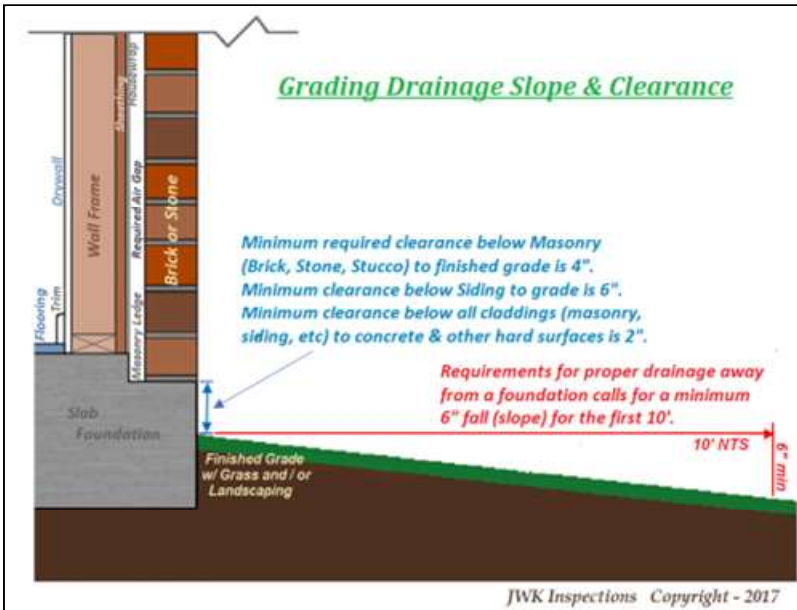
4.0 (2) Stem wall was not fully visible in all areas due to grade being too high. High grade can trap moisture next to the foundation. Inspection was limited. It is recommend that there be a minimum 4" clearance to the wall cladding. Recommend adjustment of grade.

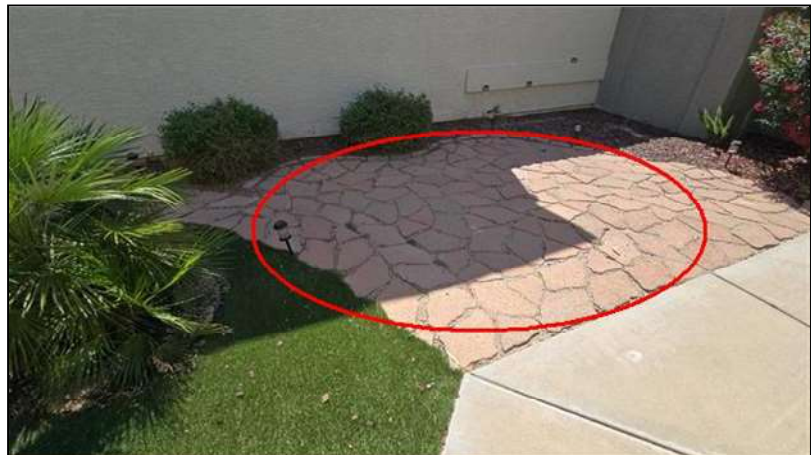
4.1 (1) Low spot observed. Area will most likely pool water. Recommended consulting with seller. Recommended repair.

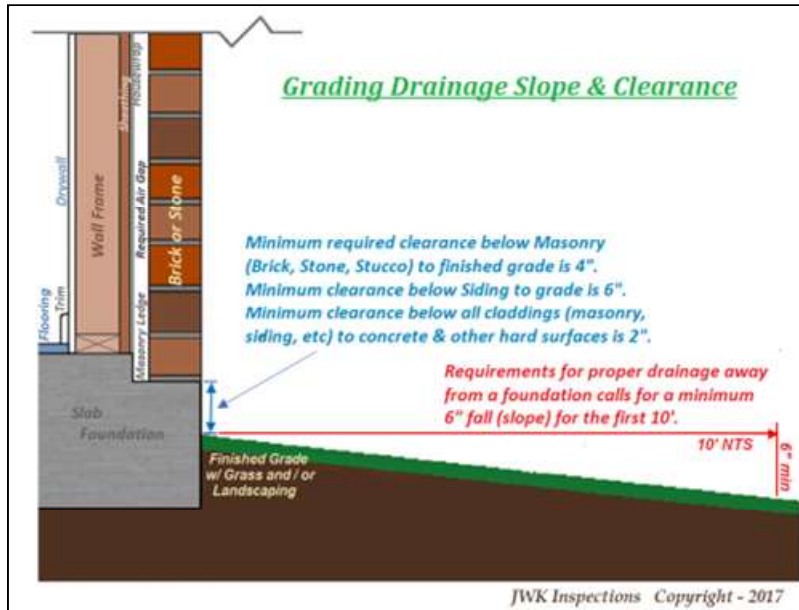
4.1 Proper Drainage Clearances

4.1 (3) Several areas - Grading is not conducive to proper drainage. The grade is either neutral or negative and will route runoff from precipitation toward the foundation. Excessive moisture under foundation can cause settling and cracking of foundation components, exterior siding, interior wall coverings and flooring. It is recommended that soil heights provide a 4" minimum clearance to the siding (stucco/paneling etc) and fall 6 inches for the first 10 feet as you

move away from the foundation. This will reduce moisture penetration into the substructures of the home. Recommend adjusting soil height to meet these criteria and direct water away from structure.

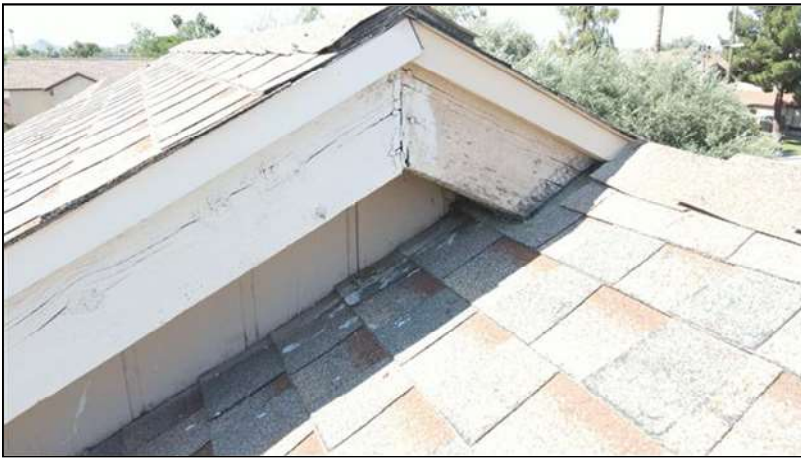
4.3 (1) The wood trim paint is failing at most of the perimeter. Moisture damage observed. Images are not all inclusive and only a representation of the types of repairs required. Recommend sealing and painting to prevent moisture penetration and damage.

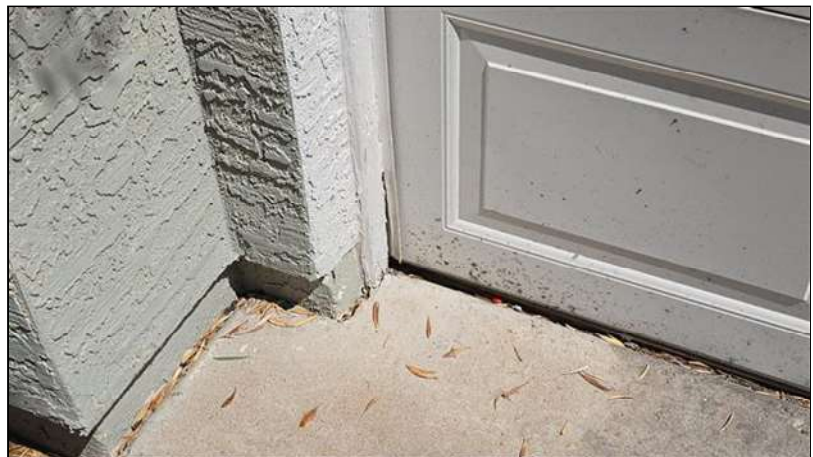
4.3 (2) The wood trim around the garage door is heavily moisture damaged. Recommend repair and replacement of garage door seal to prevent further damage.

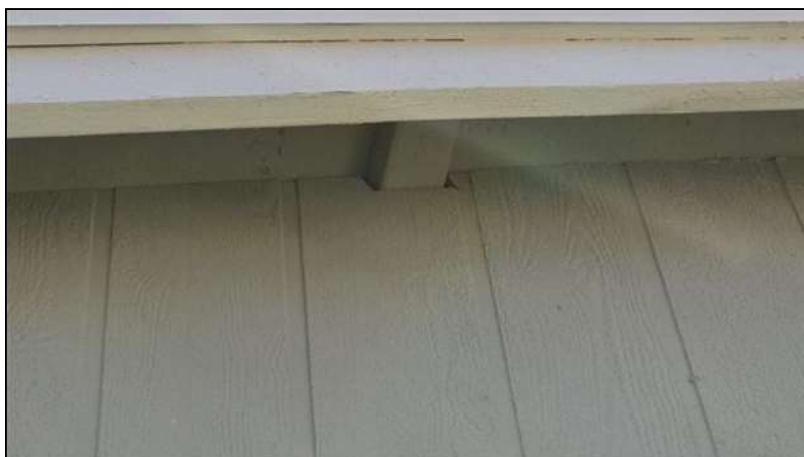
4.4 (1) Gaps observed at the eaves/soffits. Images may not be all inclusive and only a representation of the types of repairs required. Recommend sealing areas to prevent moisture and pest intrusion.

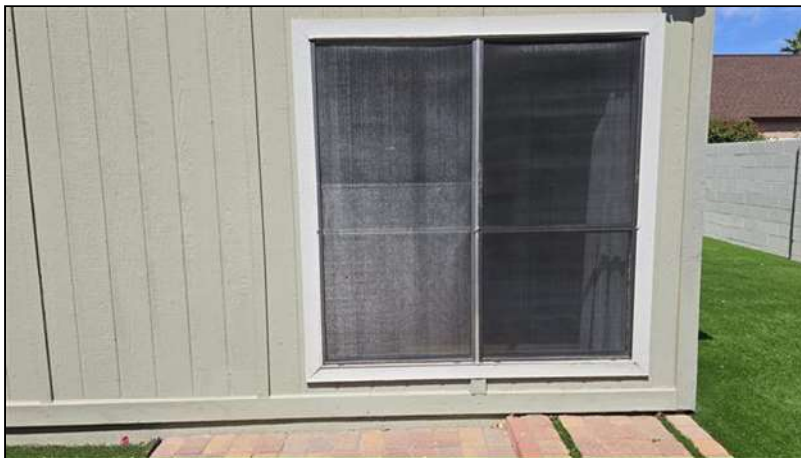
4.6 (2) Some of the screens are aged/ weathered and may need replacement. Replace as necessary. Images may not be all inclusive and only a representation of the types of repairs required.

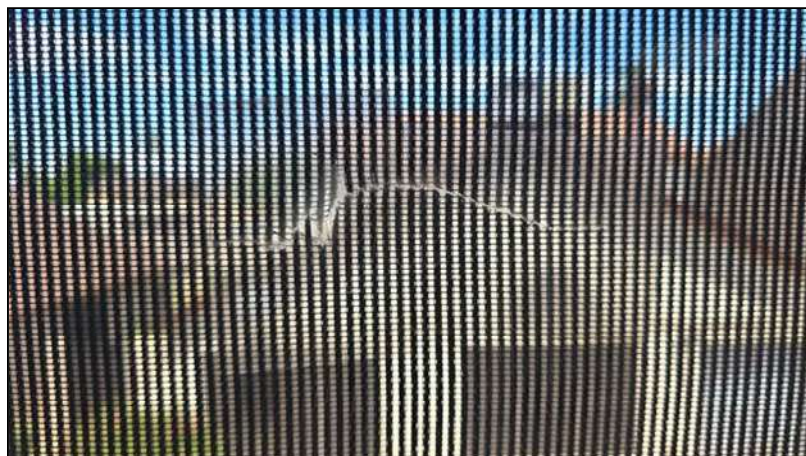
4.6 (3) Several screens are damaged. Repair/replace as necessary. Images may not be all inclusive and only a representation of the types of repairs required.

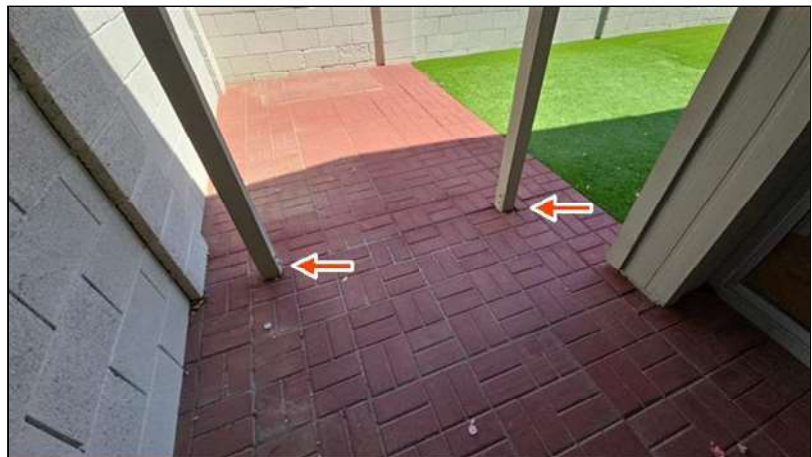
4.7 Earth to wood contact observed at the patio posts. This can allow moisture absorption and damage. This can also allow pests such as termites to enter the structure and go unnoticed. Recommend repair.

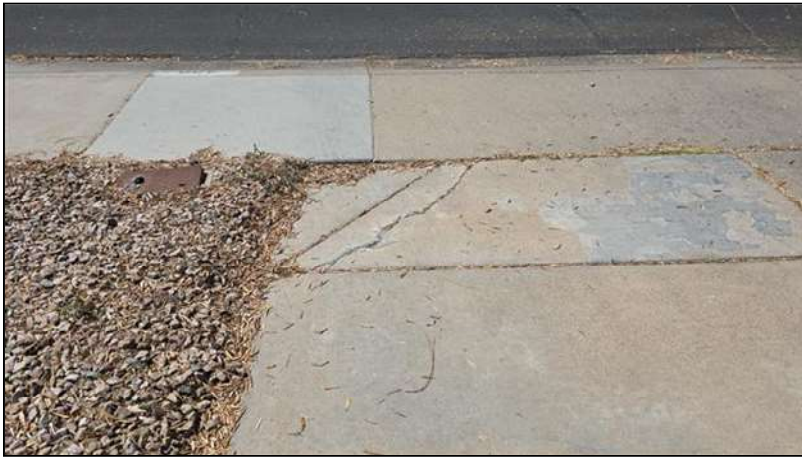
4.8 (1) Common cracking of concrete observed. This is a normal occurrence with shrinkage and settling.

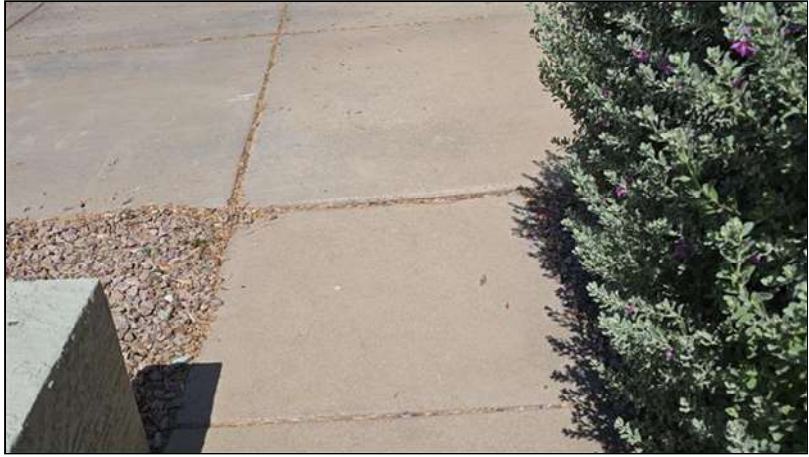
4.8 (2) The walkway has settled/shifted and is uneven and could be a trip hazard. This is typically due to excessive moisture. Repair as necessary.

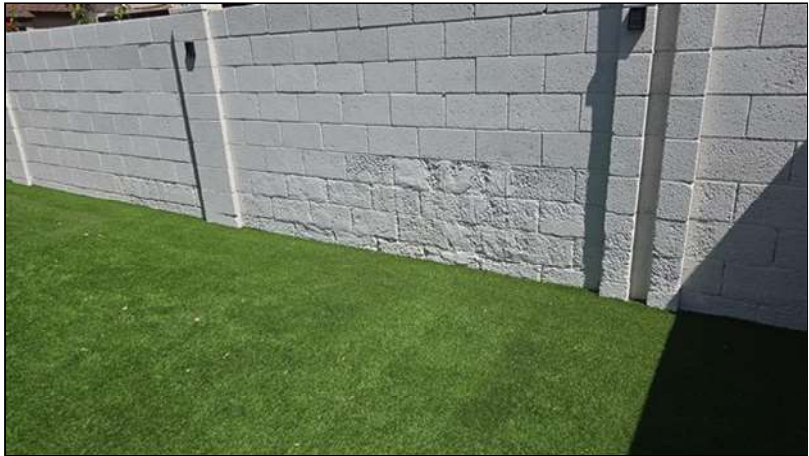
4.9 Some areas around base of fencing are spalling. This is caused by excessive moisture. This may have been from previously installed sprinklers continuously hitting the wall. Recommend consulting with seller.

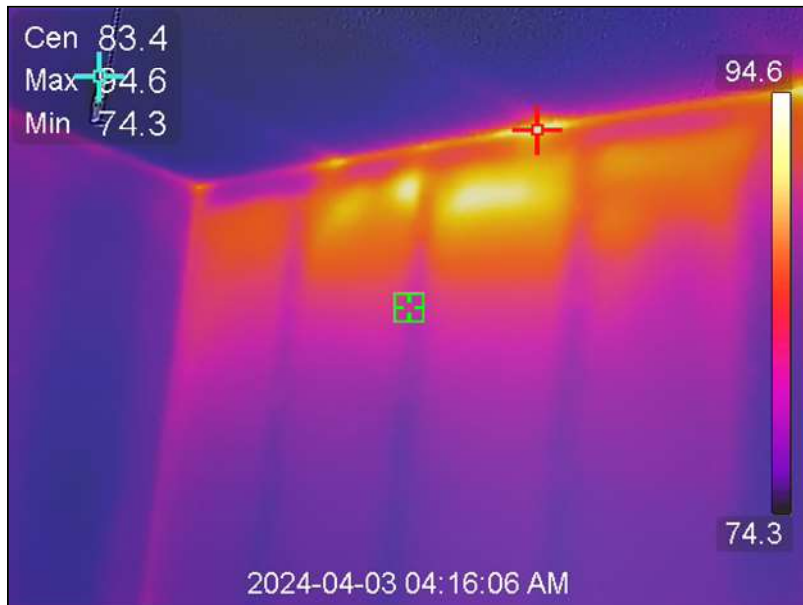
5.0 (2) Thermal anomalies observed. This is an indication that the insulation may be missing or not performing as intended. Further invasive investigation is required to confirm this. Although there is some areas potentially missing insulation, these would be considered minor and would may not provide any benefit that could reduce costs for cooling/heating. Some areas could feel cooler/warmer if in close proximity. Repair as necessary.

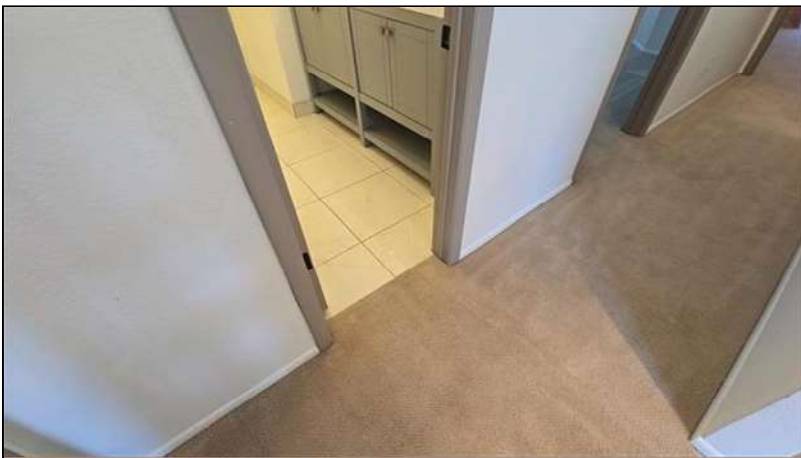
5.2 (1) Several areas - the carpet is loose and not stretched for a tight installation. Recommend repair by a qualified flooring installer. Images may not be all inclusive and only a representation of the types of repairs required.

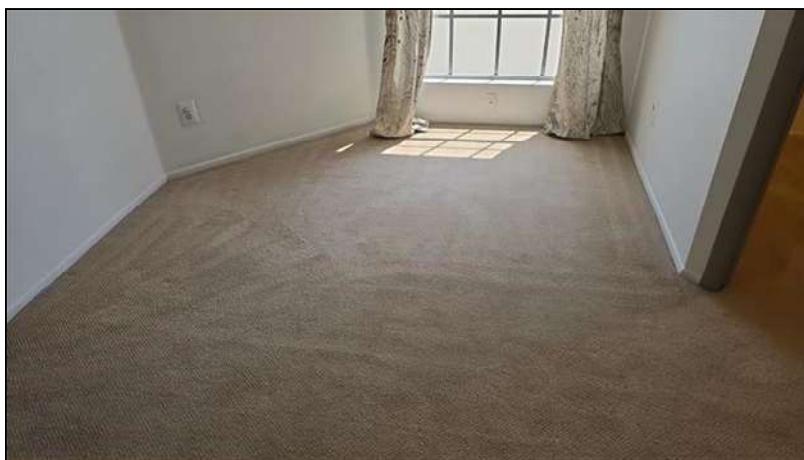
5.2 (2) The flooring/subfloor is not level in multiple areas. This was determined only by walking the floor. This could be padding or the subfloor. Carpet would need to be removed to determine cause. Repair as necessary.

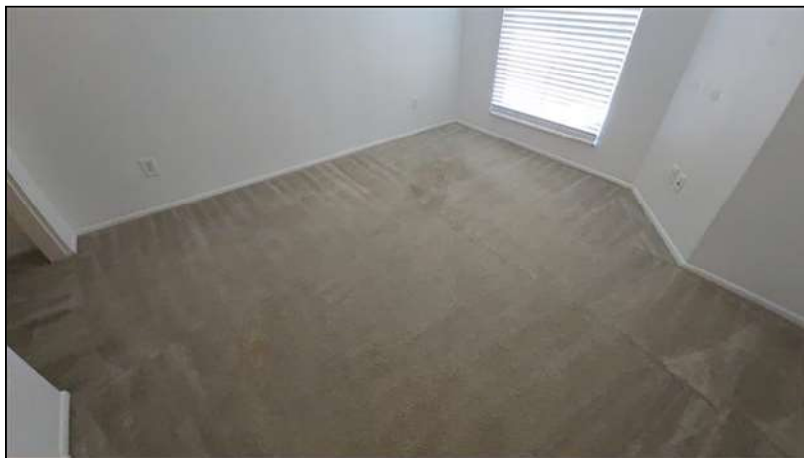
5.2 (3) The flooring creaks in the majority of the second floor. This could be a nuisance. Repair as necessary.

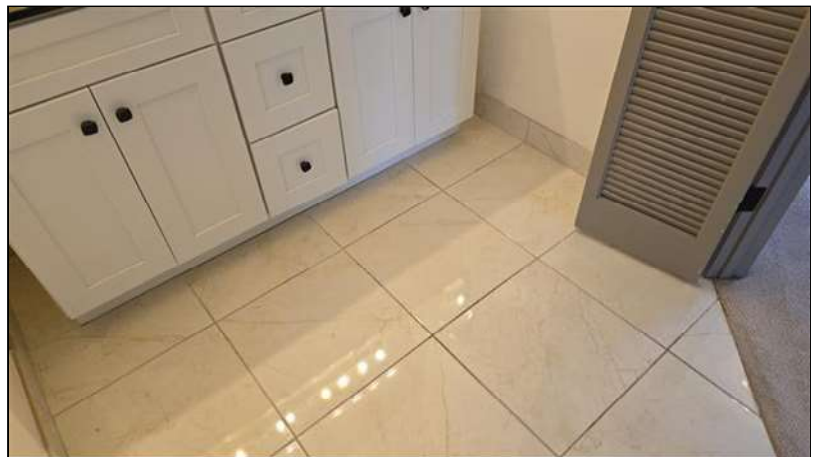
5.2

**5.2 (4)** Multiple tiles pop (make noise) when being walked on. Tiles could potentially break or come loose from the subfloor. Repair as necessary.

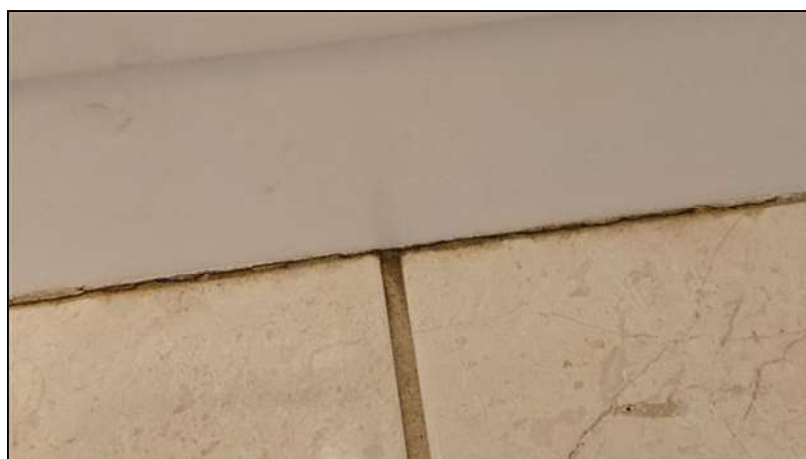
5.2 (5) Guest bathroom - Cracking around bathtub. Recommend grout/caulk these areas as required to prevent moisture from penetrating the sub-structure.

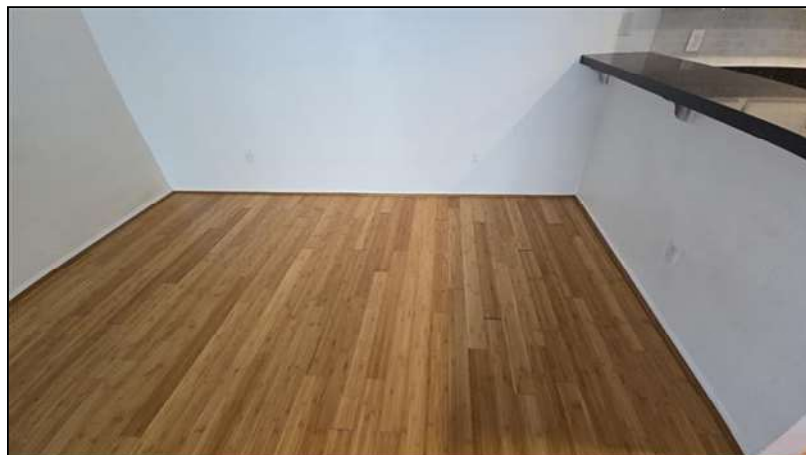
5.2 (6) Flooring has large gaps. This is most likely due to improper installation. Wood needs to be acclimated before installation as it can expand and contract. This is cosmetic and for your information. Repair as necessary.

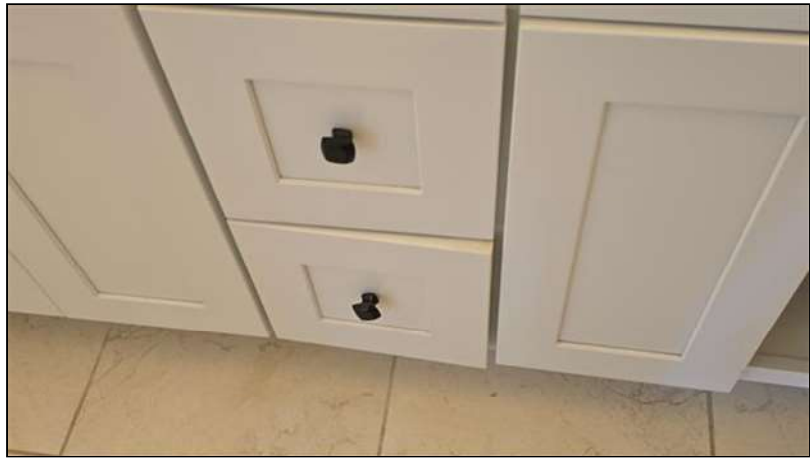
5.3 (1) The drawer in the master bathroom is crooked. Drawer feels solid and not off its tracks and may have been mounted incorrectly. Repair is necessary.

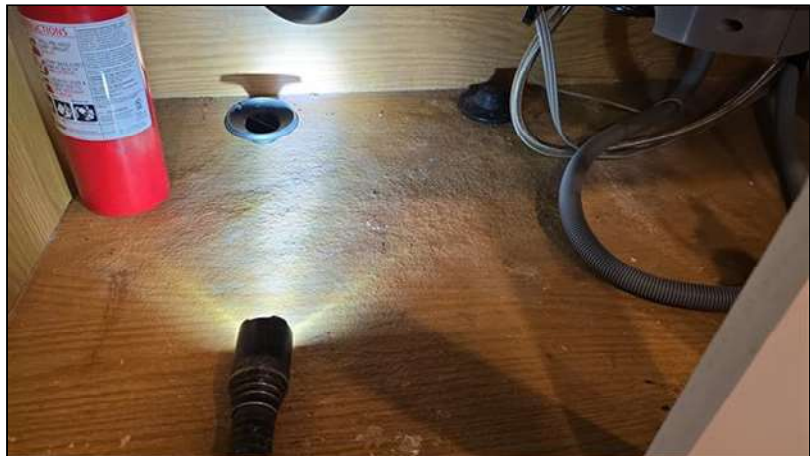
5.3 (2) Kitchen sink - the sink base has moisture damage. Recommend consulting with Seller about any previous leaks and repairs. This is a cosmetic issue only. No moisture present during inspection.

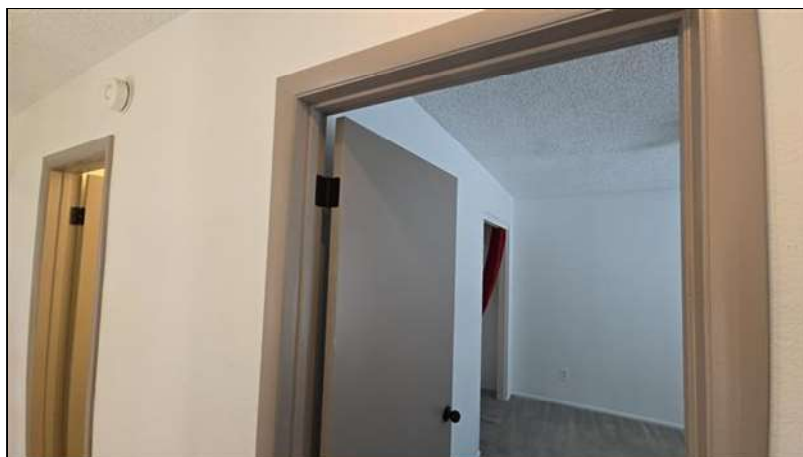
5.4 (2) Guest bedroom - the door hinge is loose and does not close properly. Recommend tightening screws to prevent damage to other hinges/door frame.

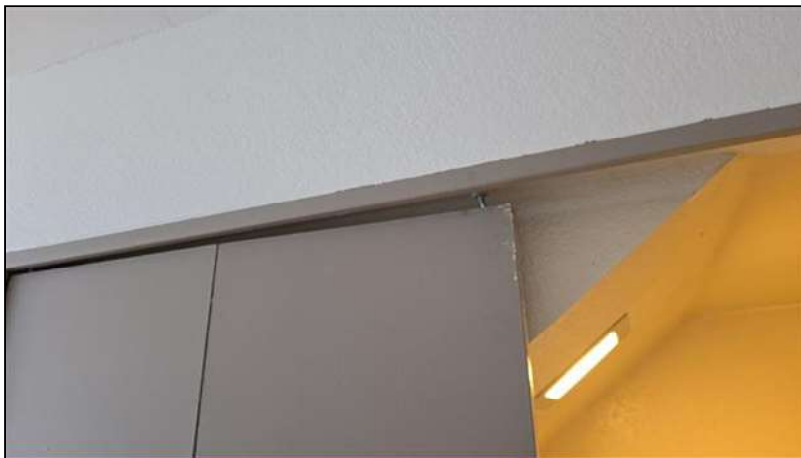
🟢 5.4 (3) Laundry - the door guide is damaged and is off its tracks. Recommend repair.

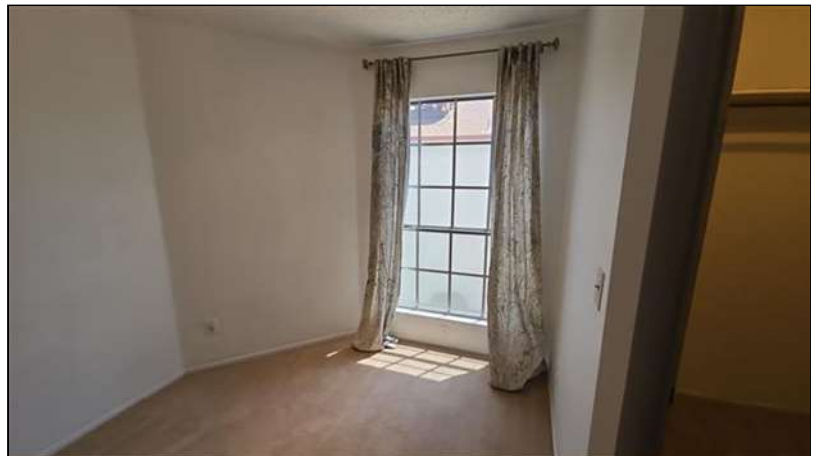
📍 5.5 (2) Master bedroom - the window will not stay up without a prop. The window balancing assembly is missing or not functioning as intended. Recommend repair for full functionality.

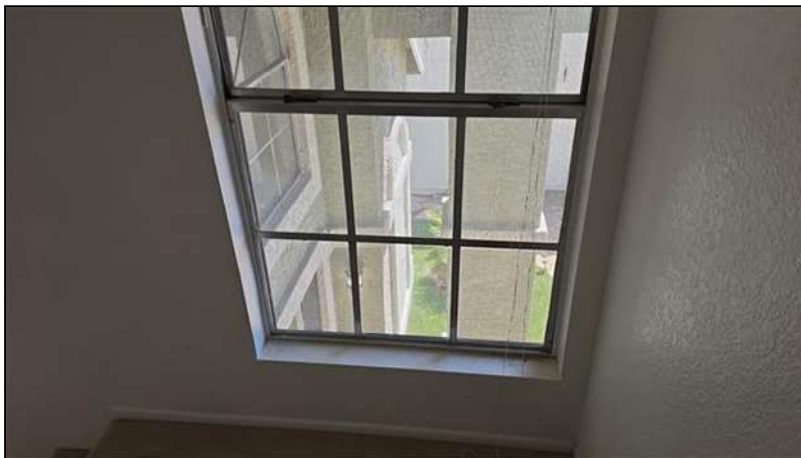
5.5 (3) Stairs - the window will not fully close and will not lock on the right side. Recommend repair.

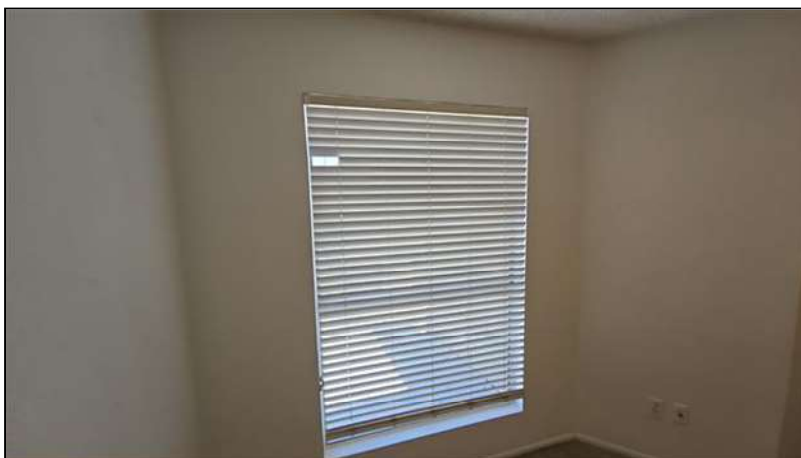
5.5 (5) Guest bedroom - the blinds are installed backwards. Recommend installing correctly.

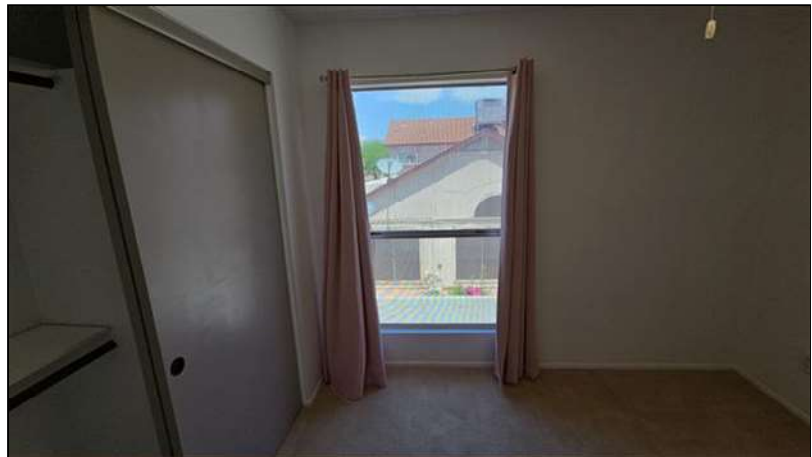
🟢 5.5 (7) Guest bedroom - the window will not stay up without a prop. The window balancing assembly is missing or not functioning as intended. Recommend repair for full functionality.

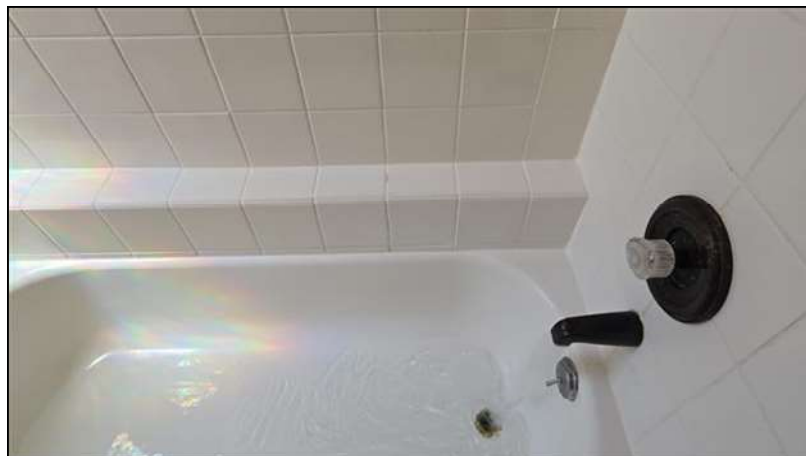
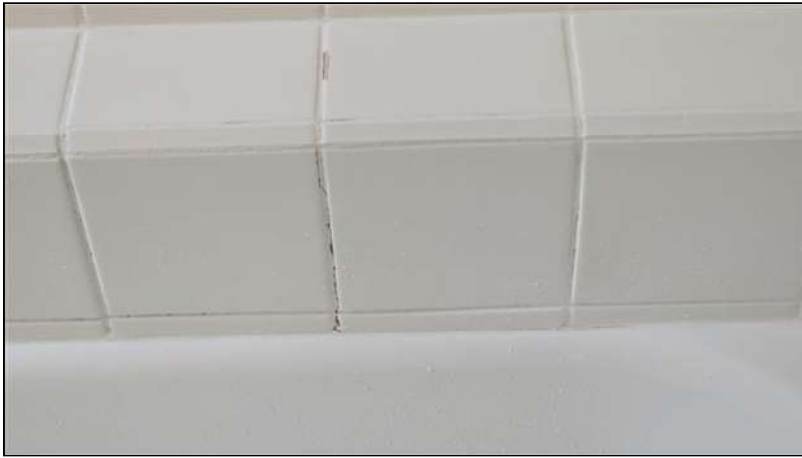
5.6 (1) Grout cracking observed at the master bathtub. Recommend repair.

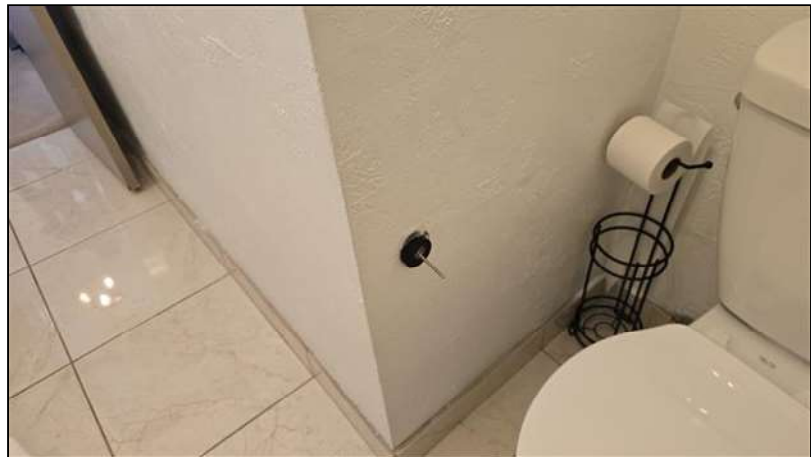
5.6 (2) Guest bathroom (upstairs) - the toilet paper holder is missing. There is a mount hanging out of the wall. Repair as necessary.

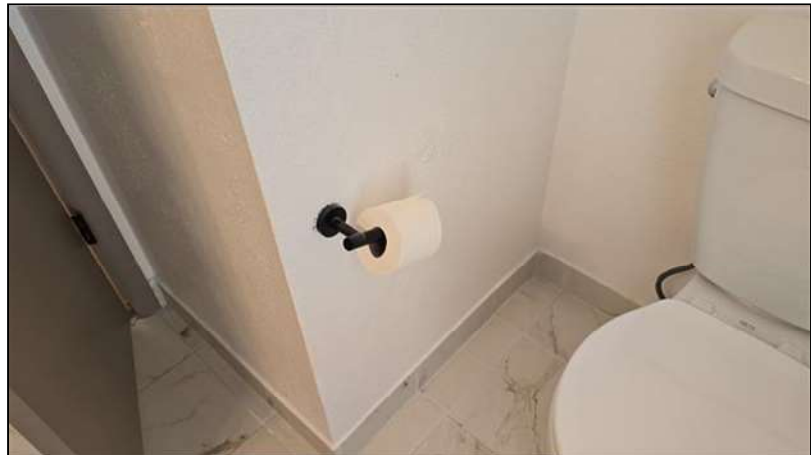
5.6 (3) Powder room - the toilet paper holder is loose. Recommend repair.

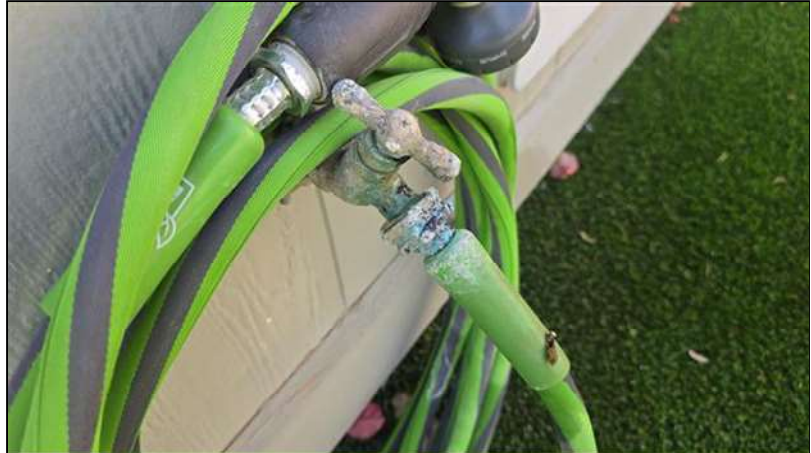
7.0 (2) Exterior (rear) - the faucet is heavily corroded and leaking. Recommended repair by a qualified plumber.

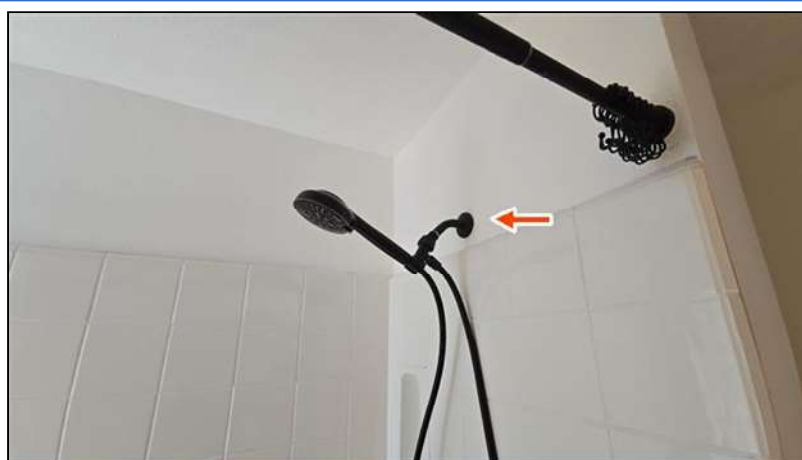
7.0 (4) The shower head piping is loose in the wall. Repeated adjustment of shower head during normal use could potential weaken piping inside the wall causing a leak. Recommend repair of the retaining clamp inside the wall to prevent piping from shifting.

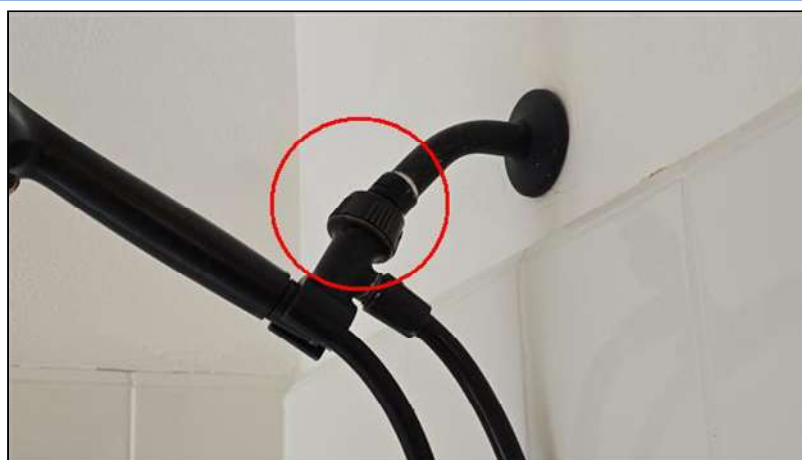
7.0 (5) Master bathtub - The shower head piping is leaking at the connection and spraying across the room. Recommend repair.

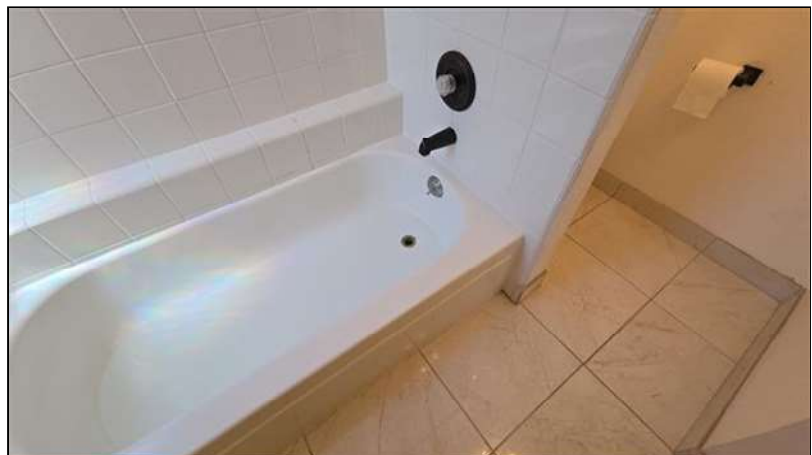
7.0 (7) Master bathtub - The drain cover is missing. Recommend replacement to prevent drain from being clogged by hair or objects that could be dropped down drain.

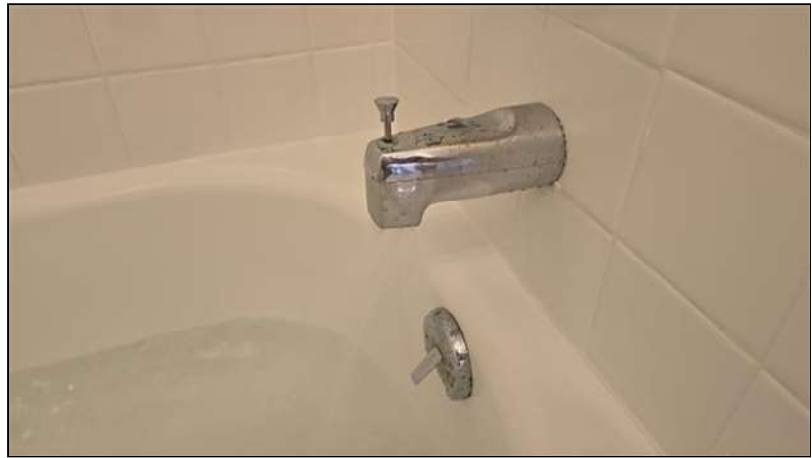
7.0 (8) Guest bathtub (upstairs) - The tub shower diverter does not fully shut off when engaged, but is partially functional. Repair as necessary

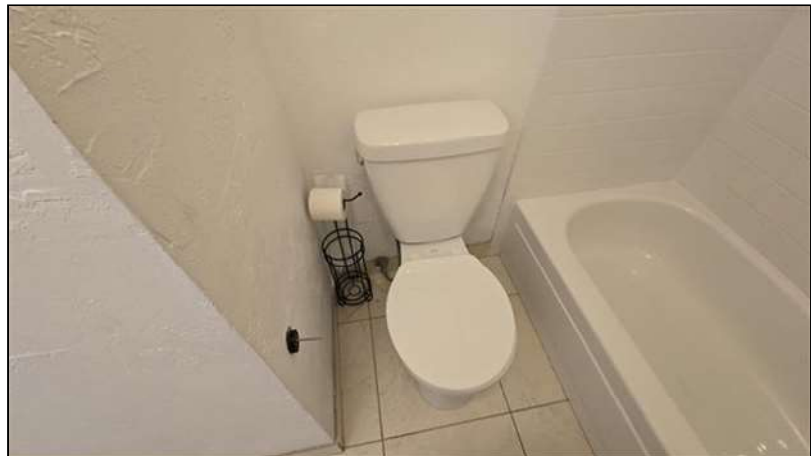
7.0 (9) Guest bath (upstairs) toilet - the bowl is loose at floor. Recommend tightening.

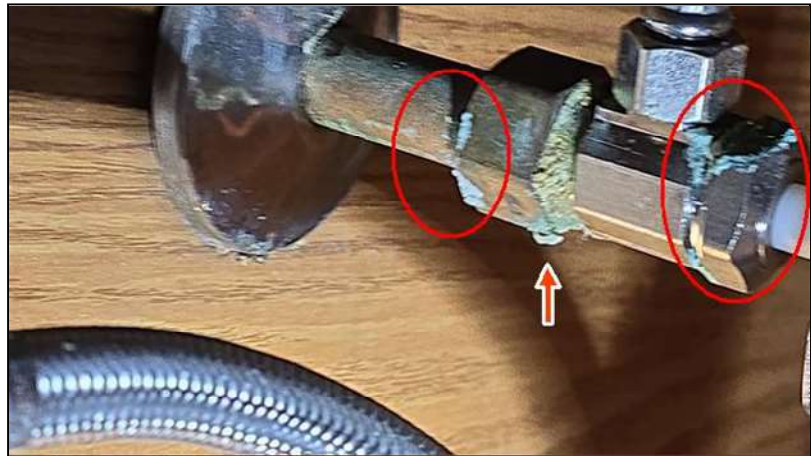
7.1 (4) Kitchen sink - piping/valves/connections are corroded and may have previously leaked (seepage) and self sealed. Recommend repair by a qualified plumber.

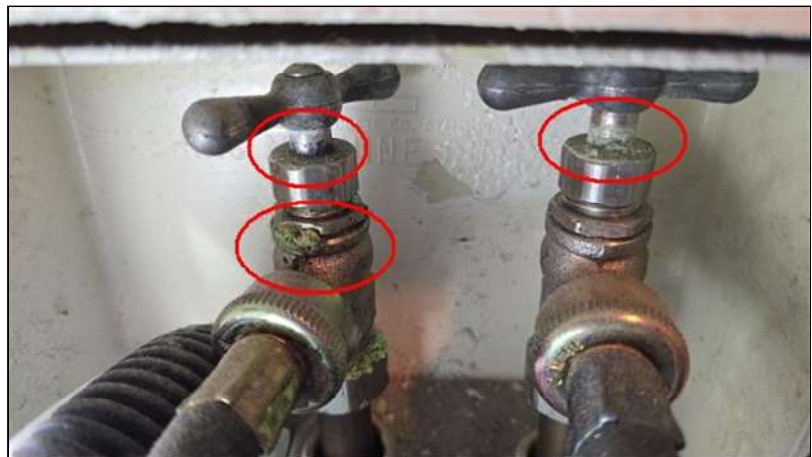
7.1 (5) Washer supply - piping/valves/connections are corroded and may have previously leaked (seepage) and self sealed. Recommend repair by a qualified plumber.

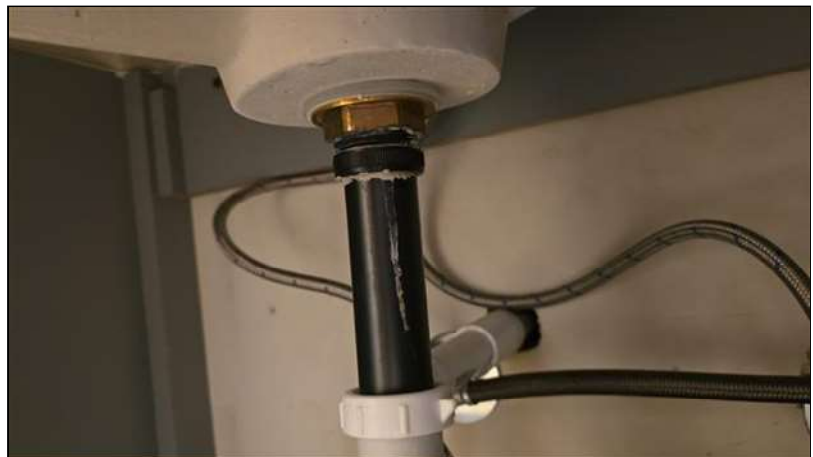
7.2 (3) Guest bath left (upstairs) sink - the plumbing drain is corroded and appears to have previously leaked (seepage) and self sealed. There is currently no moisture present at the time of the inspection. Recommend repair by a qualified plumber.

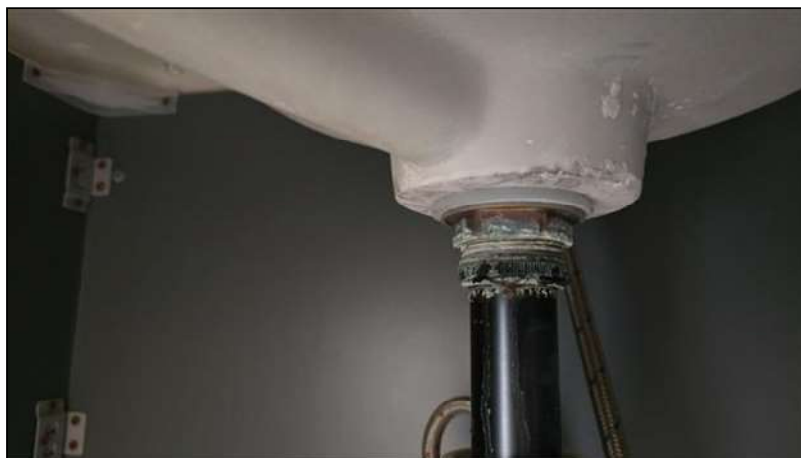
7.2 (4) Powder room sink - the plumbing drain is corroded and appears to have previously leaked (seepage) and self sealed. There is currently no moisture present at the time of the inspection. Recommend repair by a qualified plumber.
