Inspection Report

430 E Main St
Phoenix AZ 85024

Buy It Right Home Inspections LLC

Date: 5/15/2024	Time: 09:00 AM	Report ID: 20240515-430-E-Main-St
Property: 430 E Main St Phoenix AZ 85024	Customer: Joe Homebuyer	Real Estate Professional: Rhonda Carstensen My Home Group

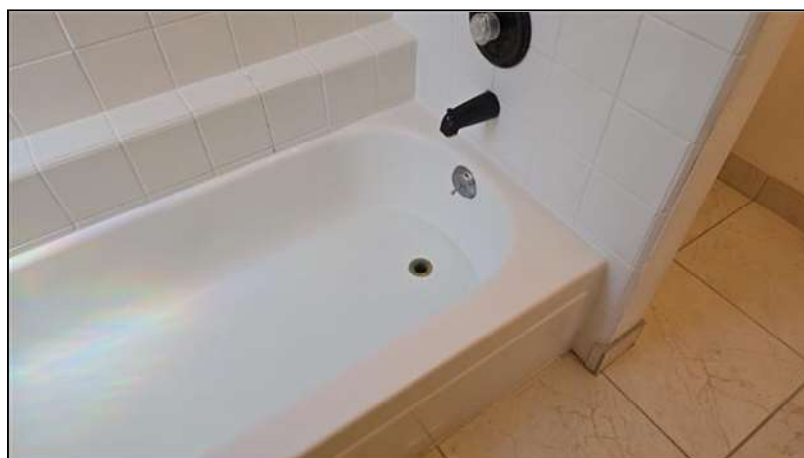
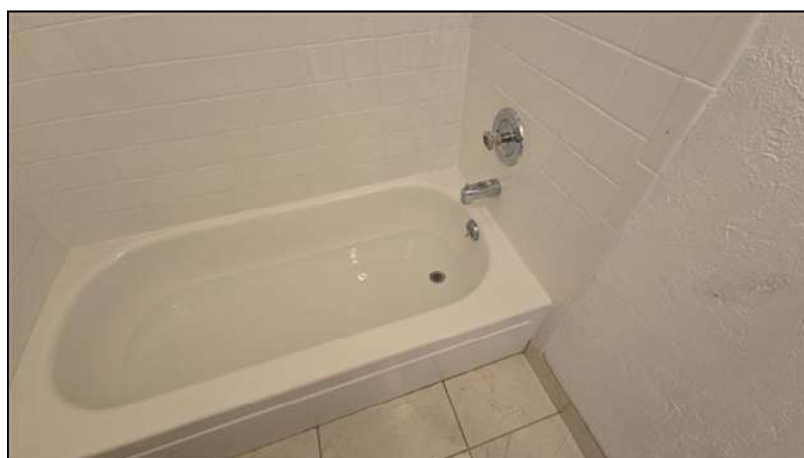
7.4 Functional drainage was visually observed from all fixtures and appears to be slow at the Master & guest bathtubs. Recommend drain be cleaned. There are several methods such as chemicals or cleaning cables that can be used to clean drains. A home inspection is a visual inspection. The inspector cannot see inside the plumbing and cannot know what the issue actually is. A more severe issue could be present and not known. A qualified plumber may be necessary to diagnose and clean the drain.

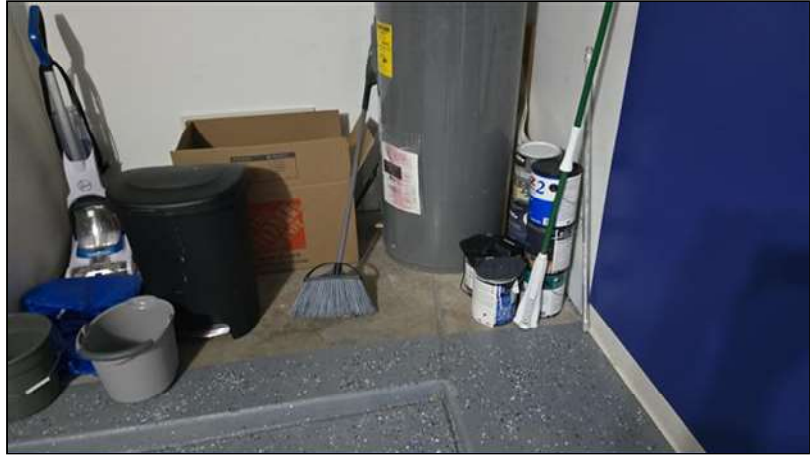
7.5 (1) The water heater tank does not have a drip pan installed. Should water heater leak it could cause damage to pedestal or surrounding areas. This is a recommended addition.

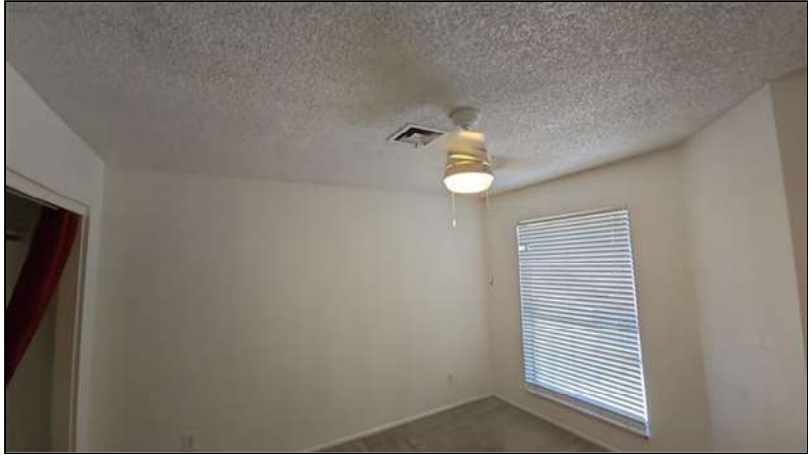
8.0 (1) Guest bedroom - The ceiling fan wobbles. Recommend adjusting the balance of the blades.

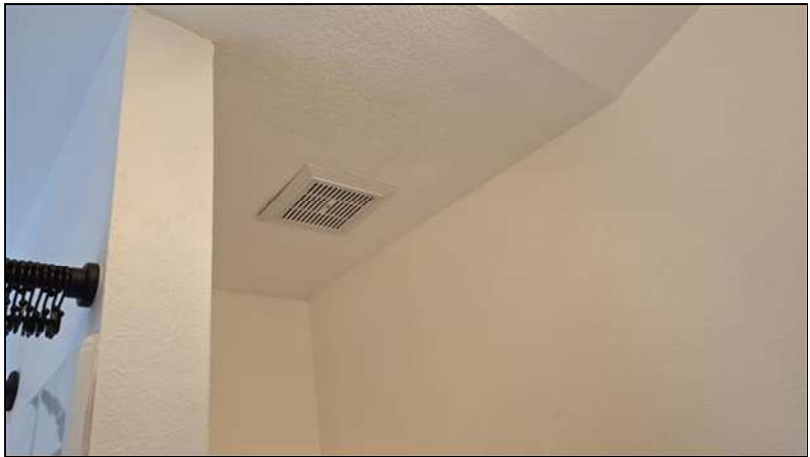
8.0 (2) Master bathroom- the exhaust fan does not turn on with the switch and only buzzes. A large number of house fires occur from faulty exhaust fans. Recommend replacement for safety.

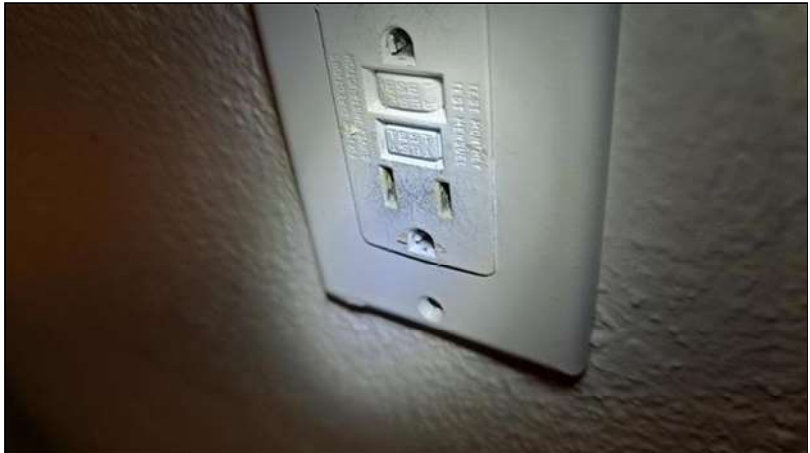
8.1 (1) Master bathroom - the outlet appears to be burnt or overheated. Recommend repair by a qualified electrician.

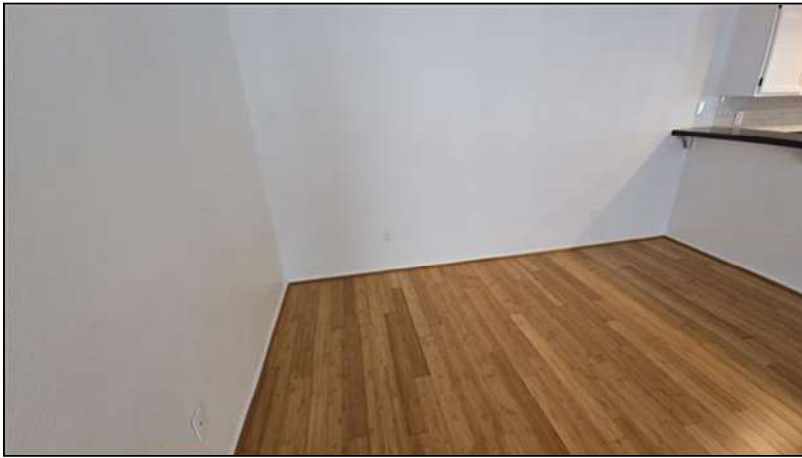
8.1 Dining room

8.1 (2) Multiple outlets are loose in the wall. Recommend repair.

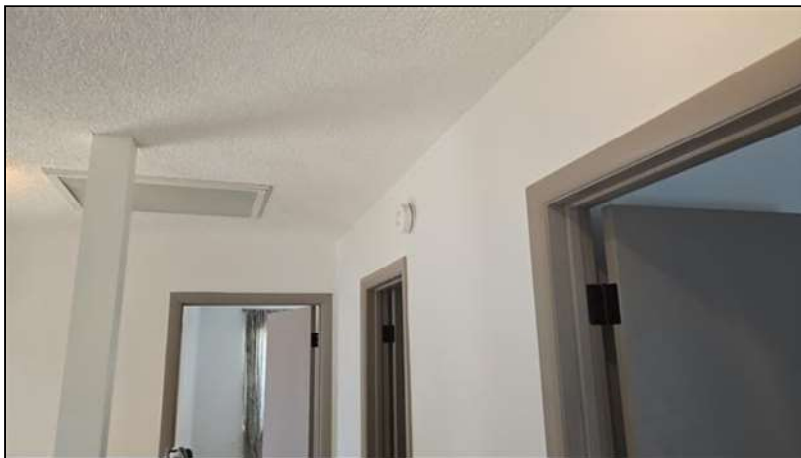
8.3 (3) The smoke detectors appear to be original. This would make them over 10 years old. It is recommend to replace smoke detectors over 10 years old as they may not properly function. Recommend replacement.

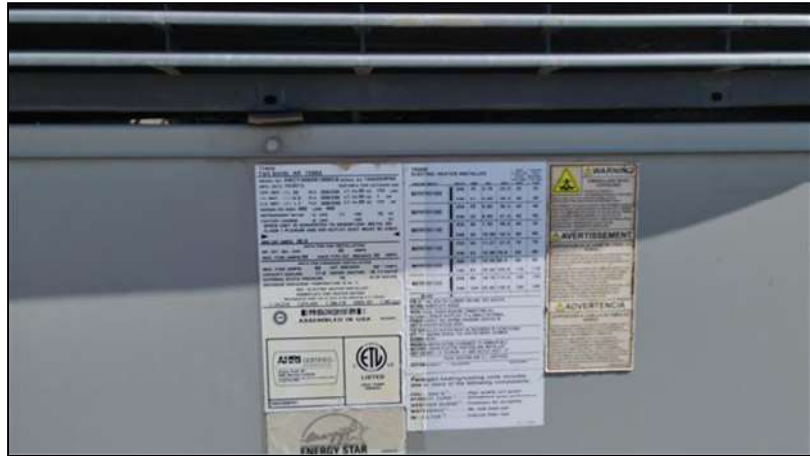
9.0

The unit ran for over 3 hrs and only brought the temperature down from 77°F to 72°F. The lowest obtainable temperature from a register was only 58°F. Properly functioning units will be in the mid 50's or lower. These are more indications that the sure is not functioning properly.

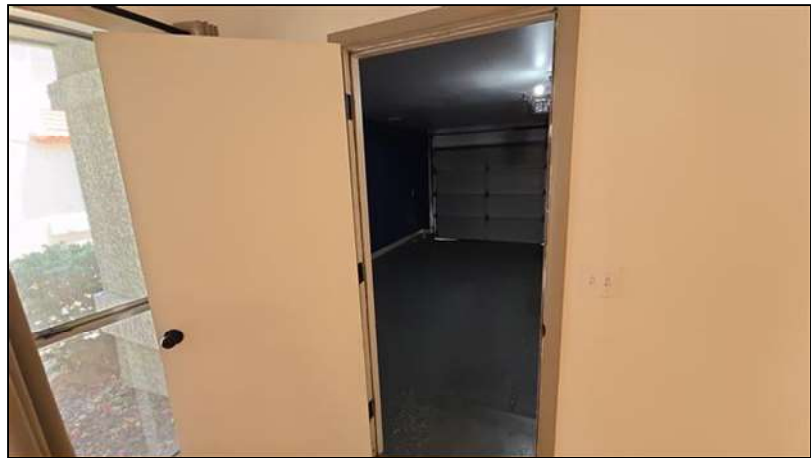
10.0 Garage - Doors into garage areas should self close, latch and have a seal to prevent carbon monoxide gases from entering livable space. Occupant door did not self close and latch. Recommend repair for safety.

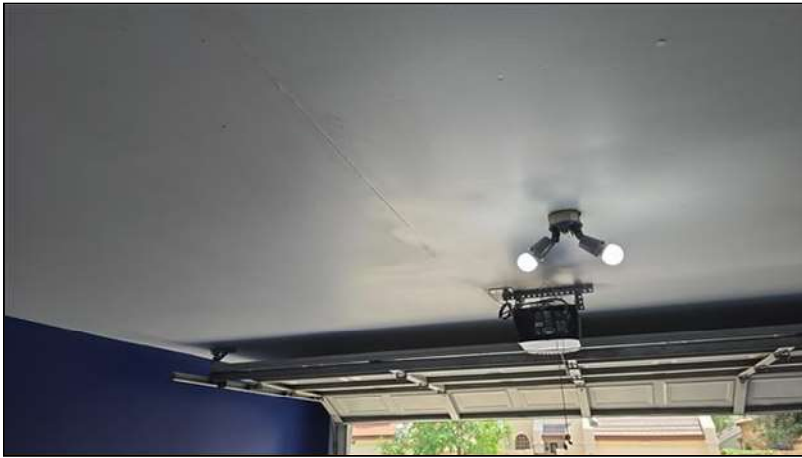
10.2 Common cracking observed in ceiling drywall. Recommend repair.

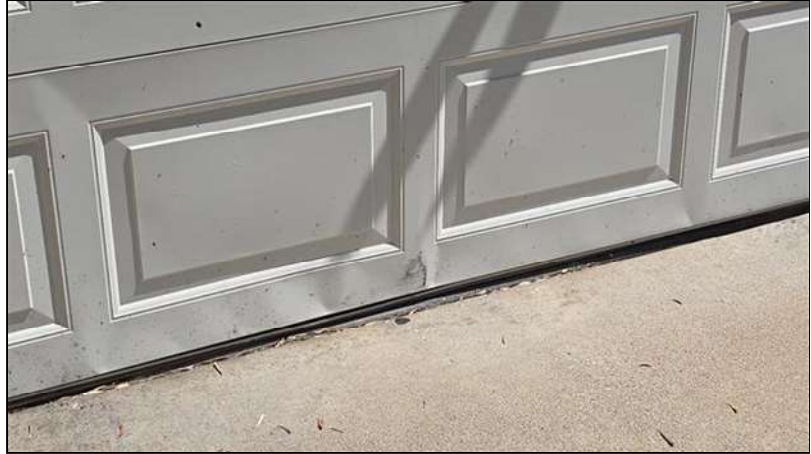
10.4 (1) Damage was observed to garage door. This appears to be cosmetic and not affecting the operation of the door at the time of the inspection, but may become worse over time as use continues to stress the damaged area. Recommend monitoring for further damage. Repair as necessary.
