# Inspection Report

**Property Address:**

1234 E. Main St  
Phoenix AZ 85040

**Buy It Right Home Inspections LLC**

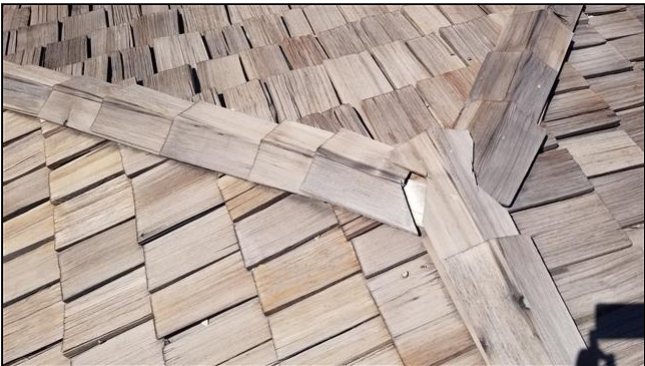
2.0

**2.0 (1)** Back side - Ridge shingle is loose and could blow off. Recommend securing shingle.

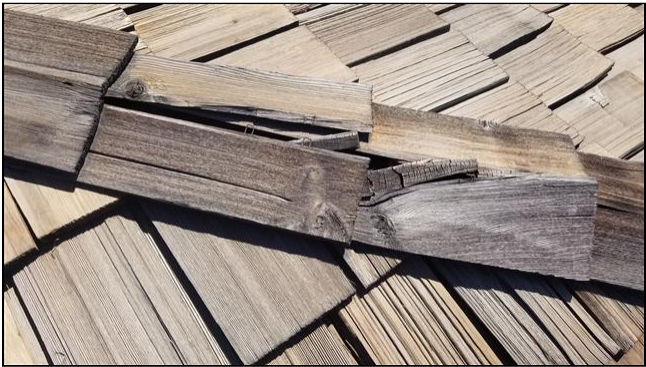
2.0

**2.0 (2)** SE side - Ridge shingles are damaged. Recommend repair by qualified roofing contractor.

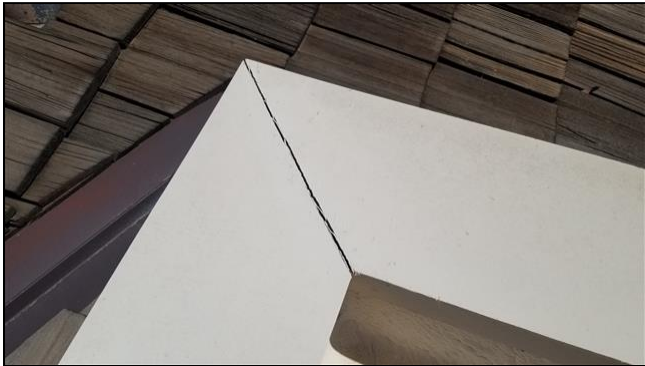
2.0

**2.0** (3) Observed some areas of cracking around perimeter of flat roof. Recommend sealing these areas to prevent moisture penetration into substructures..

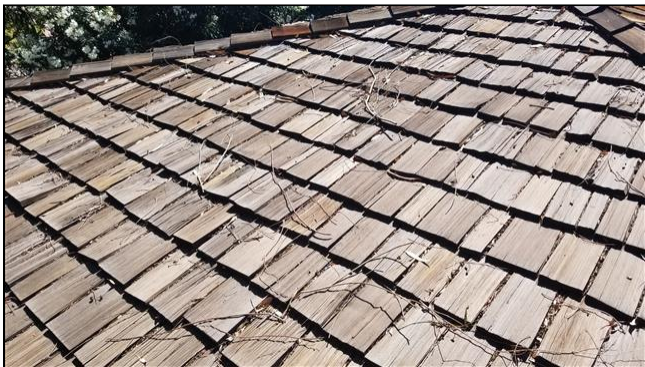
2.1

**2.1** Front of home - Observed areas with excessive debris. Excessive debris can cause water to back up, trap moisture and cause premature failure of roof coverings. Recommend removal of debris. The gutter is full of debris and dirt. Recommend cleaning to allow proper drainage of system.

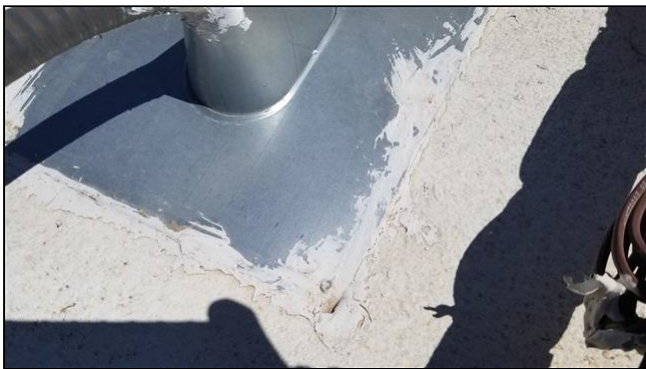
2.2

**2.2** Cracking elastomeric coating observed. Recommend sealing flashing for HVAC system that was added after roof coating.

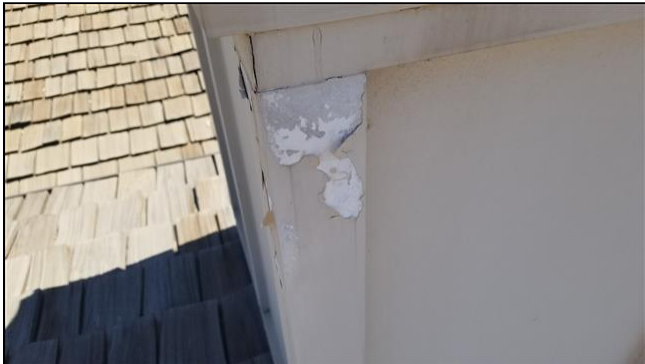
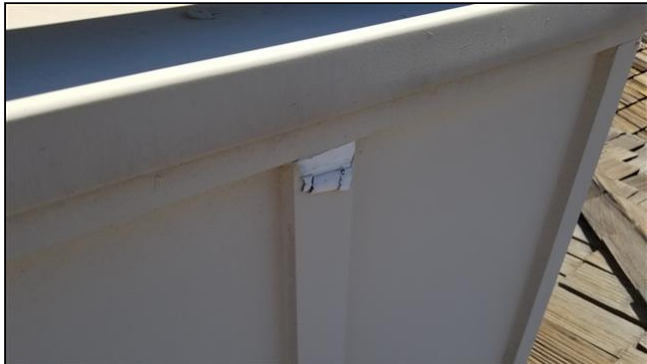
2.3

**2.3** Observed some areas of peeling paint on chimneys chase. Recommend painting to protect substructure from moisture penetration.

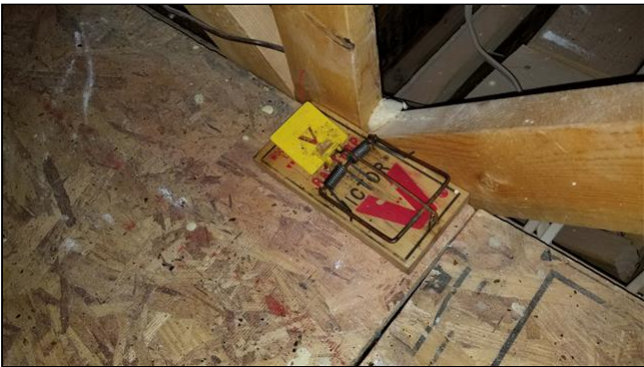
3.0

**3.0** Inspection of the roof structure and attic is limited due to insulation covering most of the attic and access being restricted. No obvious issues or leaks were observed. Rodent trap observed in attic.

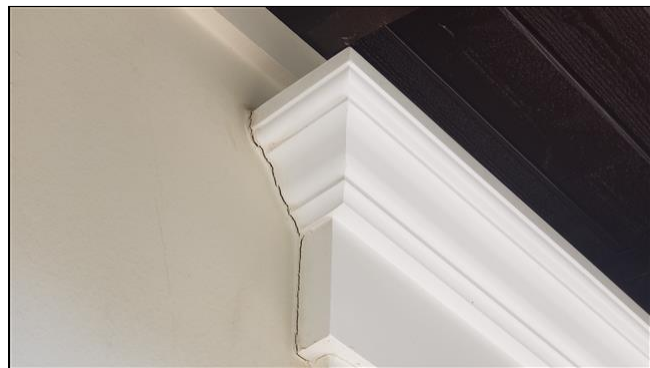
4.1

**4.1** The siding/trim is cracking. Recommend sealing areas to prevent moisture penetration into substructures.

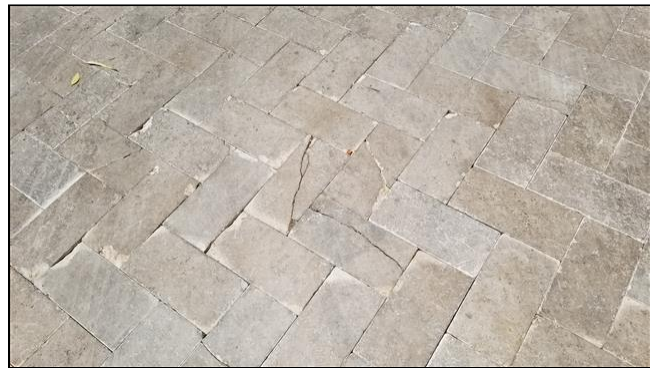
4.7

**4.7** Several broken and loose pavers observed in driveway. Recommend repair

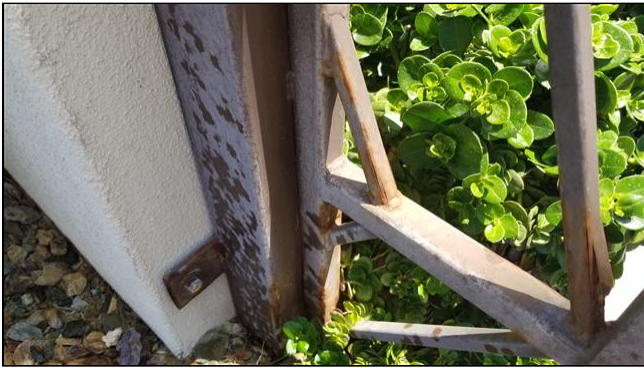
4.8

**4.8 (2)** Metal entry gate is rusting. Recommend prep and paint to prevent further deterioration. Recommend redirecting sprinklers to eliminate spray on metal structures. Gate contacts ground and will not fully open. Recommend adjustment.

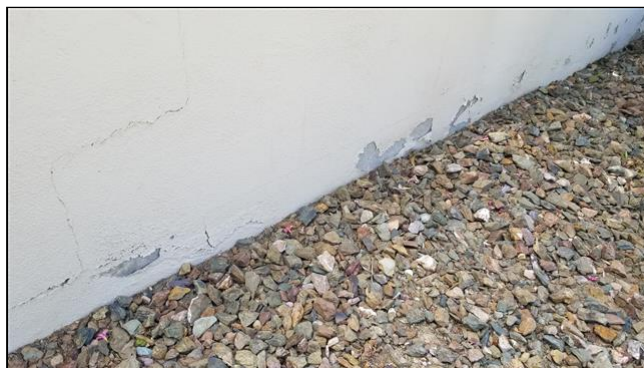
4.8

**4.8 (3)** Some areas around base of fencing are spalling. This is caused by excessive moisture. Recommend verifying that sprinkler systems and neighbors sprinkler/drip systems are not over watering in these areas and soaking through. Recommend painting these areas to protect block from deterioration.

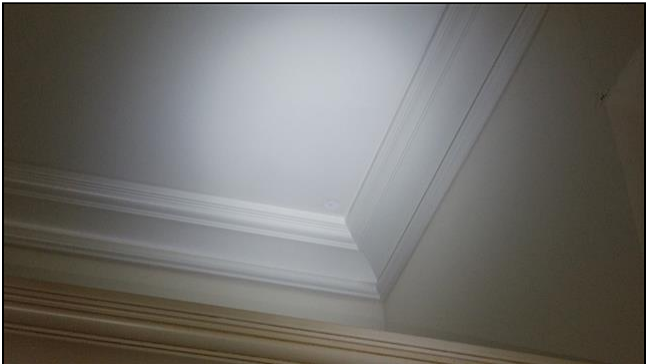
5.0

**5.0** Normal wear and tear as well as common minor drywall cracking observed in ceilings and walls. Evidence of repairs in the kitchen above refrigerators.

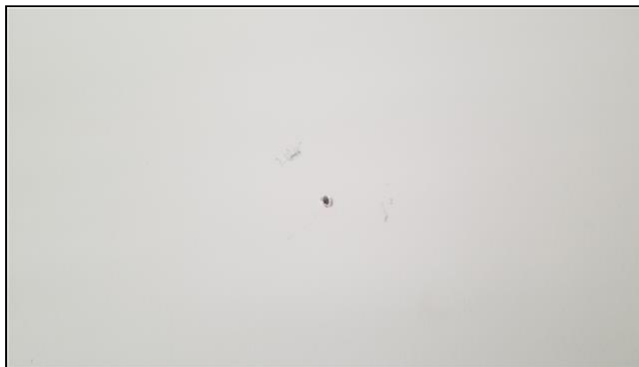
5.1

**5.1** (1) Minor damage noted in master bath toilet room.

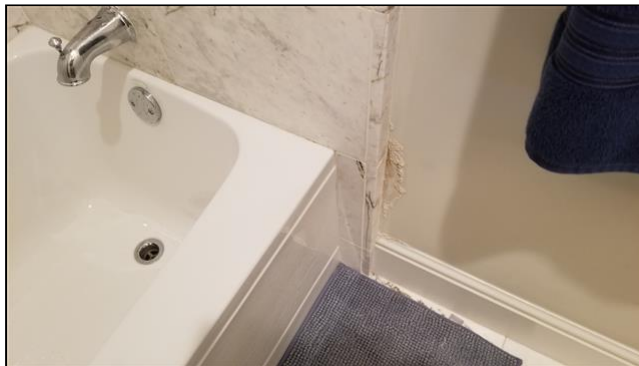
5.1

**5.1** (2) Guest bath off of game room - Moisture damage observed at edge of shower. This is an active leak. Moisture is present. Recommend repair.

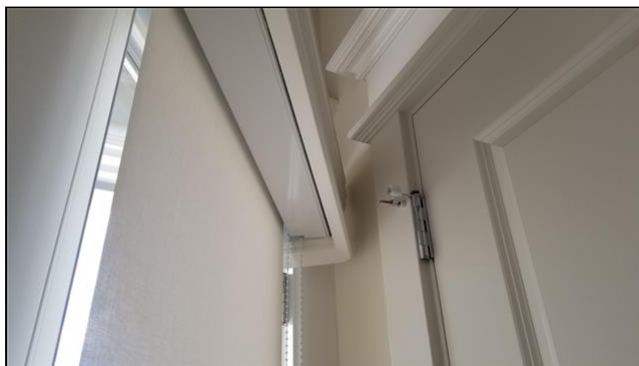
5.4

**5.4** Master bath exterior door does not fully open due to installation of blinds.

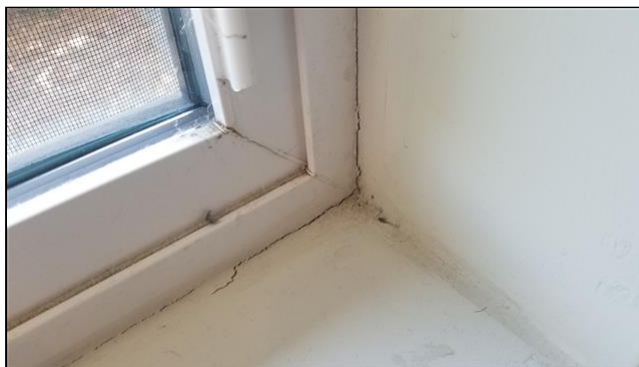
5.5

**5.5** Several - Windows is cracking around perimeter of window. This is a cosmetic issue. Repair as needed.

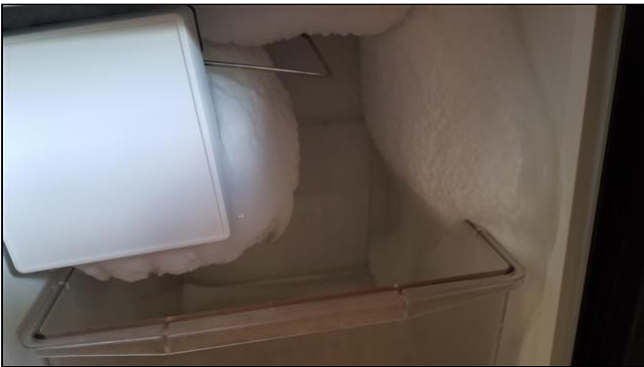
6.5

**6.5** Ice maker at wet bar has frozen over. Recommend repair.

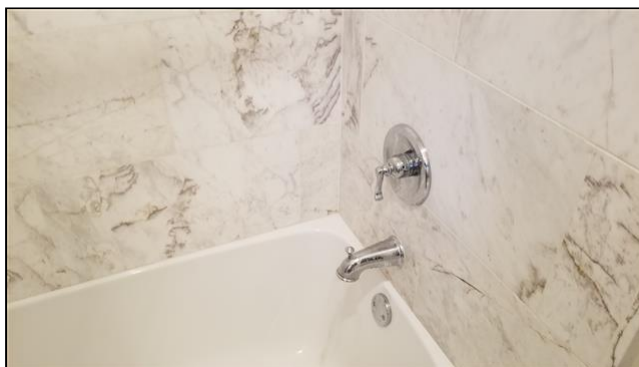
7.3

**7.3 (1)** Guest bathroom off of the game room - tub faucet is loose does not function. Diverter valve for shower is stuck. Recommend repair.

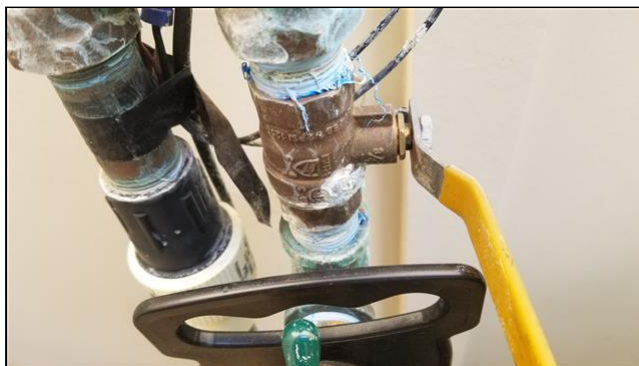
7.3

**7.3 (2)** Atrium to guest quarters - piping is corroded and appears to have previously leaked. Recommend repair

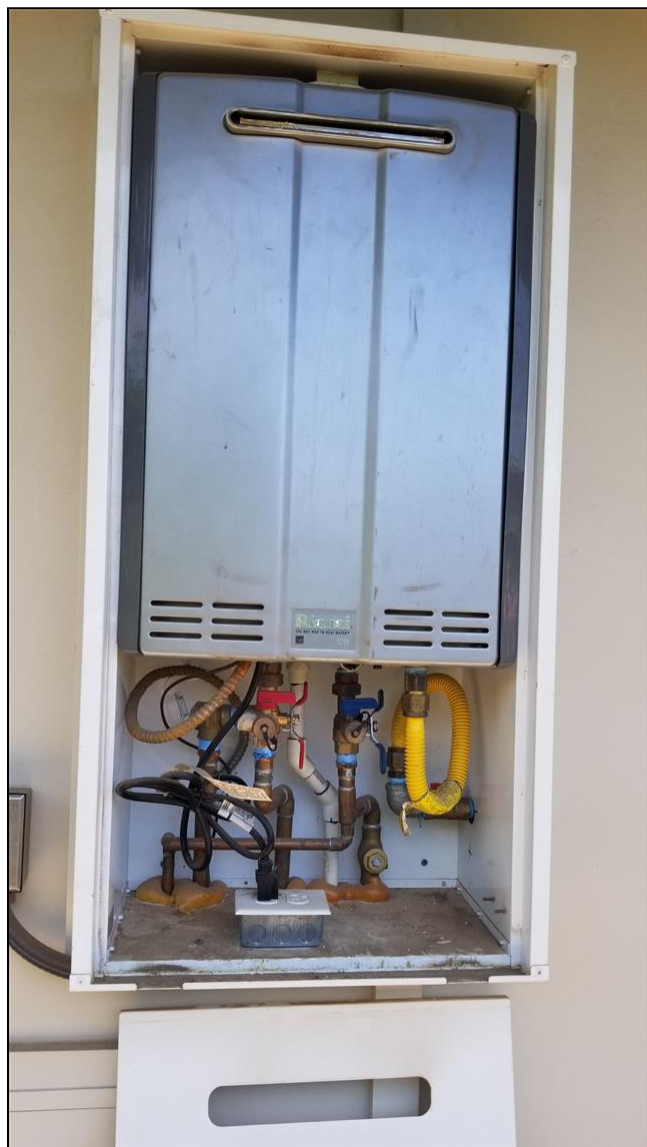
7.7 SW side exterior

**7.7** Corrosion at water heater piping both units same location. Recommend repair by qualified plumber.

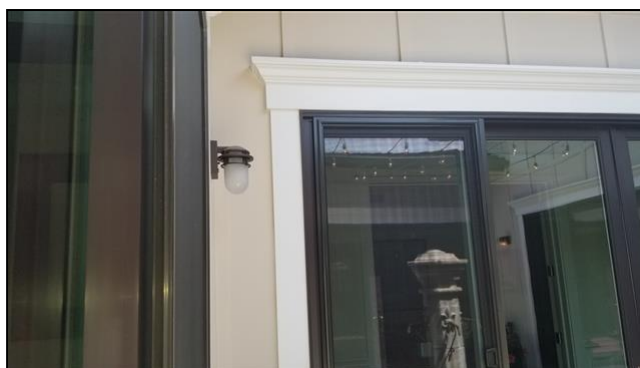
8.4

**8.4** Atrium - The light fixture does not work (try bulb first).

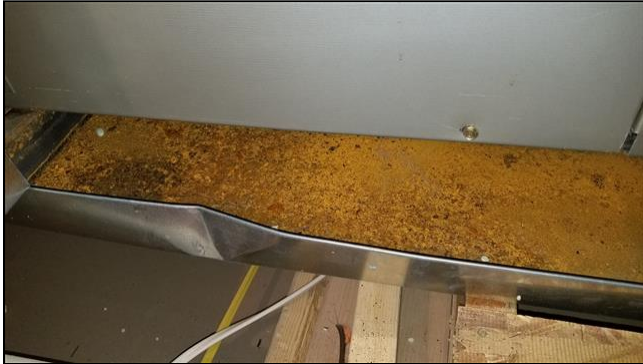
9.0

**9.0** (1) Both units near game room access hatch - Rust observed at mounting frame indicating condensate system is overflowing outside of panel. Rusting/staining also observed in secondary condensate drip pans of both units. Recommend evaluation from a qualified HVAC technician.

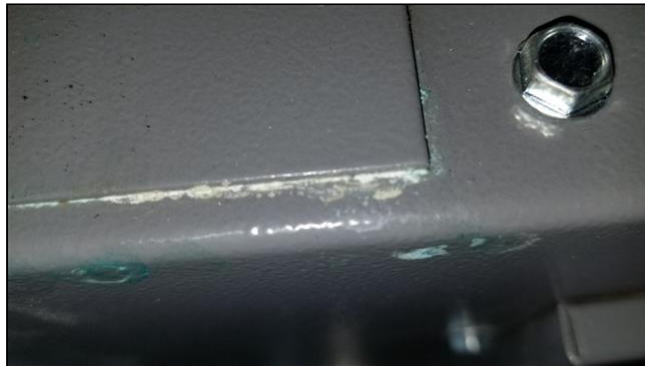
9.0

**9.0** (2) Unit #5 - no secondary drip line present. System has been draining through panel. Recommend further evaluation by an HVAC technician.

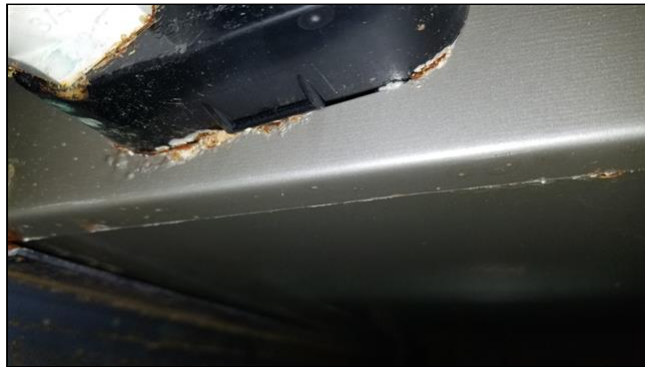
9.0

**9.0** (3) Unit # 4 - observed corrosion around condensate fitting indicating that fitting is not sealed correctly. Recommend further evaluation by an HVAC technician..

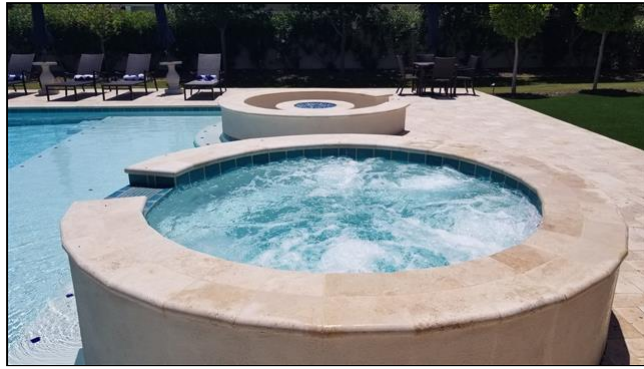
12.6

**12.6** Several spa therapy heads do not produce blower agitation. Recommend evaluation from a qualified pool repair technician.

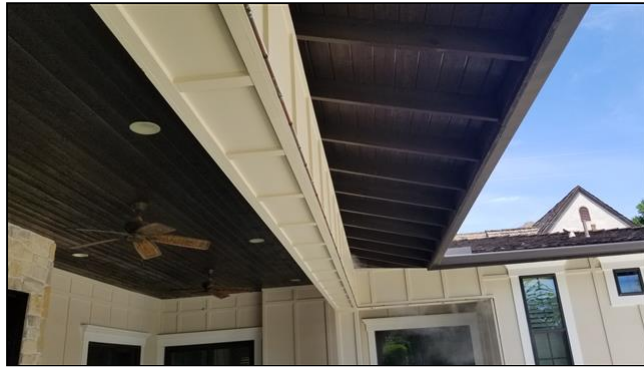
12.8

**12.8** Majority of misting system heads are plugged. Recommend cleaning.

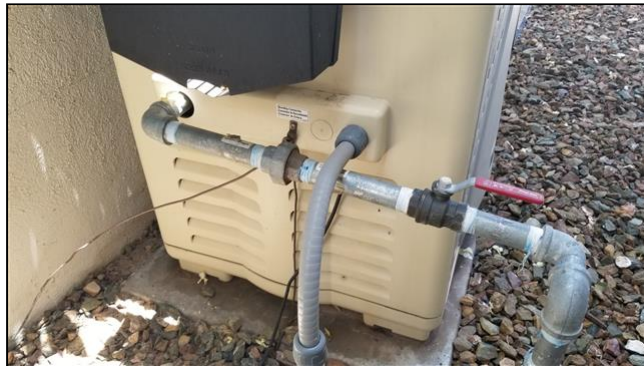
12.9

**12.9** Missing sediment trap for gas line at pool heater. Recommend repair by a qualified plumber.

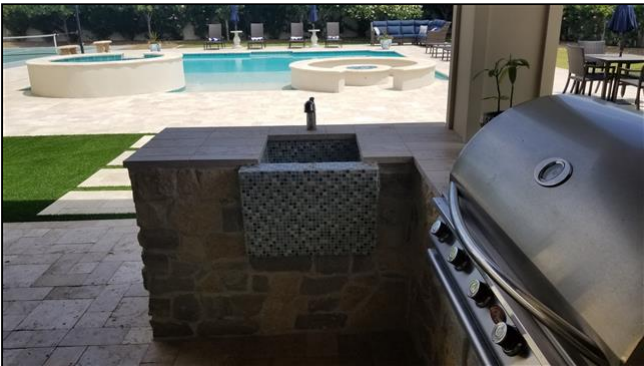
13.0

**13.0** Hot water is not present at patio.

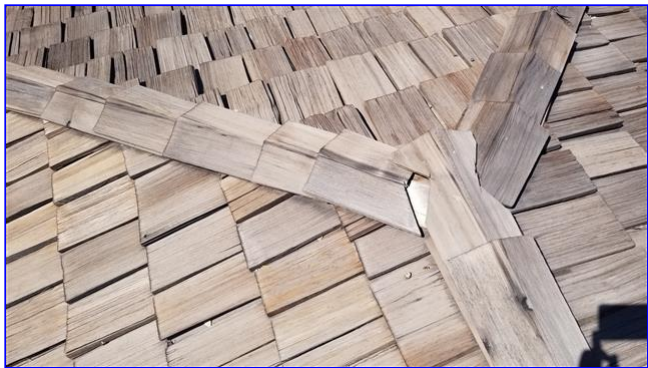
2.0

- (1) Back side - Ridge shingle is loose and could blow off. Recommend securing shingle.

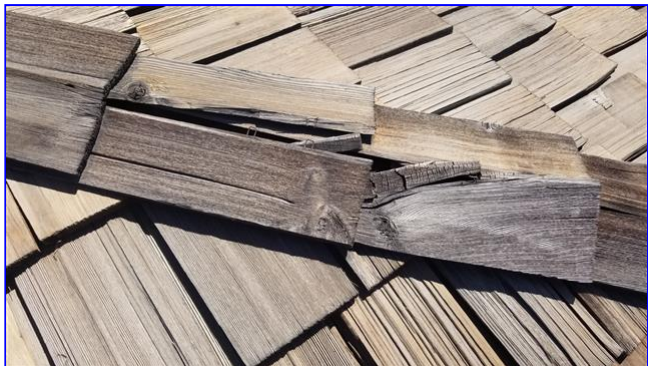
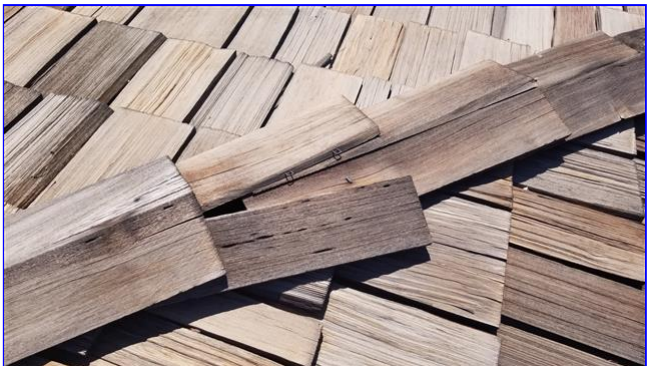
2.0

(2) SE side - Ridge shingles are damaged. Recommend repair by qualified roofing contractor.

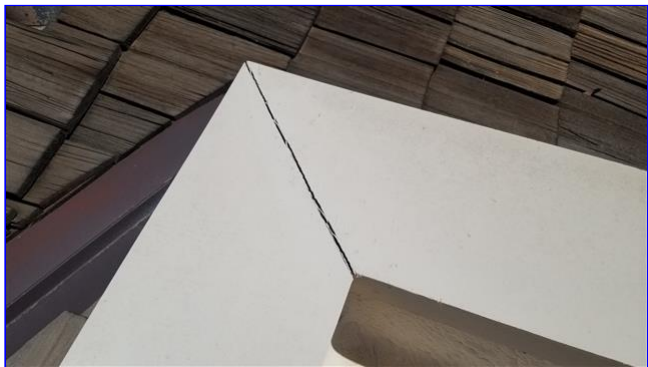
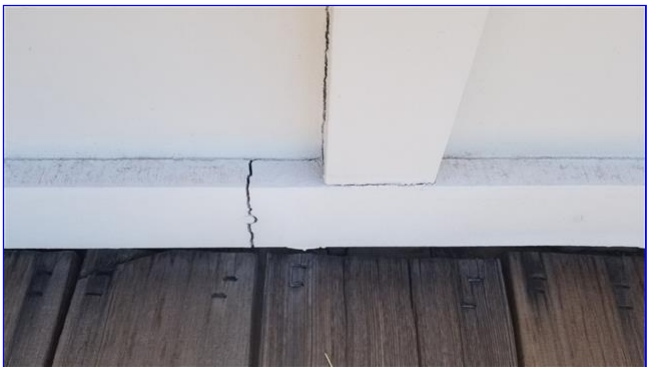
2.0

(3) Observed some areas of cracking around perimeter of flat roof. Recommend sealing these areas to prevent moisture penetration into substructures..

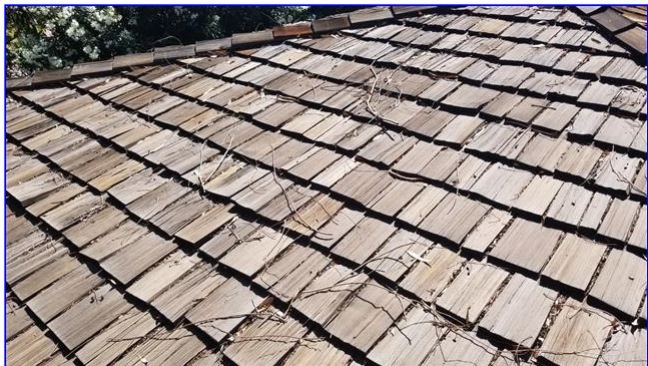
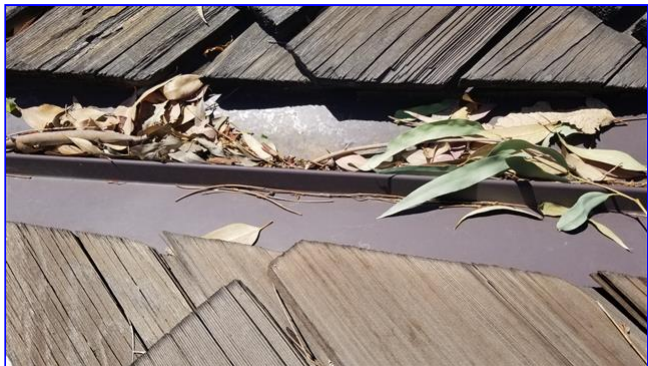
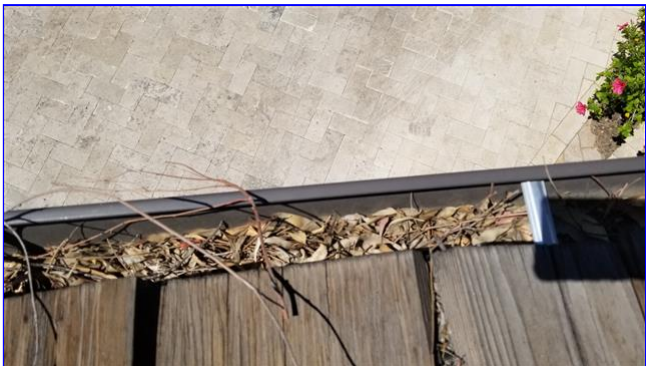
2.1

Front of home - Observed areas with excessive debris. Excessive debris can cause water to back up, trap moisture and cause premature failure of roof coverings. Recommend removal of debris. The gutter is full of debris and dirt. Recommend cleaning to allow proper drainage of system.

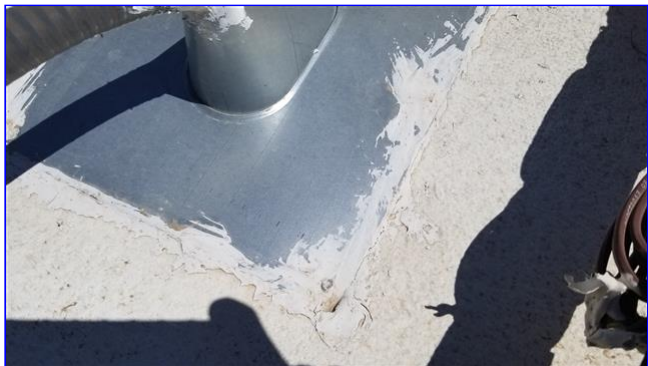
2.2

Cracking elastomeric coating observed. Recommend sealing flashing for HVAC system that was added after roof coating.

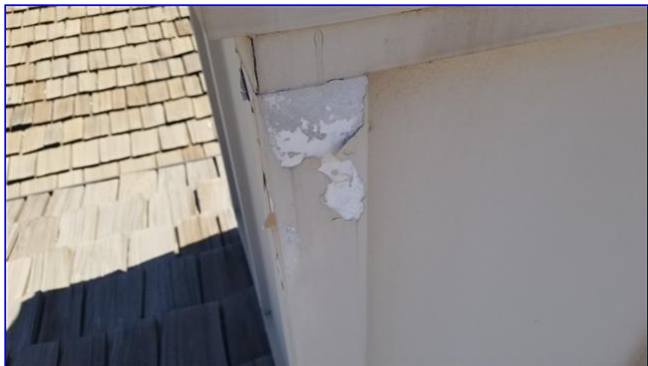
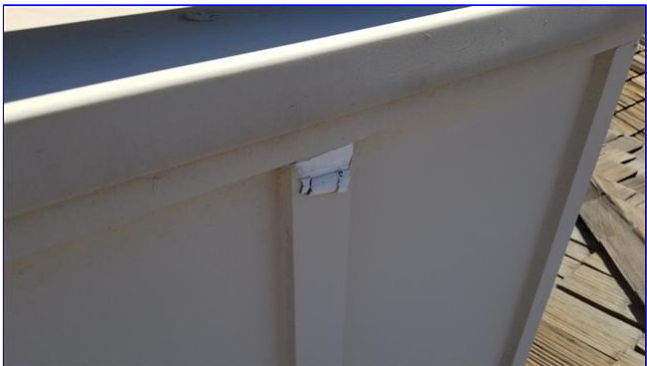
2.3

Observed some areas of peeling paint on chimneys chase. Recommend painting to protect substructure from moisture penetration.

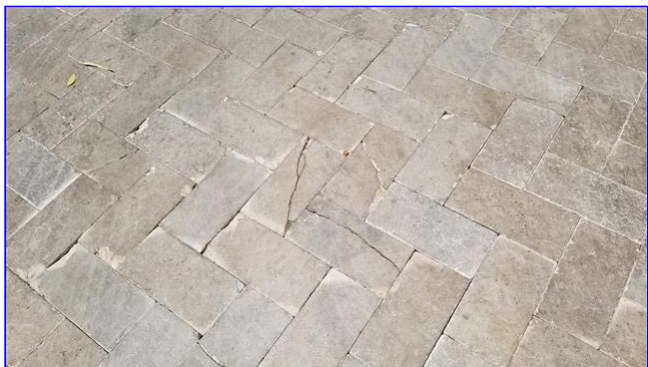
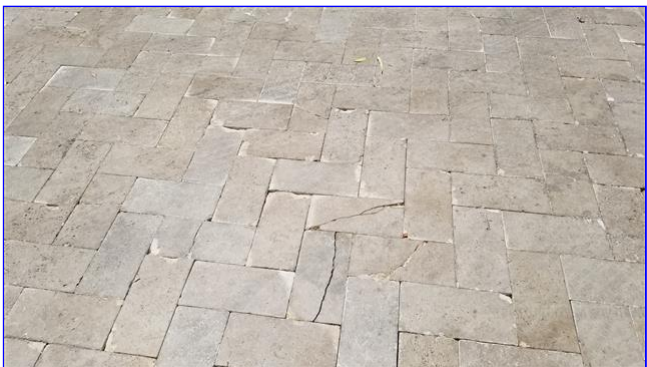
4.7

Several broken and loose pavers observed in driveway. Recommend repair

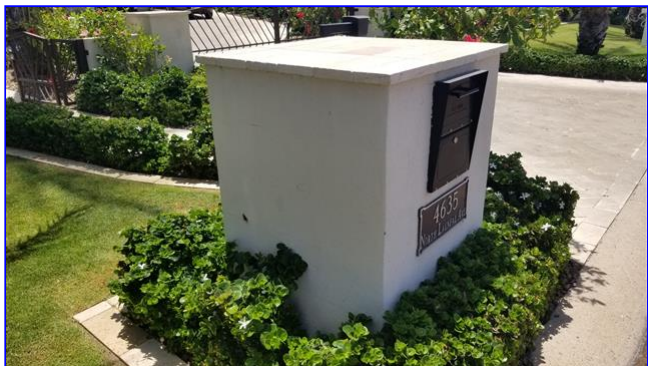
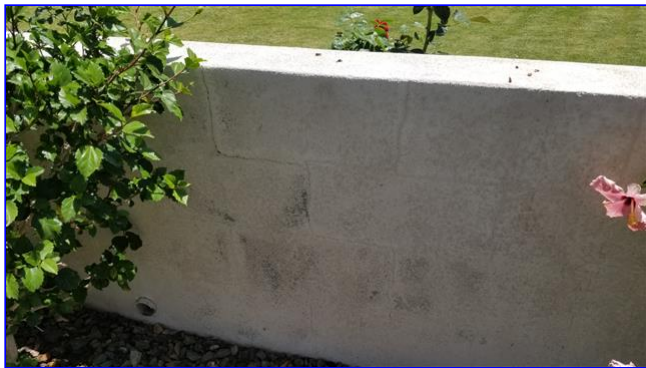
4.8

(1) Front of home - Observed cracking in retaining wall in several areas. This does not appear to compromise the structural integrity at this time.

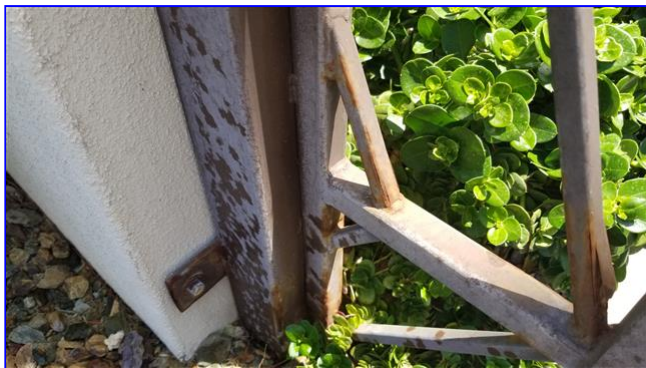
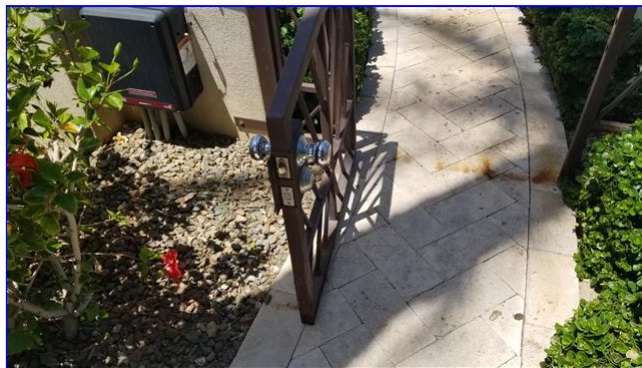
4.8

(2) Metal entry gate is rusting. Recommend prep and paint to prevent further deterioration. Recommend redirecting sprinklers to eliminate spray on metal structures. Gate contacts ground and will not fully open. Recommend adjustment.

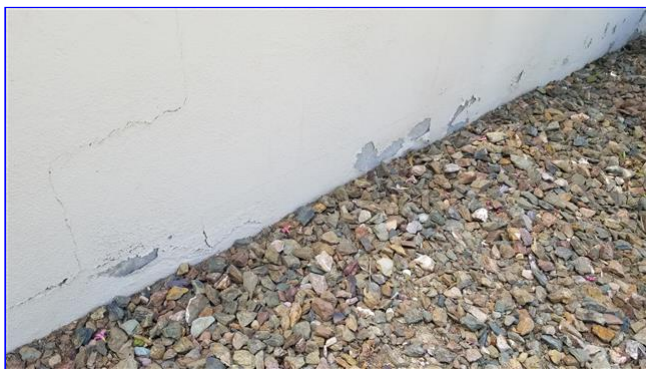
4.8

(3) Some areas around base of fencing are spalling. This is caused by excessive moisture. Recommend verifying that sprinkler systems and neighbors sprinkler/drip systems are not over watering in these areas and soaking through. Recommend painting these areas to protect block from deterioration.

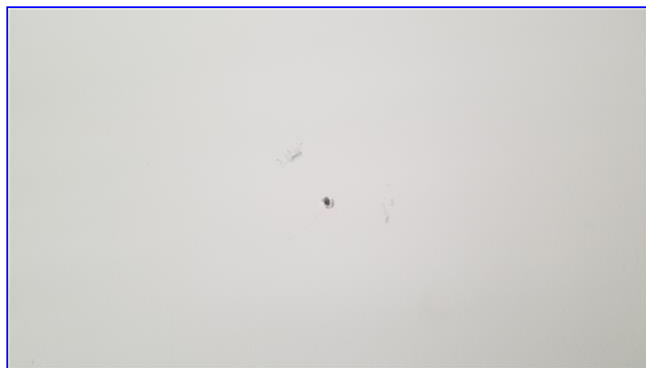
5.1

(1) Minor damage noted in master bath toilet room.

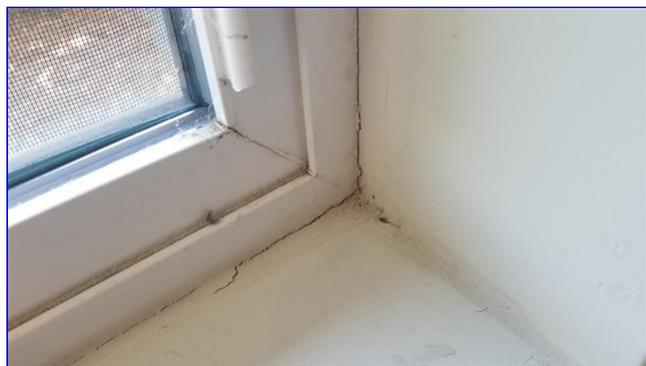
5.5

Several - Windows is cracking around perimeter of window. This is a cosmetic issue. Repair as needed.

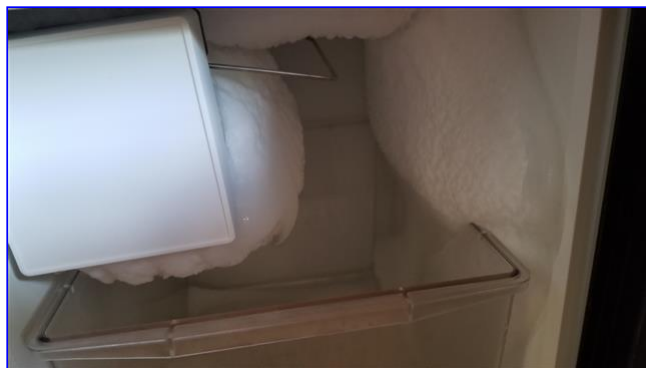
6.5

Ice maker at wet bar has frozen over. Recommend repair.

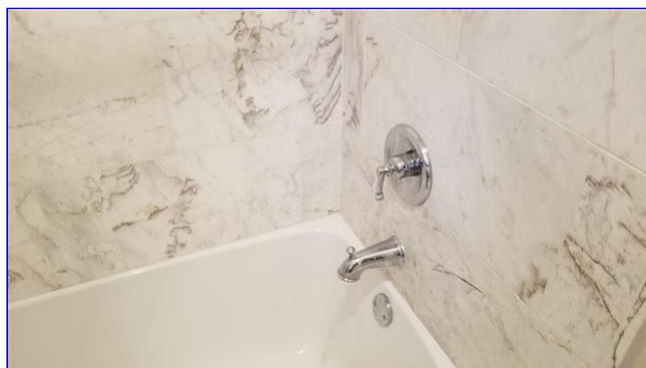
7.3

(1) Guest bathroom off of the game room - tub faucet is loose does not function. Diverter valve for shower is stuck. Recommend repair.

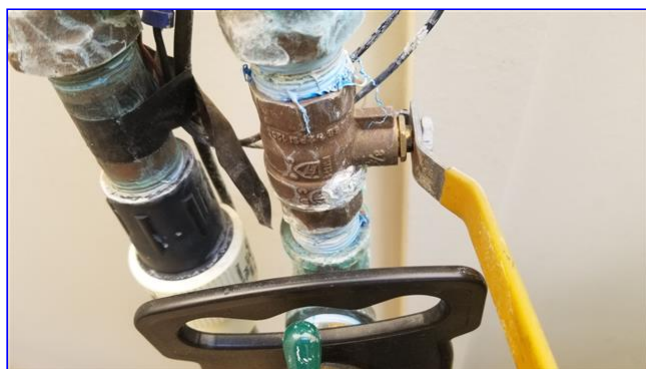
7.3

(2) Atrium to guest quarters - piping is corroded and appears to have previously leaked. Recommend repair

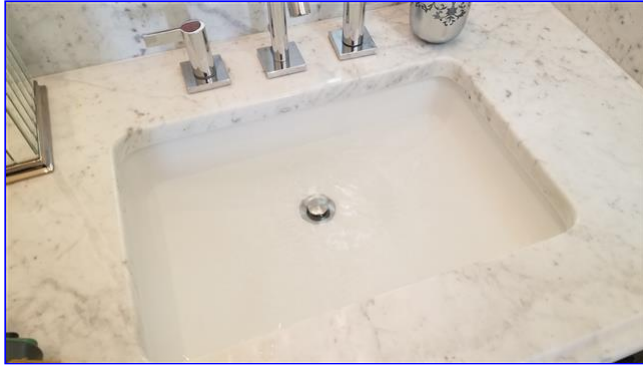
7.6

Functional drainage was visually observed from all fixtures and appears to be slow at the Guest bath sink (front). Recommend repair.

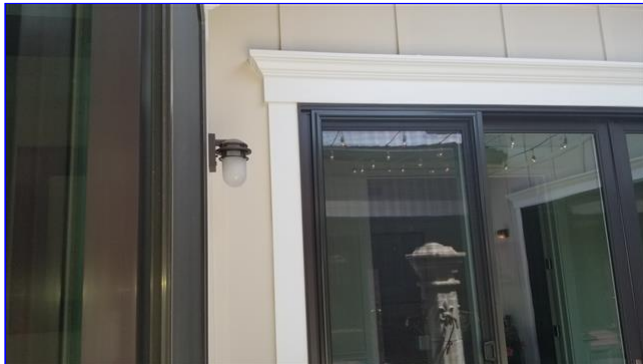
8.4

Atrium - The light fixture does not work (try bulb first).

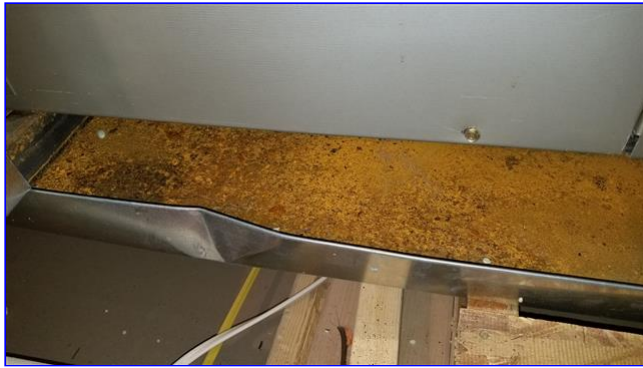
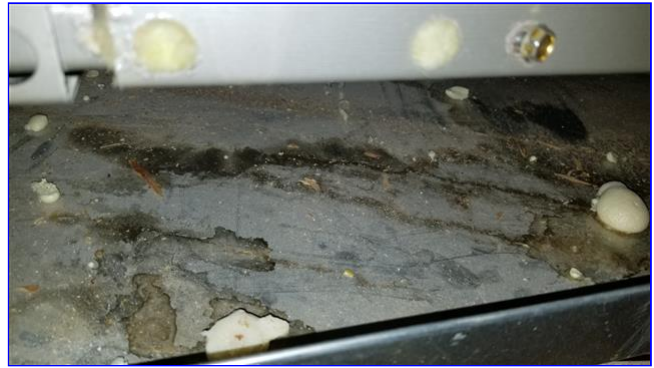
9.0

(1) Both units near game room access hatch - Rust observed at mounting frame indicating condensate system is overflowing outside of panel. Rusting/staining also observed in secondary condensate drip pans of both units. Recommend evaluation from a qualified HVAC technician.

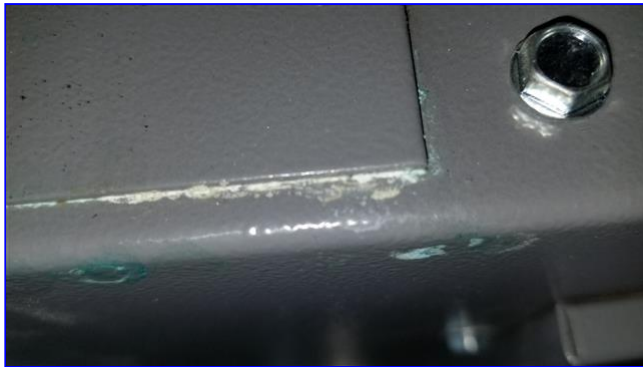
9.0

(2) Unit #5 - no secondary drip line present. System has been draining through panel. Recommend further evaluation by an HVAC technician.

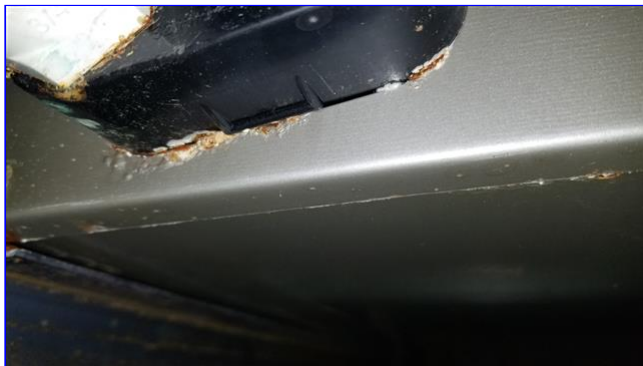
9.0

(3) Unit # 4 - observed corrosion around condensate fitting indicating that fitting is not sealed correctly. Recommend further evaluation by an HVAC technician..

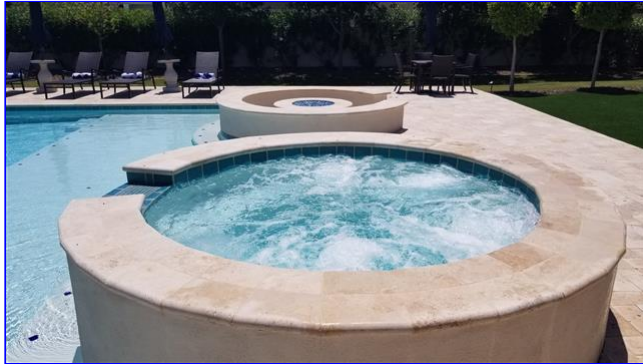
12.6

Several spa therapy heads do not produce blower agitation. Recommend evaluation from a qualified pool repair technician.

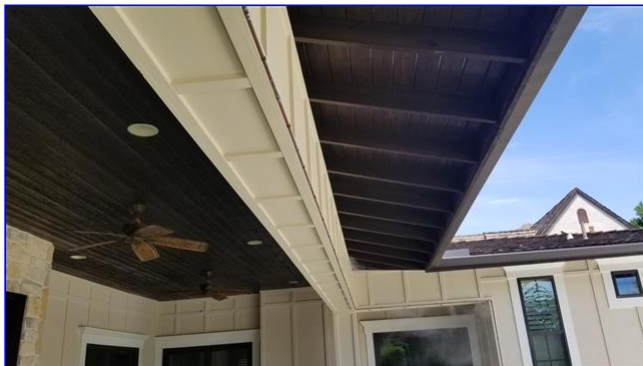
12.8

Majority of misting system heads are plugged. Recommend cleaning.

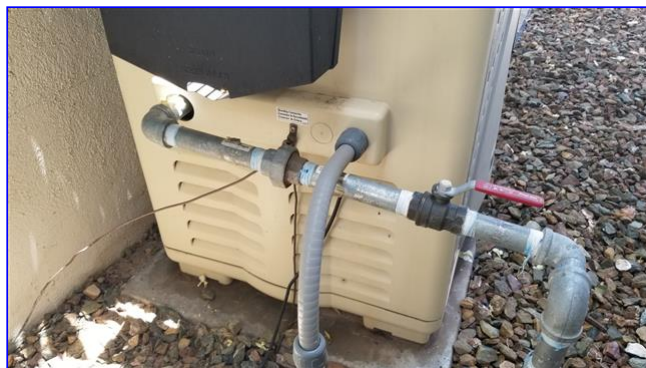
12.9

Missing sediment trap for gas line at pool heater. Recommend repair by a qualified plumber.
