Inspection Report

430 E Main St
Phoenix AZ 85024

Buy It Right Home Inspections LLC

Date: 5/15/2024	Time: 09:00 AM	Report ID: 20240515-430-E-Main-St
Property: 430 E Main St Phoenix AZ 85024	Customer: Joe Homebuyer	Real Estate Professional: Rhonda Carstensen My Home Group

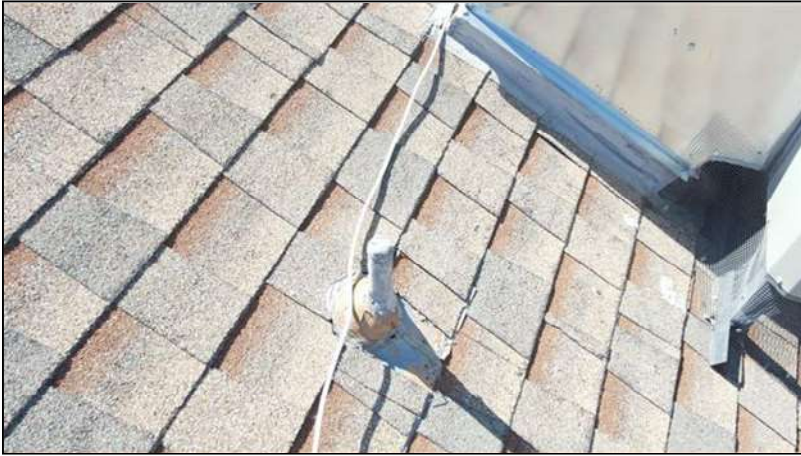
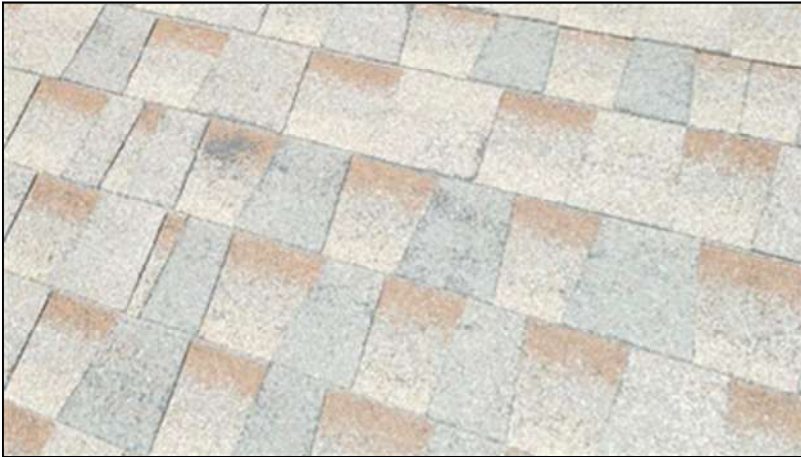
1.1 The average life span of architectural shingles is 20-25 years in Arizona. The roof coverings are showing significant signs of ageing and are nearing or at the end of their useful life. Recommend consulting with a qualified roofing contractor regarding repairs/replacement.

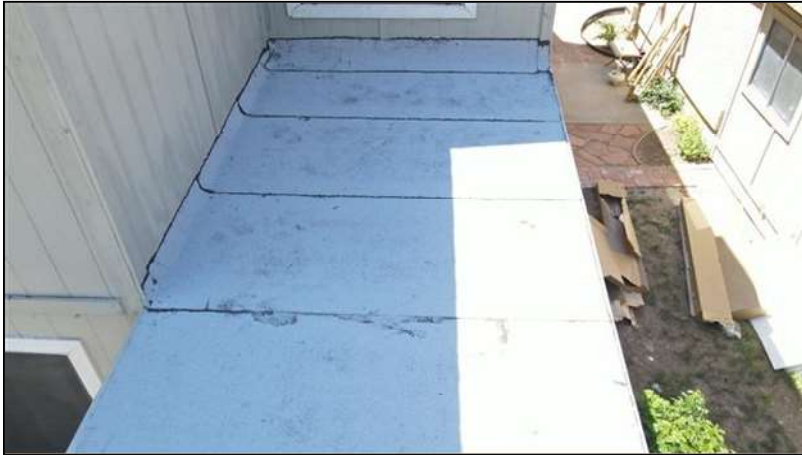
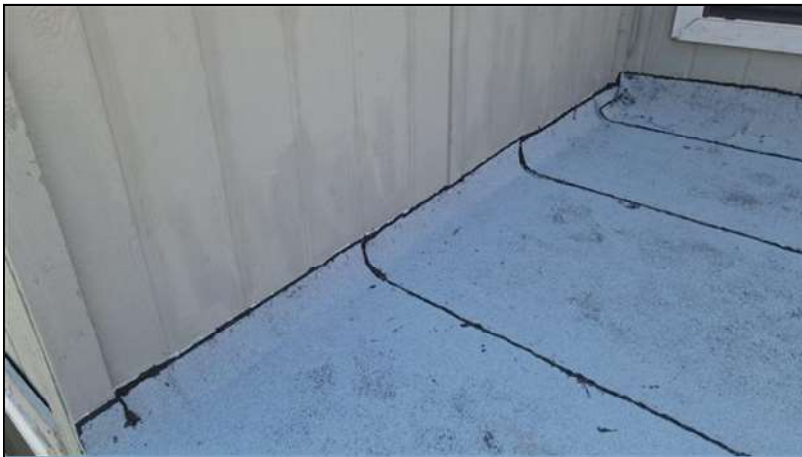
1.2 The average life span of roll composition roofing is 10-12 years in Arizona. It is common for roll composition material to fail before or after expected life span due to many factors including temperature, winds, rain, pooling water, etc. The roof coverings are at the end of useful life. Recommend consulting with a qualified roofing contractor about required repairs.

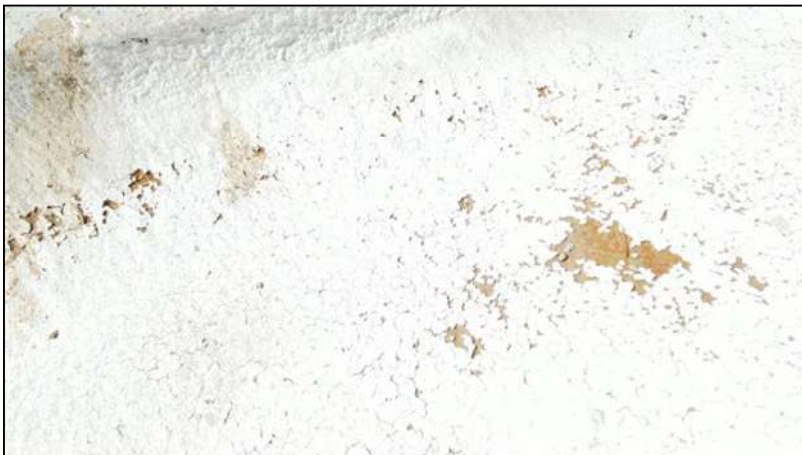
1.3 (1) The elastomeric coating is deteriorated and at the end of its useful life. Recommend areas be re-coated as required by a qualified roofing contractor.

Elastomeric coatings have a limited life span typically 5 or 10 years depending on the product used. This is a regular maintenance item that will need to be re-applied as it deteriorates.

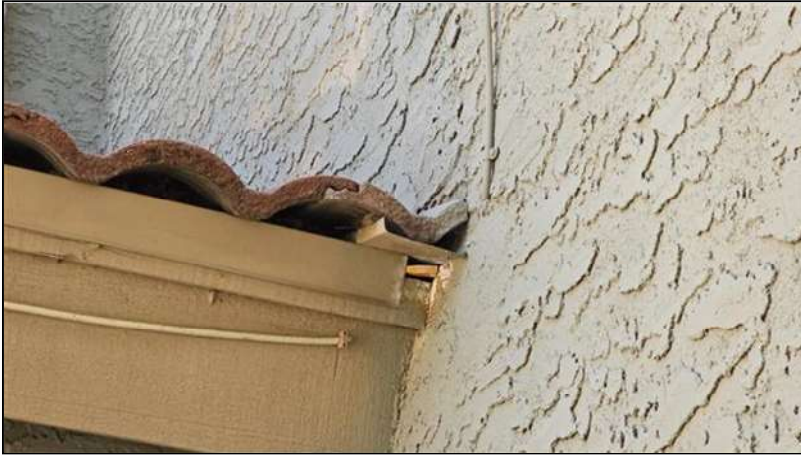
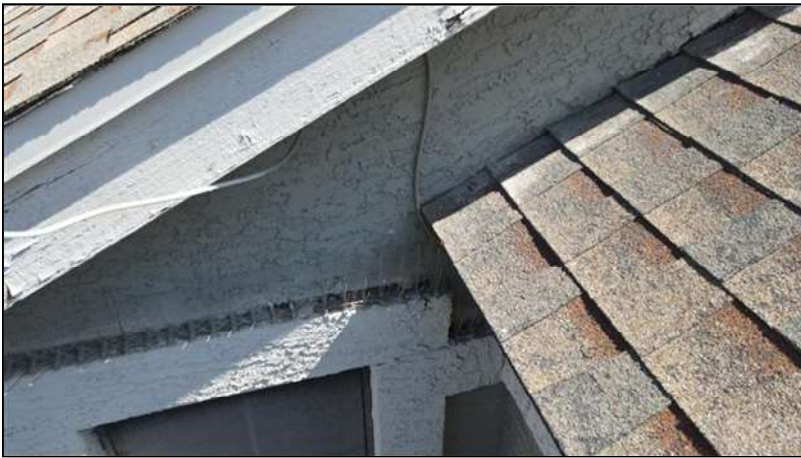
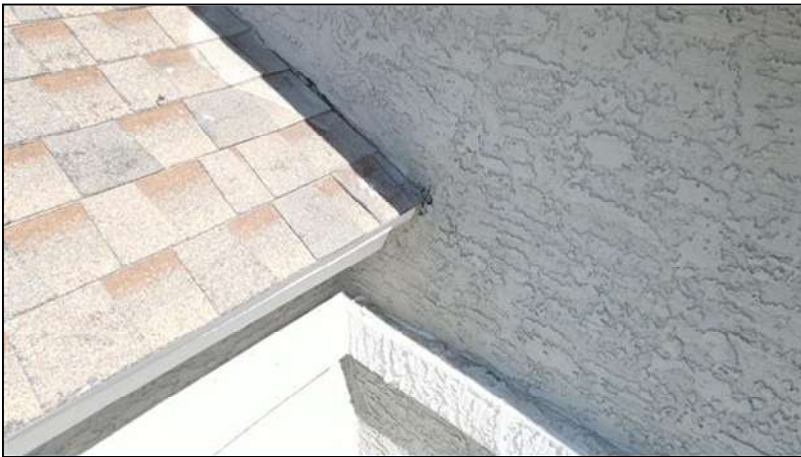
1.6 (1) Kickout flashing is missing in multiple areas. Kickout flashing directs water flow away from the structure which can cause moisture damage. This is currently a standard construction method. Recommend kickout flashing be added.

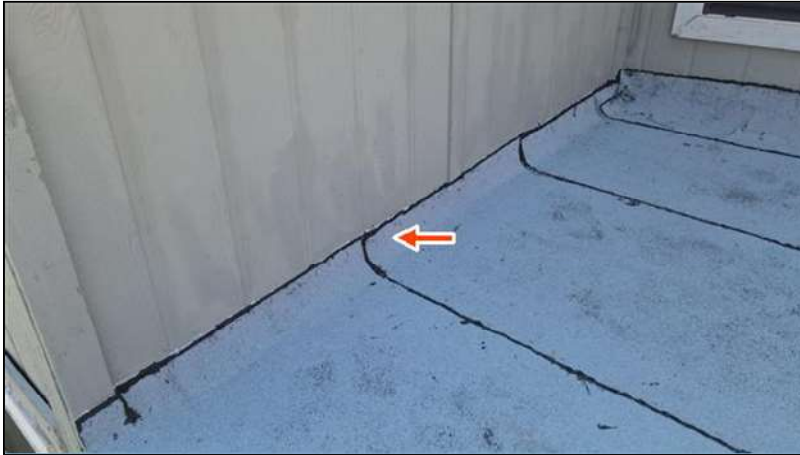
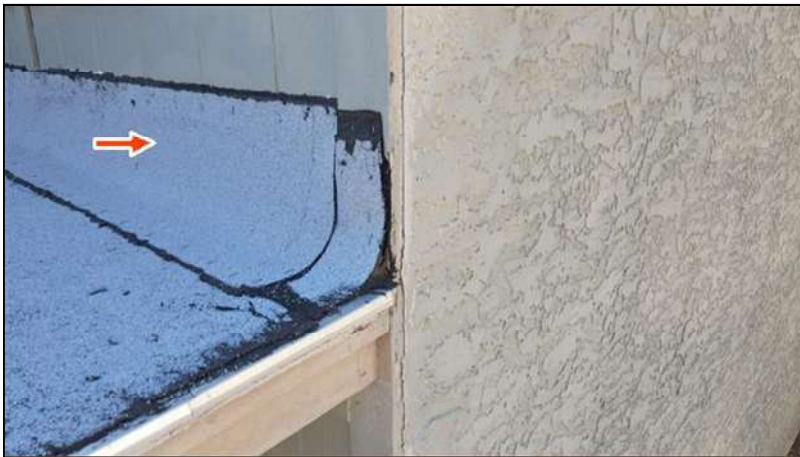
1.6 (2) The patio roof coverings were not installed to workmanlike standards. There is no flashing or counter flashing installed. Edge of roof coverings are dependant on sealant stopping moisture. This is a maintenance item as sealants will deteriorate and need repair. Properly installed flashing will require no maintenance. Recommend flashings be installed

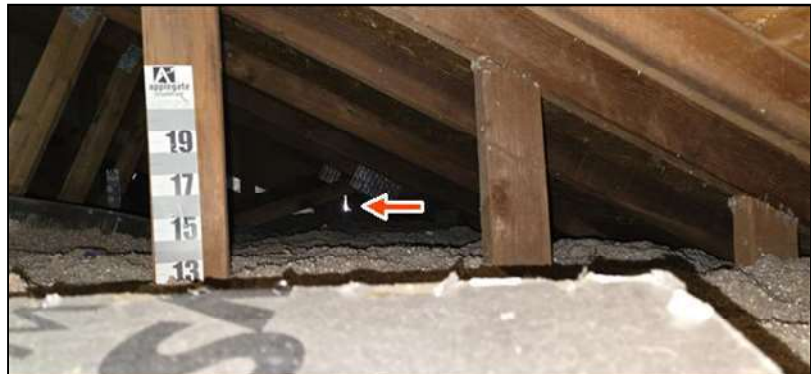
2.0 (2) Large gap observed in the attic. Recommend sealing these areas as required to prevent moisture and pest intrusion.

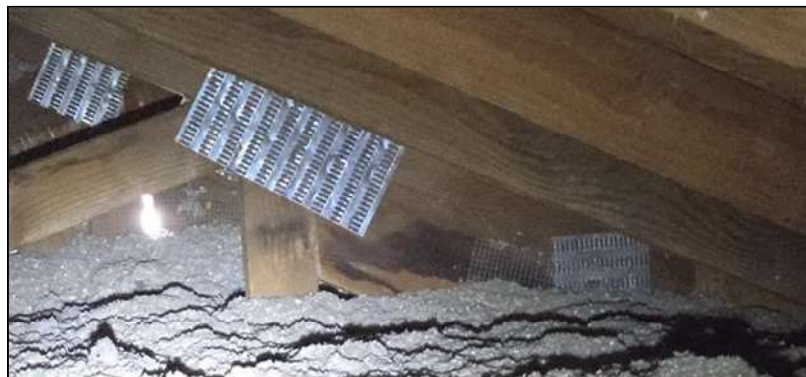
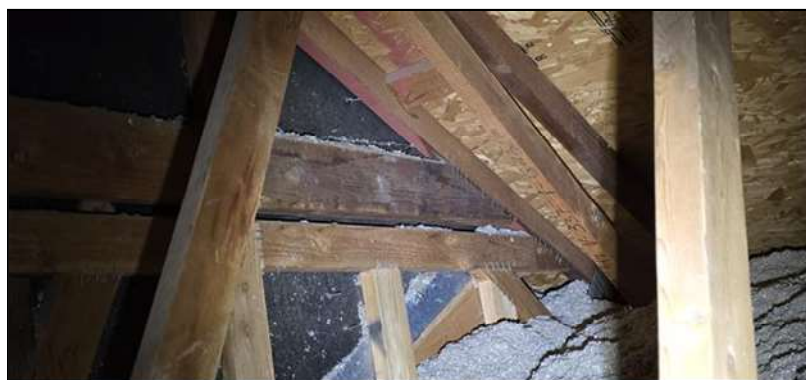
2.0 (3) Moisture staining was observed in the attic. This is common for this style and age of home as the owners do not replace roof coverings before they have already failed. Due to the current condition of the installed roof coverings, the inspector believes these may be active leaks. Recommend a qualified roofing contractor perform an invasive inspection of the roof coverings to determine cause. Repair as necessary. See roofing section.

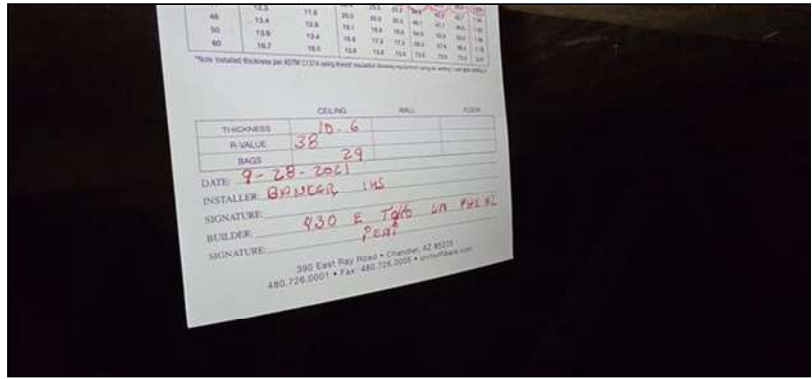
2.1 Additional insulation has been added since the original build (2021). This is for your information.

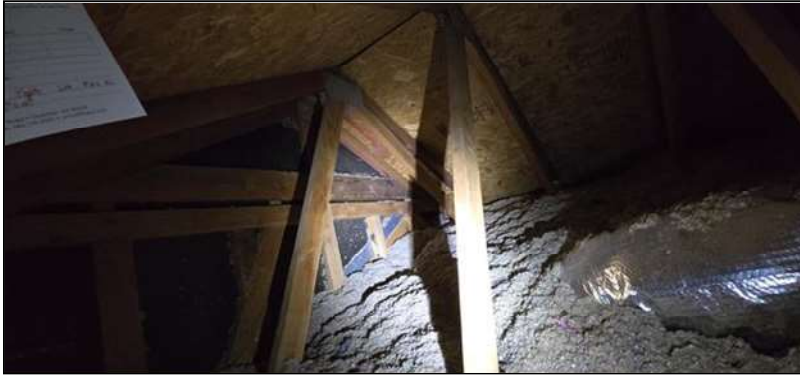
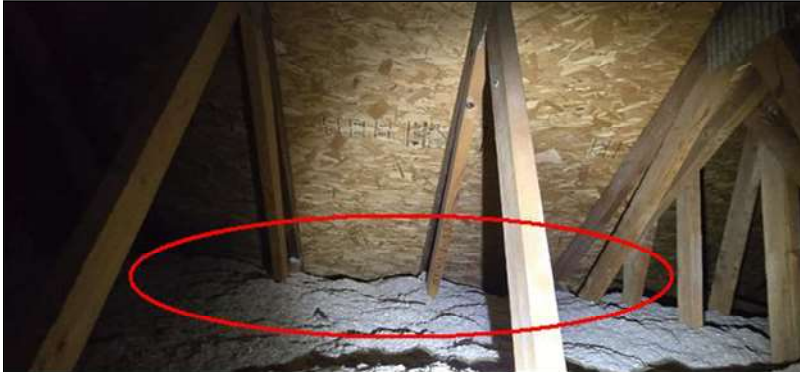
2.2 The Installed attic ventilation does not appear adequate. The attic ventilation operates on the theory of convection. As heat rises it escapes the upper vents as the low pressure pulls cooler air in through the lower vents. Proper vent placement and ratio of upper to lower vents is critical. Improper venting could create abnormal temperatures as well as not being able to remove moisture from the attic. This could increase energy costs and allow microbial growth to more easily occur. Recommend repair.

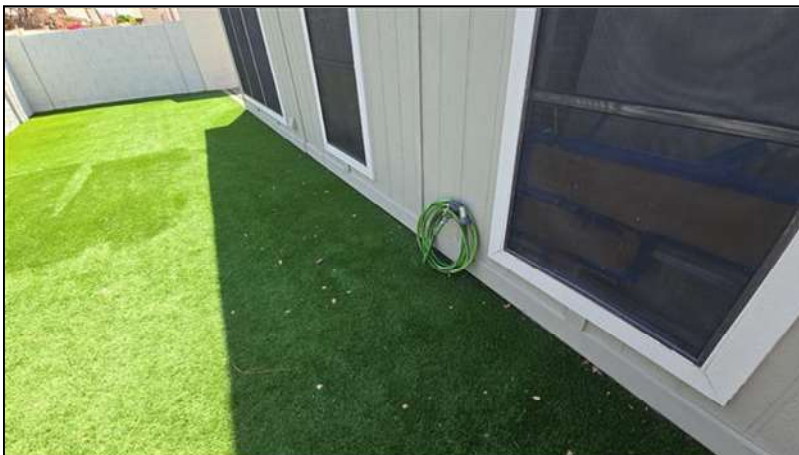
4.0 (2) Stem wall was not fully visible in all areas due to grade being too high. High grade can trap moisture next to the foundation. Inspection was limited. It is recommend that there be a minimum 4" clearance to the wall cladding. Recommend adjustment of grade.

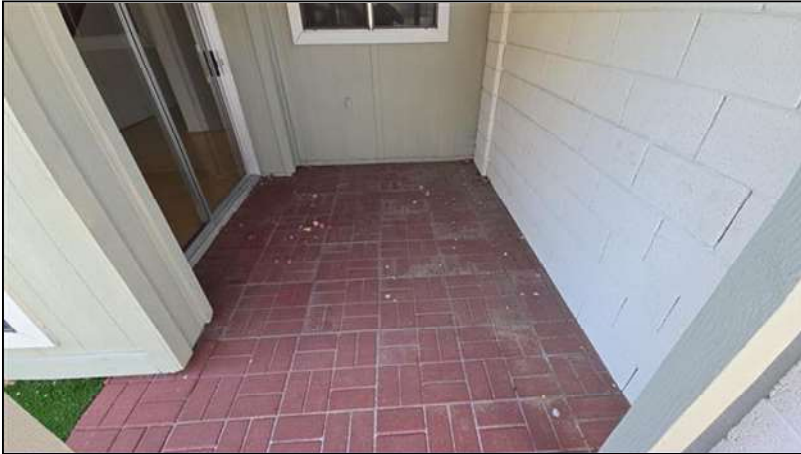
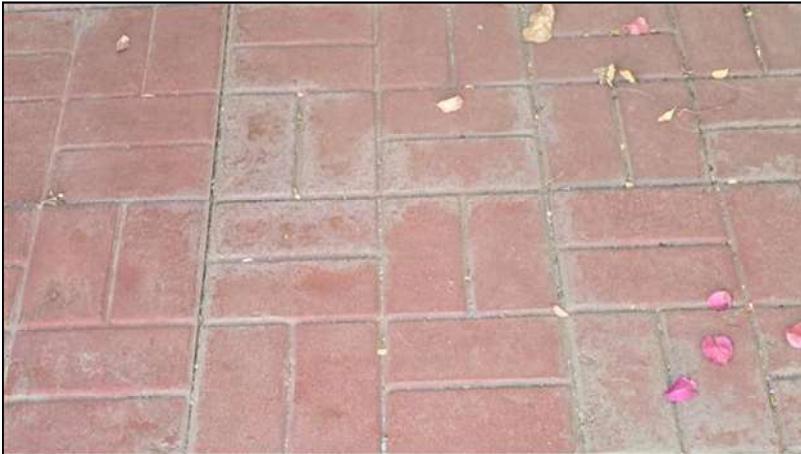
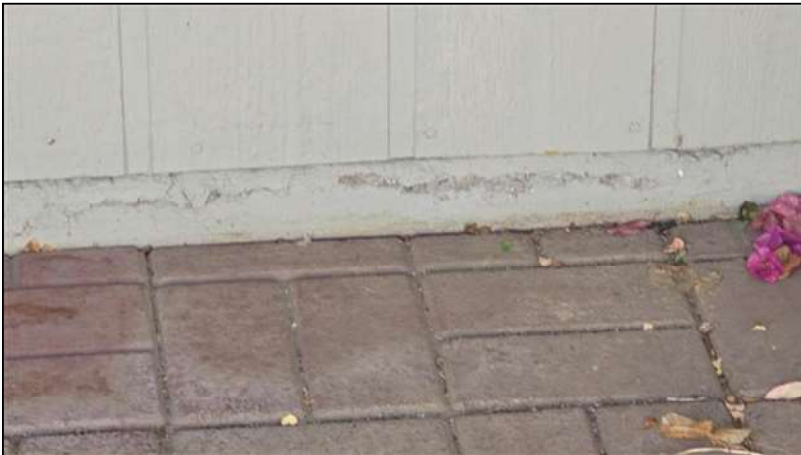
4.1 (2) The patio appears to be pooling water. Grading is not conducive to proper drainage. This is causing heavy spalling on the foundation. Horizontal cracking is starting to form. Recommend patio be corrected to prevent damage to the foundation which could be costly to repair.

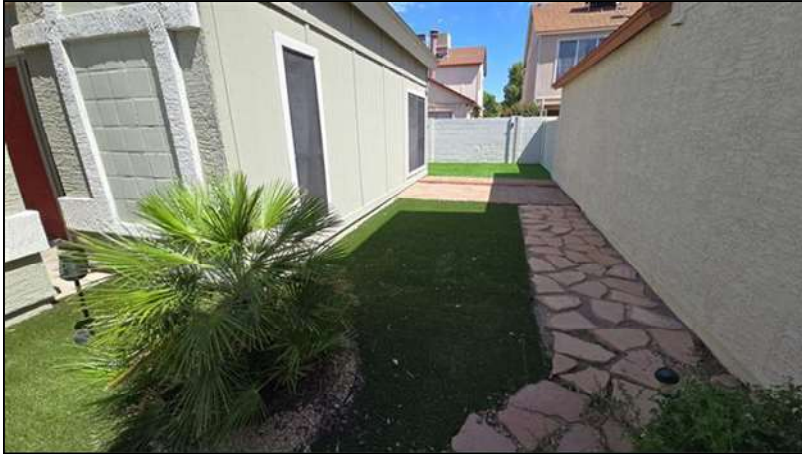
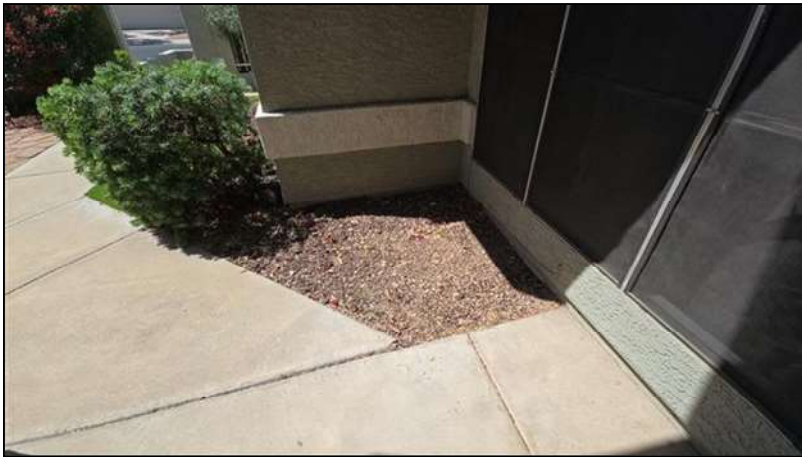
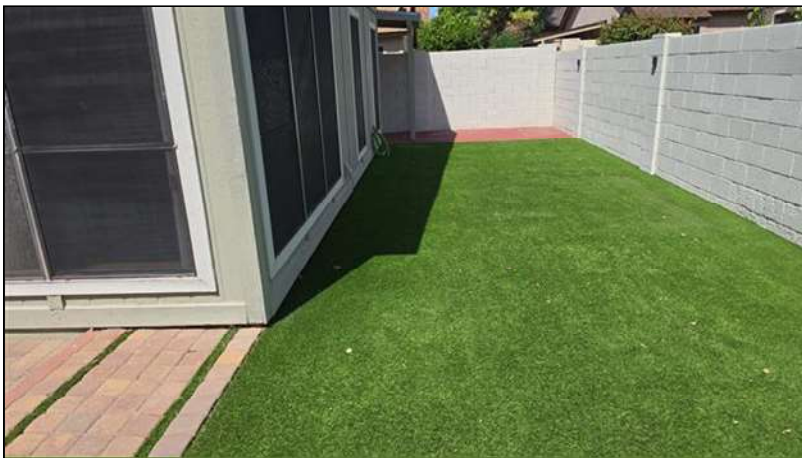
4.1 (3) Several areas - Grading is not conducive to proper drainage. The grade is either neutral or negative and will route runoff from precipitation toward the foundation. Excessive moisture under foundation can cause settling and cracking of foundation components, exterior siding, interior wall coverings and flooring. It is recommended that soil heights provide a 4" minimum clearance to the siding (stucco/paneling etc) and fall 6 inches for the first 10 feet as you

move away from the foundation. This will reduce moisture penetration into the substructures of the home. Recommend adjusting soil height to meet these criteria and direct water away from structure.

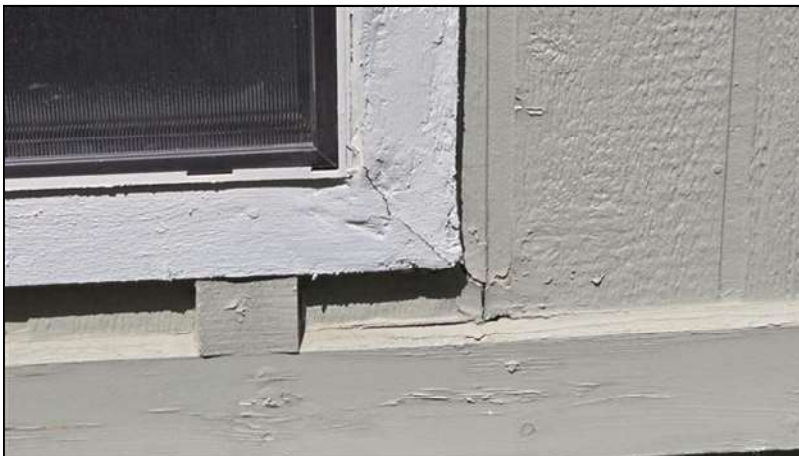
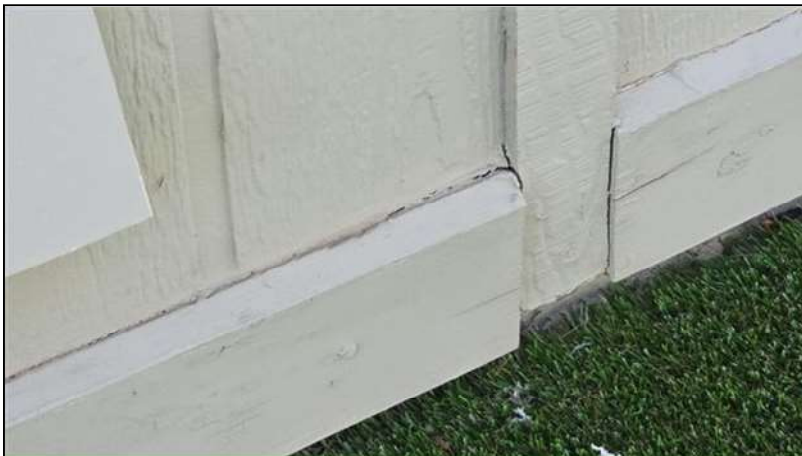
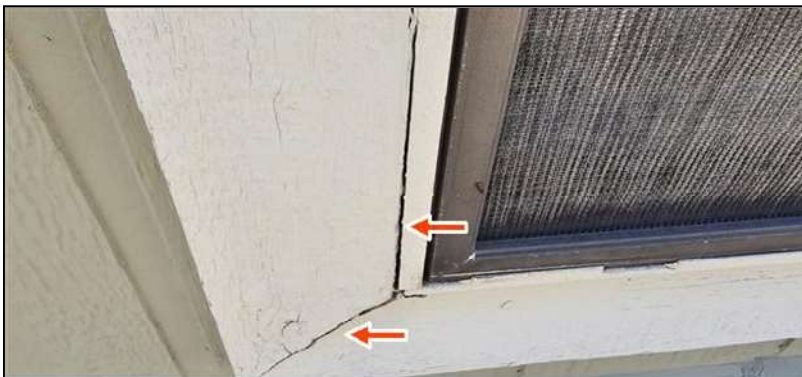
4.2 (1) Common cracking and penetrations observed in siding and trim. Recommend keeping cracks/penetrations sealed and painted to prevent moisture penetration and pest intrusion. **Images are not all inclusive and only a representation of the types of repairs required.**

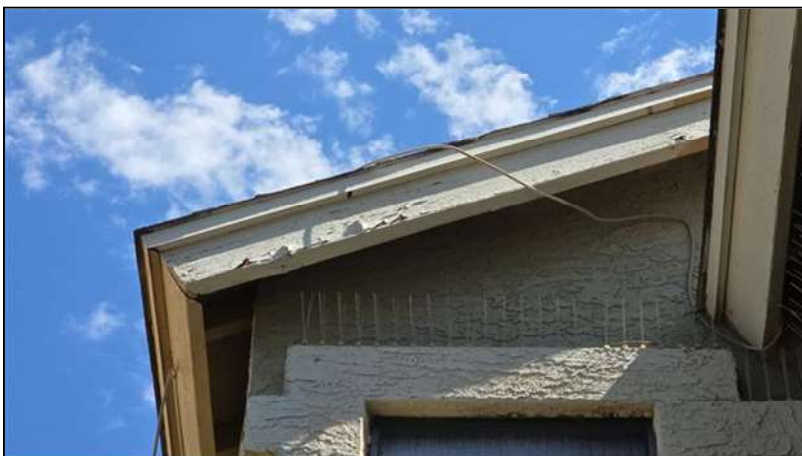
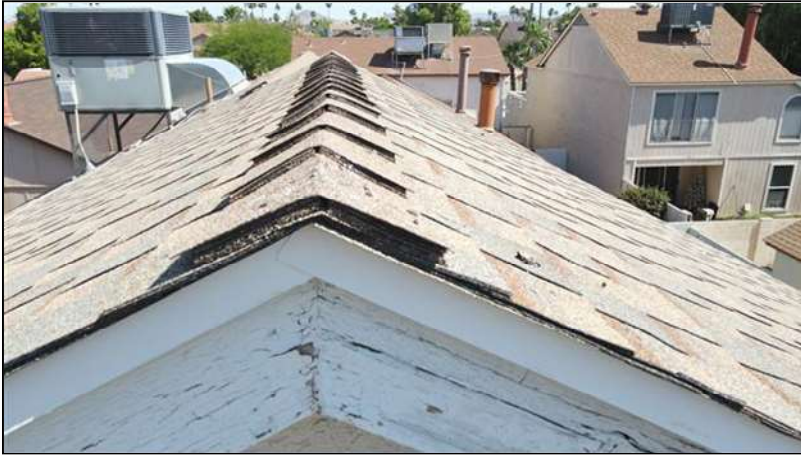
4.3 (1) The wood trim paint is failing at most of the perimeter. Moisture damage observed. Images are not all inclusive and only a representation of the types of repairs required. Recommend sealing and painting to prevent moisture penetration and damage.

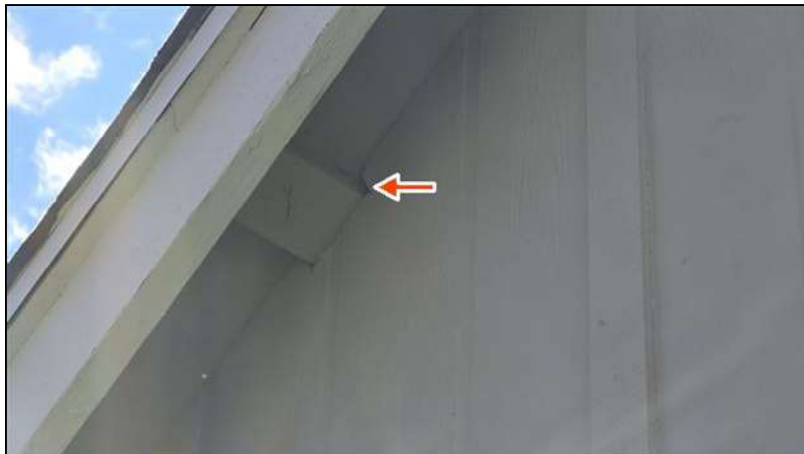
4.4 (1) Gaps observed at the eaves/soffits. Images may not be all inclusive and only a representation of the types of repairs required. Recommend sealing areas to prevent moisture and pest intrusion.

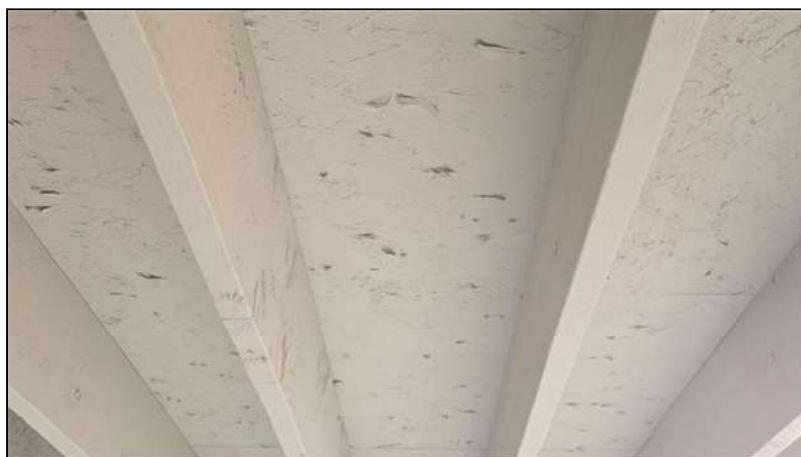
4.4 (2) Incorrect nail length was used for the roof coverings. This is a cosmetic issues only. Repair as necessary.

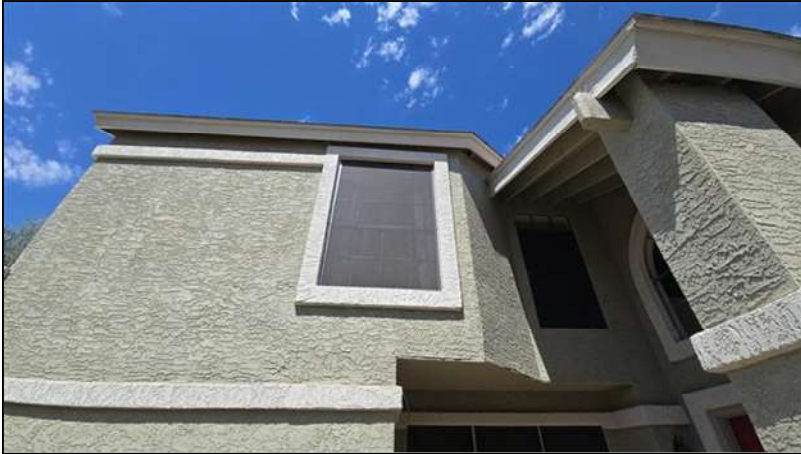
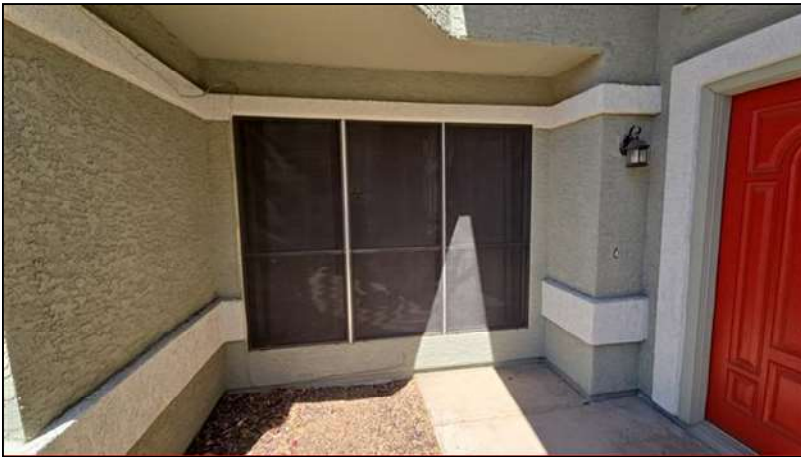
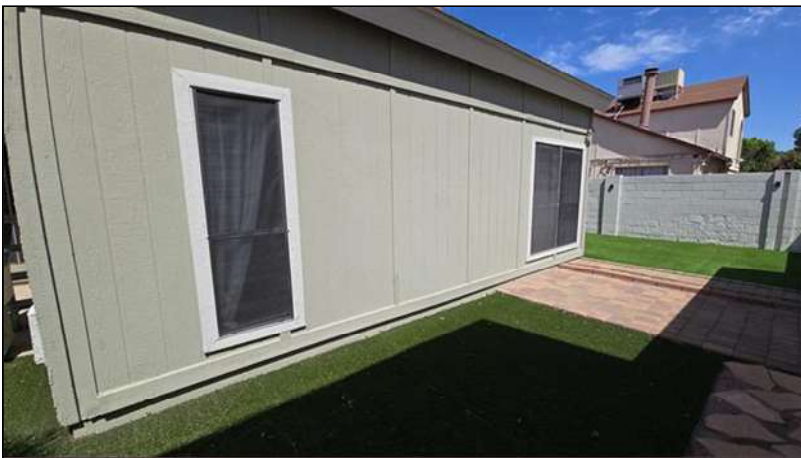
4.6 (1) Some of the windows have full shade screens installed. Images may not be all inclusive and only a representation. Inspection of these windows was limited.

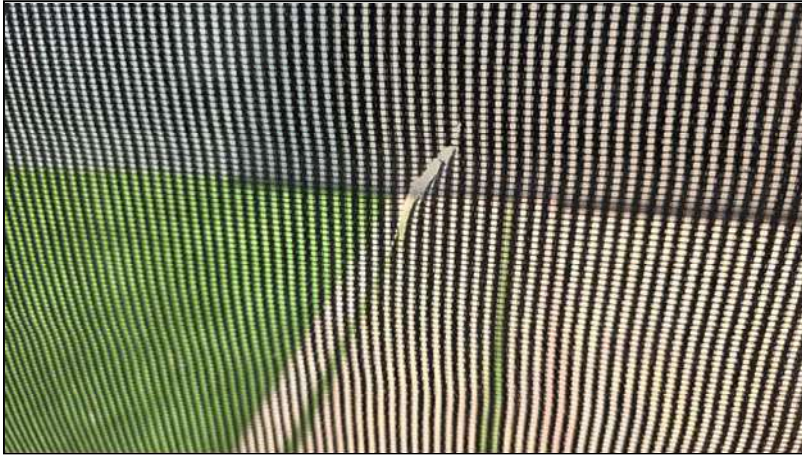
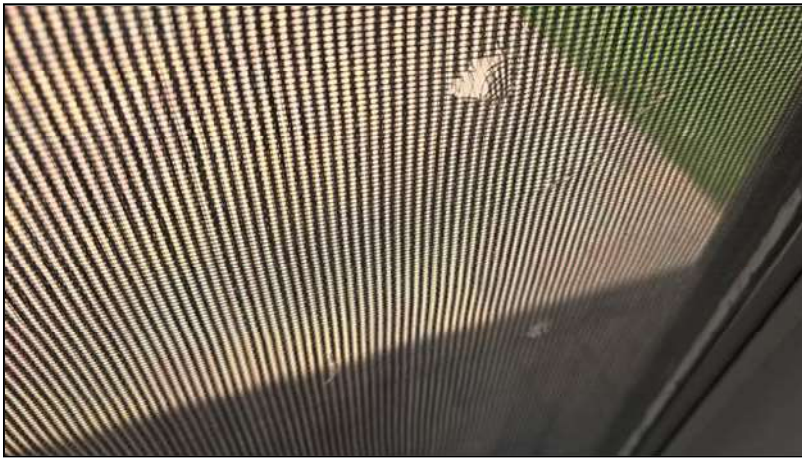
4.6 (3) Several screens are damaged. Repair/replace as necessary. Images may not be all inclusive and only a representation of the types of repairs required.

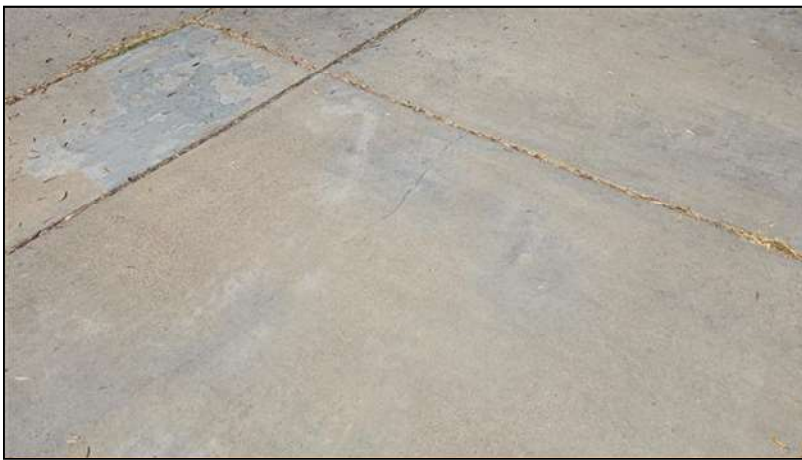
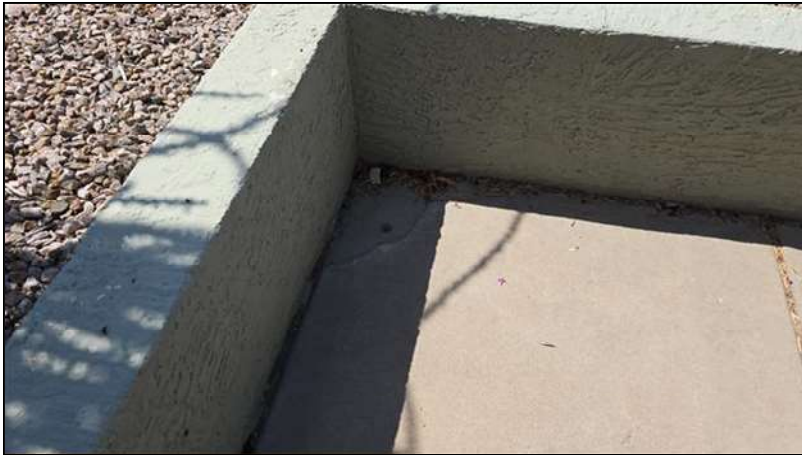
4.8 (1) Common cracking of concrete observed. This is a normal occurrence with shrinkage and settling.

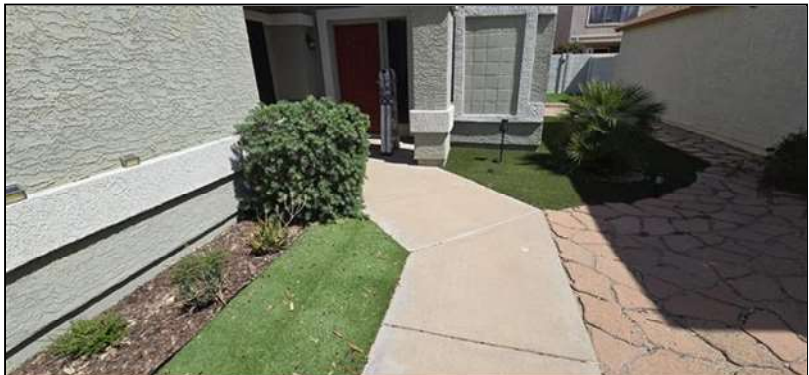
4.11 Vegetation contacting siding can cause moisture retention close to the foundation on the neighboring property. Moisture can cause premature deterioration of the structure and can also attract termites. Recommend trimming vegetation back 12" from structure. Images may not be all inclusive and only a representation of the types of issues observed. Inspection was limited in these areas.

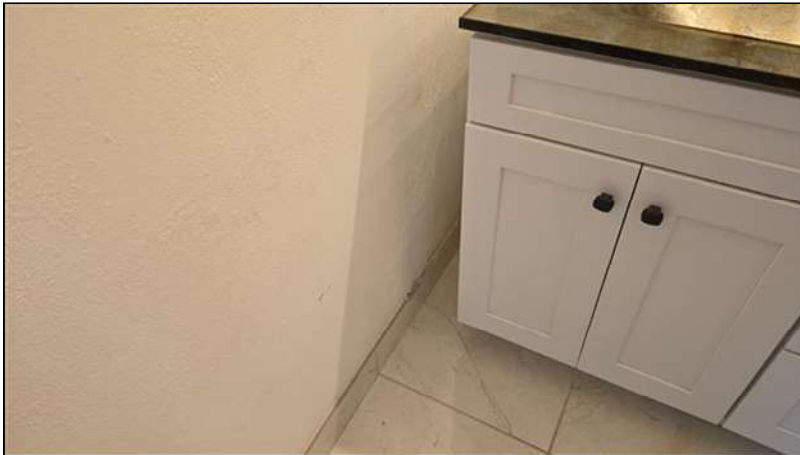
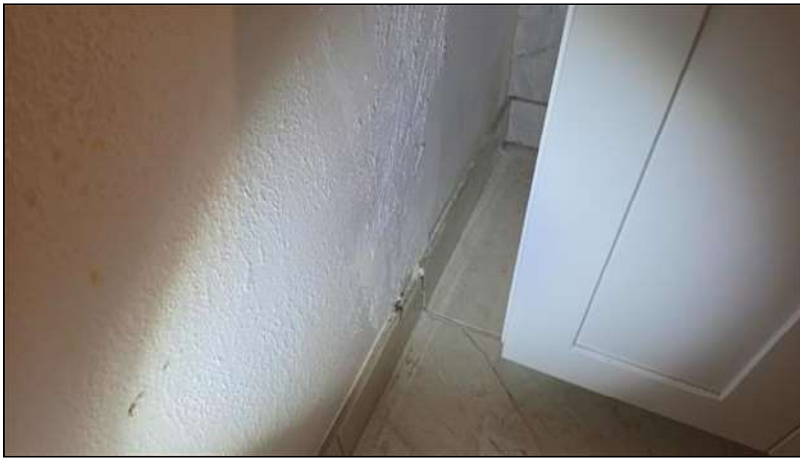
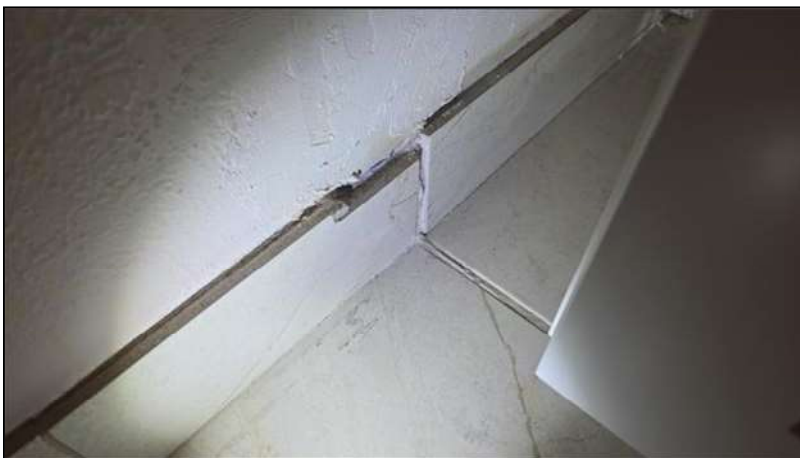
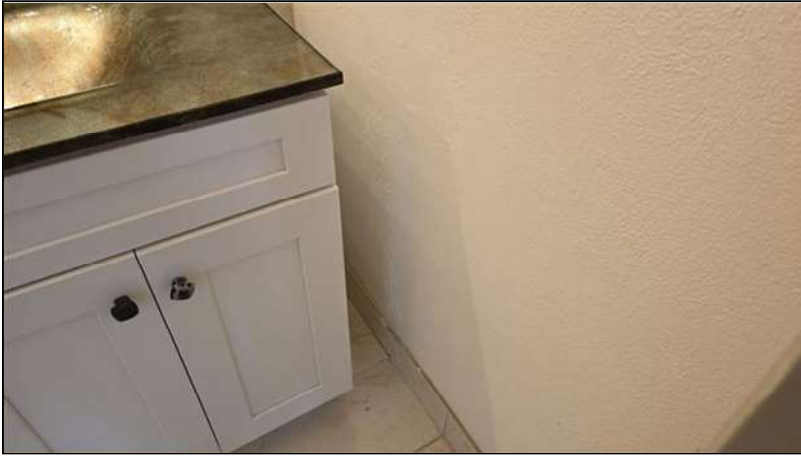
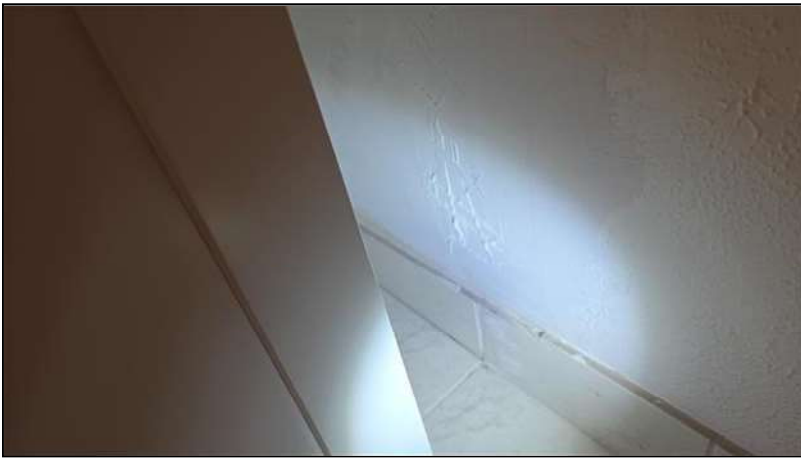
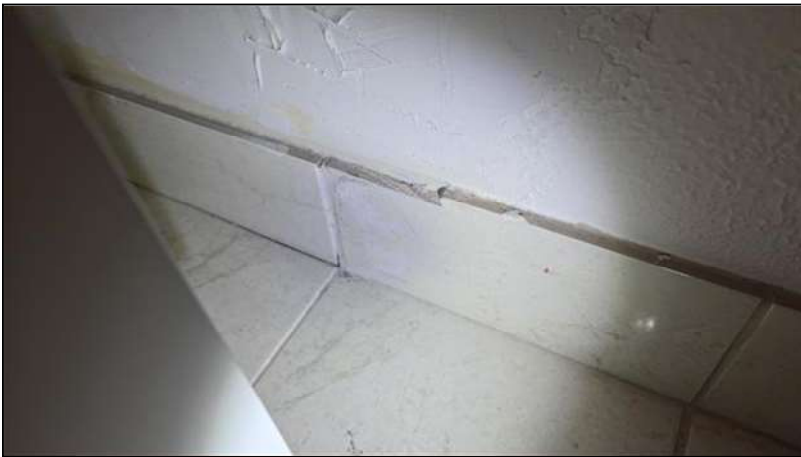
5.0 (1) Areas of repair observed at the master bathroom. Areas appear to have previously had a sink basin installed next to the wall which has now had to be textured. Texture does not match the rest of the walls. Recommend consulting with seller.

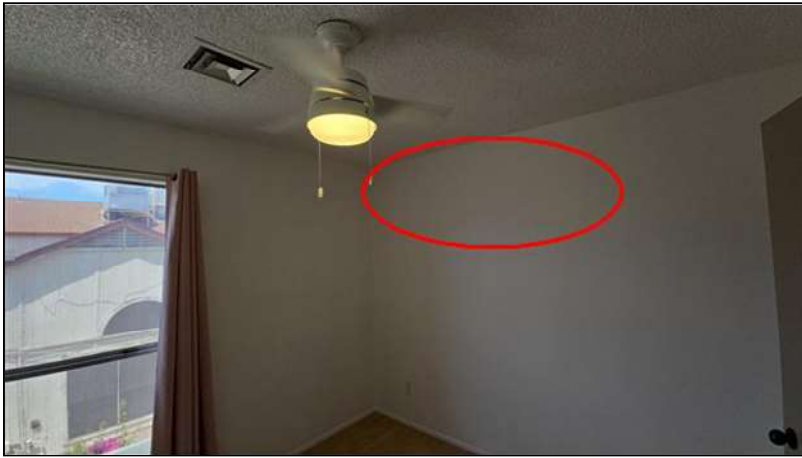
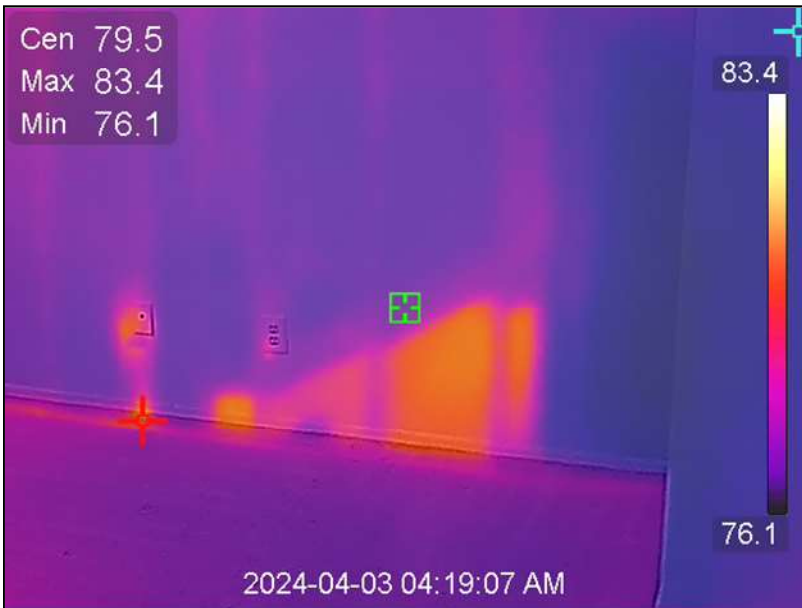
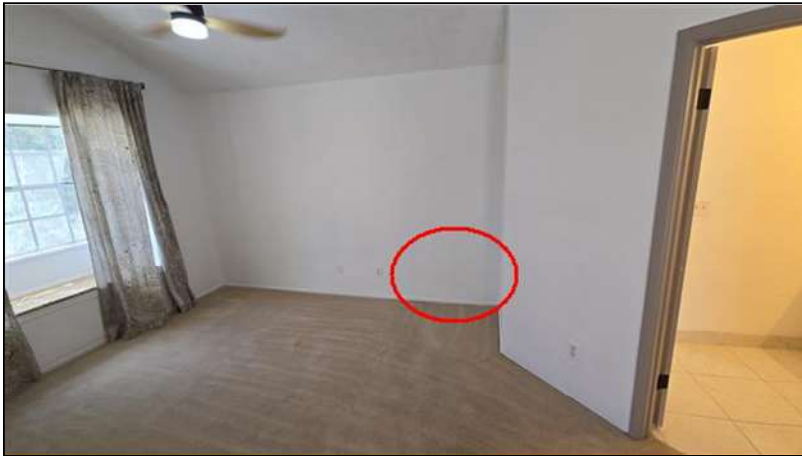
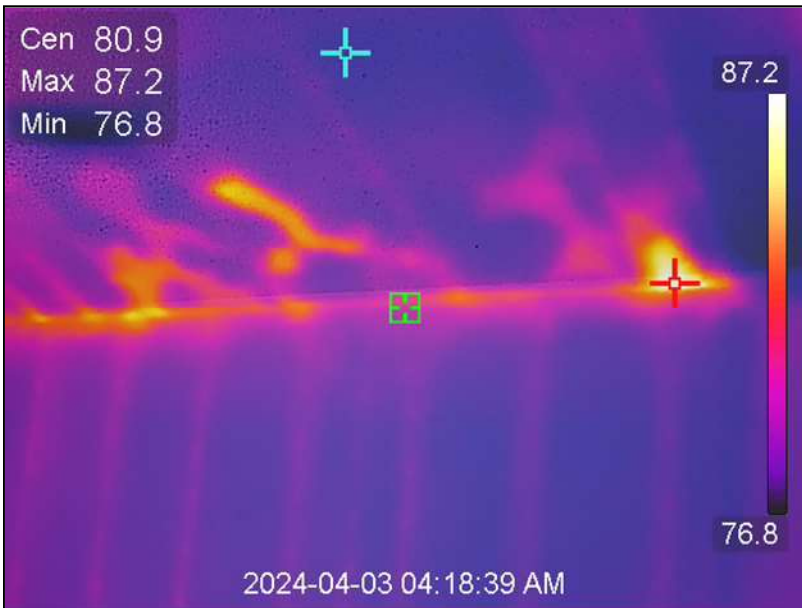
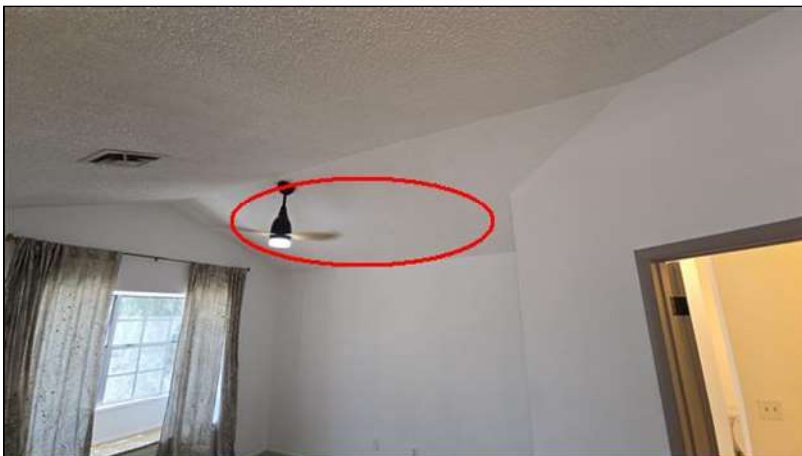
5.0 (2) Thermal anomalies observed. This is an indication that the insulation may be missing or not performing as intended. Further invasive investigation is required to confirm this. Although there is some areas potentially missing insulation, these would be considered minor and would may not provide any benefit that could reduce costs for cooling/heating. Some areas could feel cooler/warmer if in close proximity. Repair as necessary.

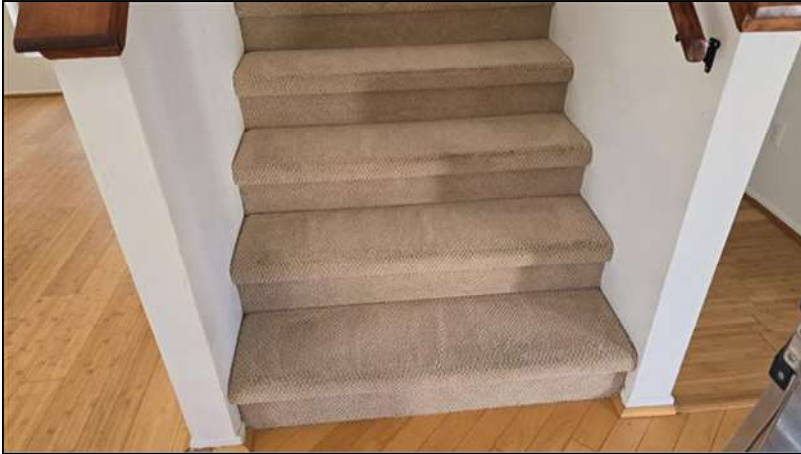
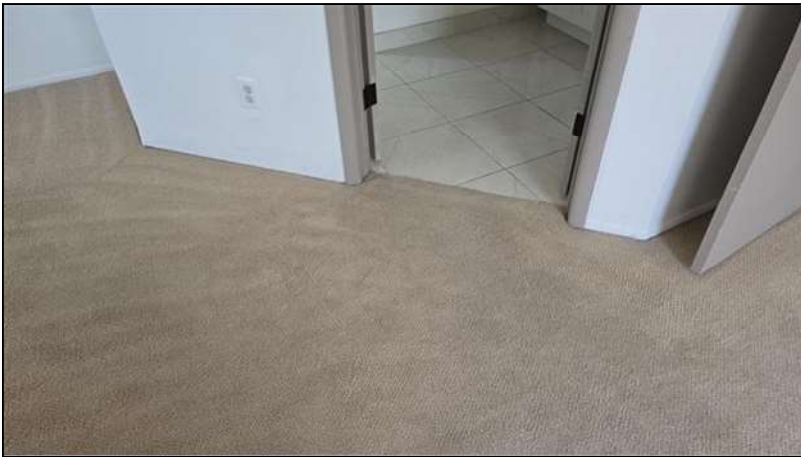
5.2 (1) Several areas - the carpet is loose and not stretched for a tight installation. Recommend repair by a qualified flooring installer. Images may not be all inclusive and only a representation of the types of repairs required.

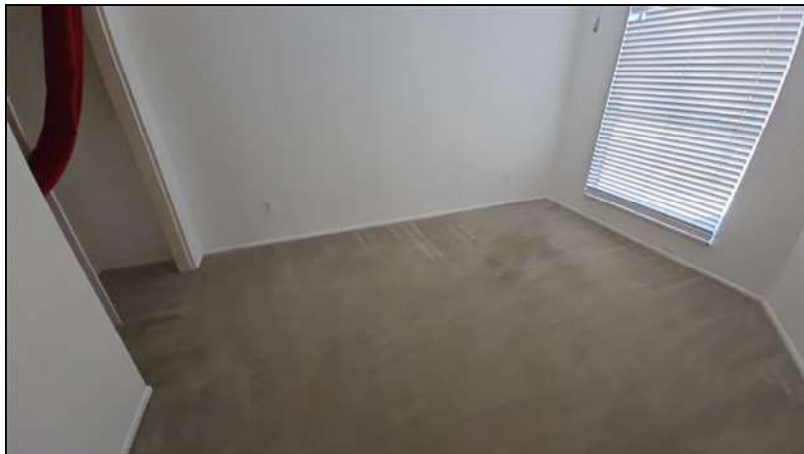
5.2 (2) The flooring/subfloor is not level in multiple areas. This was determined only by walking the floor. This could be padding or the subfloor. Carpet would need to be removed to determine cause. Repair as necessary.

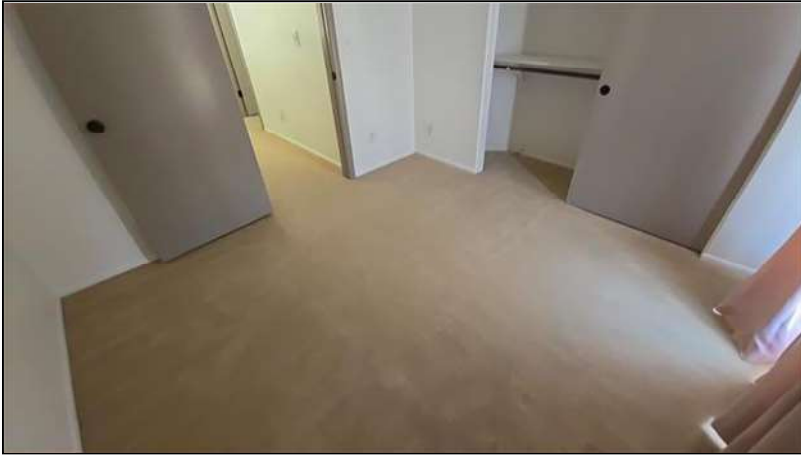
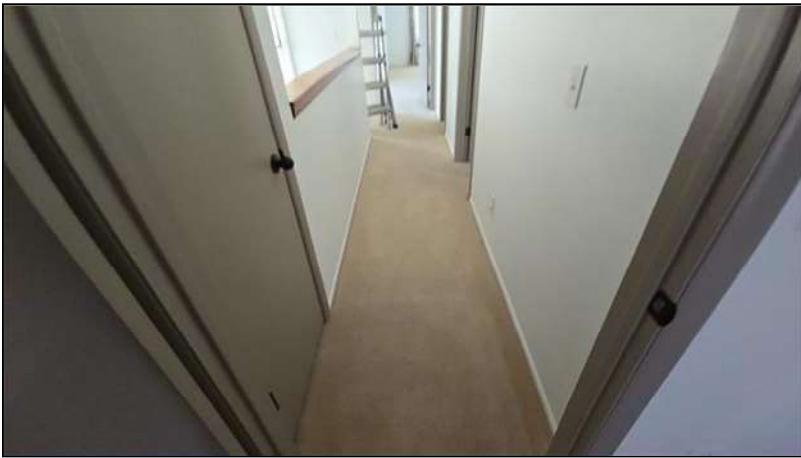
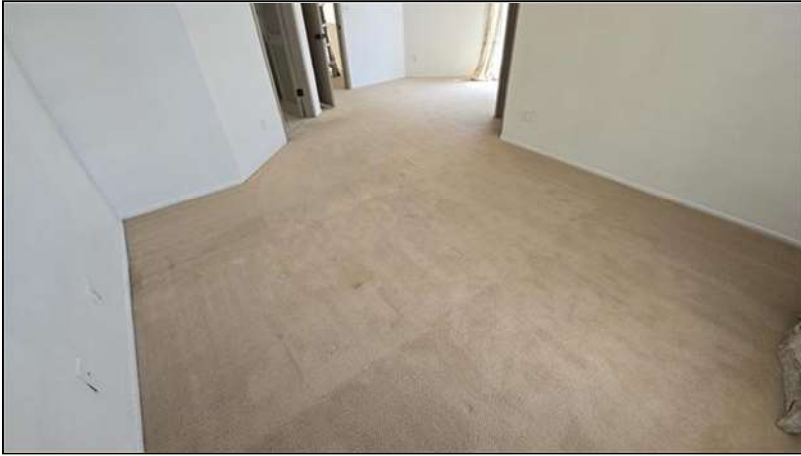
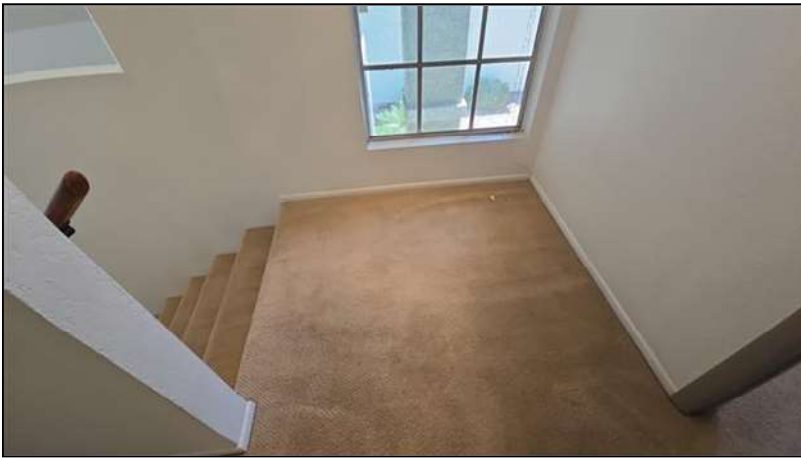
5.2 (3) The flooring creaks in the majority of the second floor. This could be a nuisance. Repair as necessary.

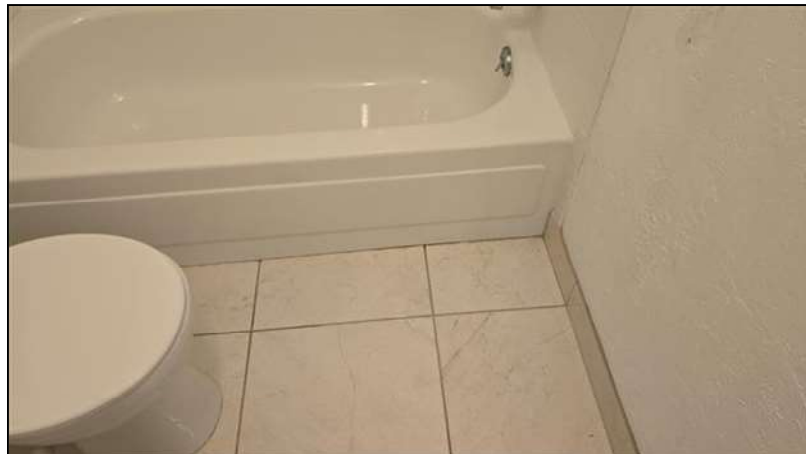
5.2 (5) Guest bathroom - Cracking around bathtub. Recommend grout/caulk these areas as required to prevent moisture from penetrating the sub-structure.
