Inspection Report

430 E Main St
Phoenix AZ 85024

Buy It Right Home Inspections LLC

Date: 5/15/2024	Time: 09:00 AM	Report ID: 20240515-430-E-Main-St
Property: 430 E Main St Phoenix AZ 85024	Customer: Joe Homebuyer	Real Estate Professional: Rhonda Carstensen My Home Group

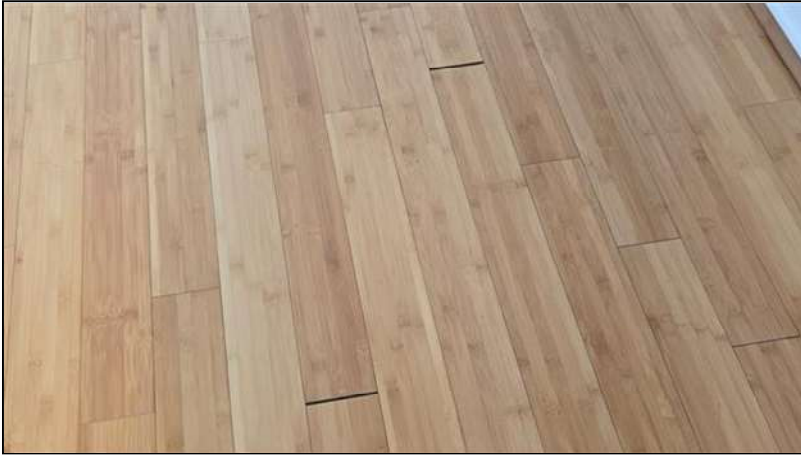
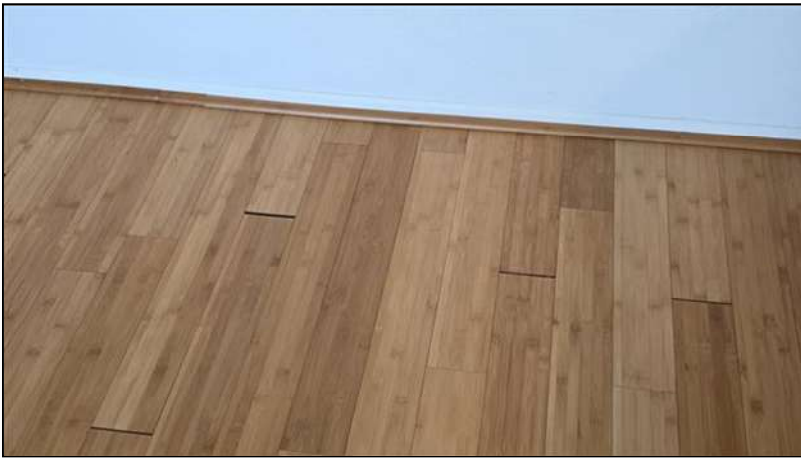
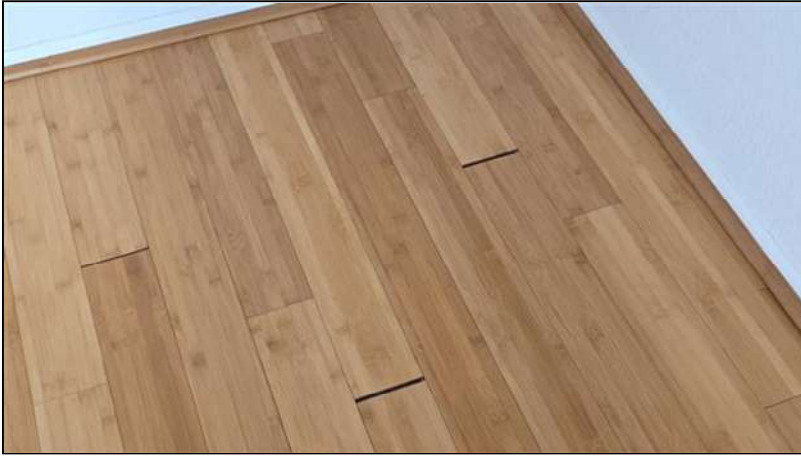
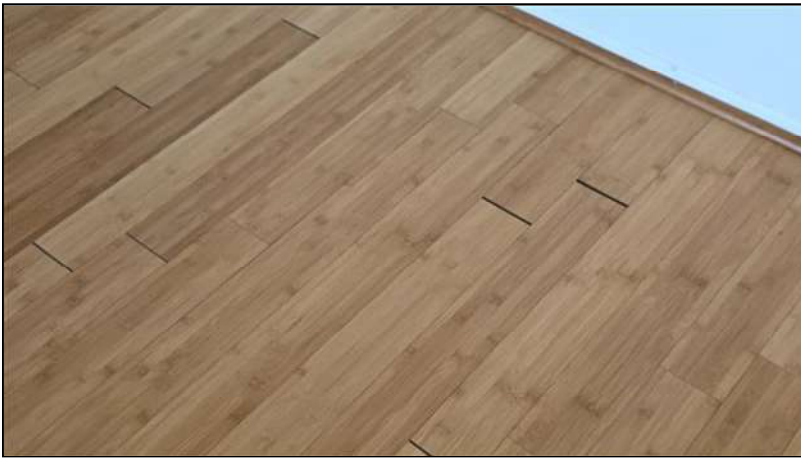
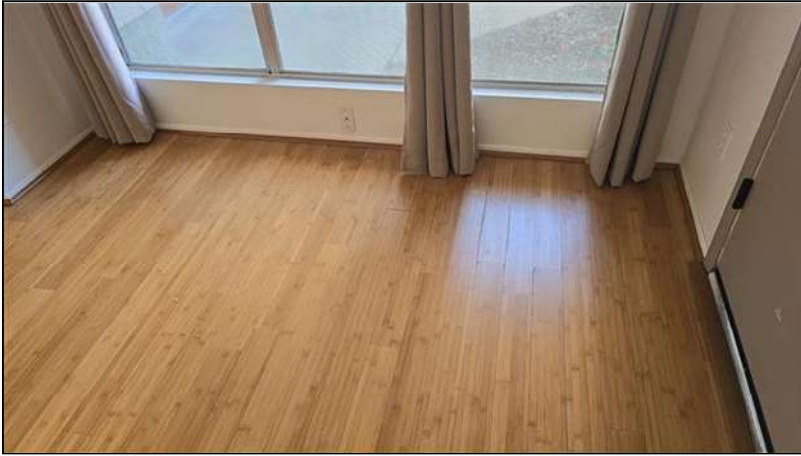
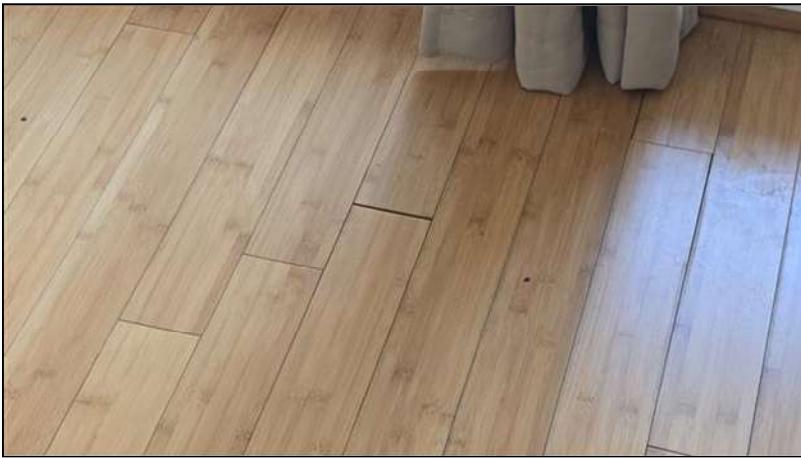
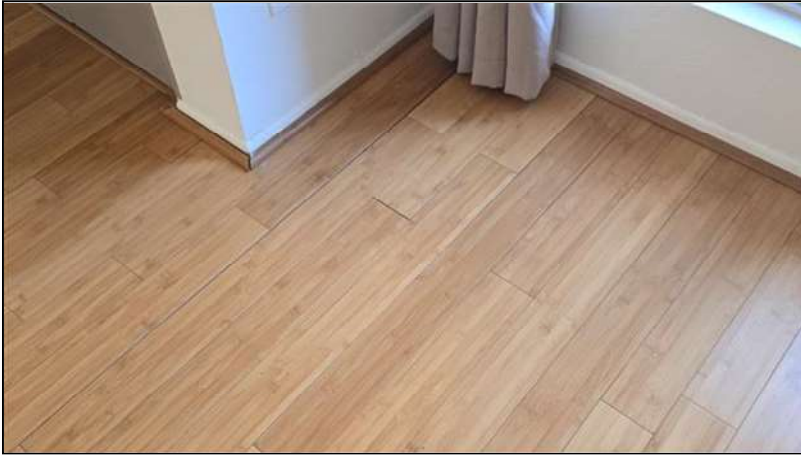
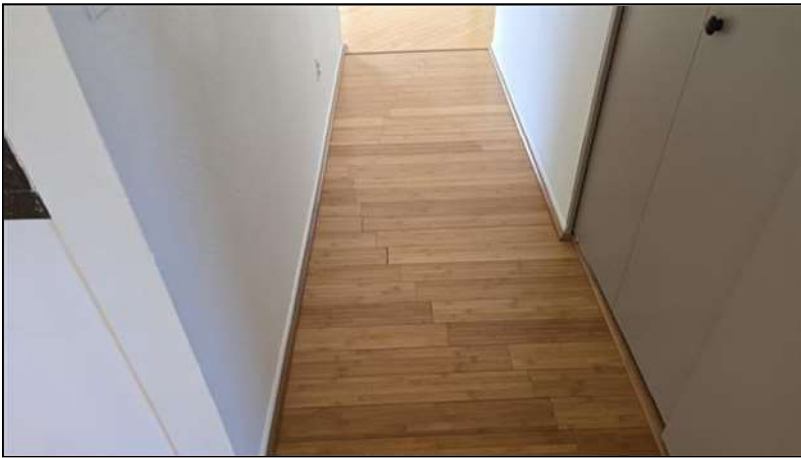
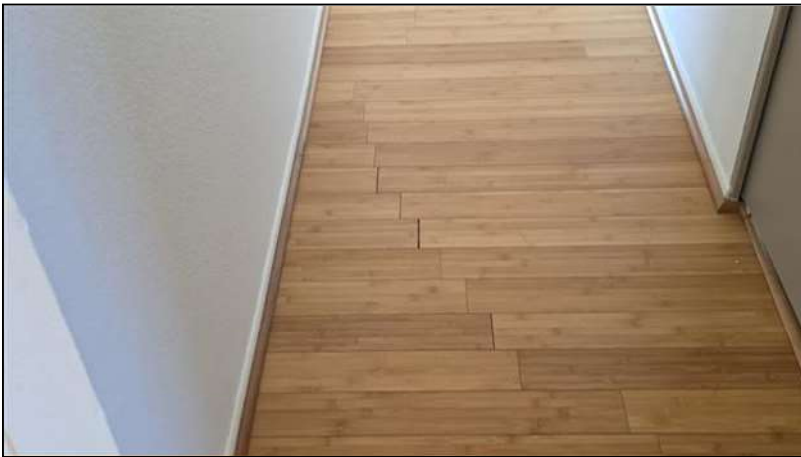
5.2 (6) Flooring has large gaps. This is most likely due to improper installation. Wood needs to be acclimated before installation as it can expand and contract. This is cosmetic and for your information. Repair as necessary.

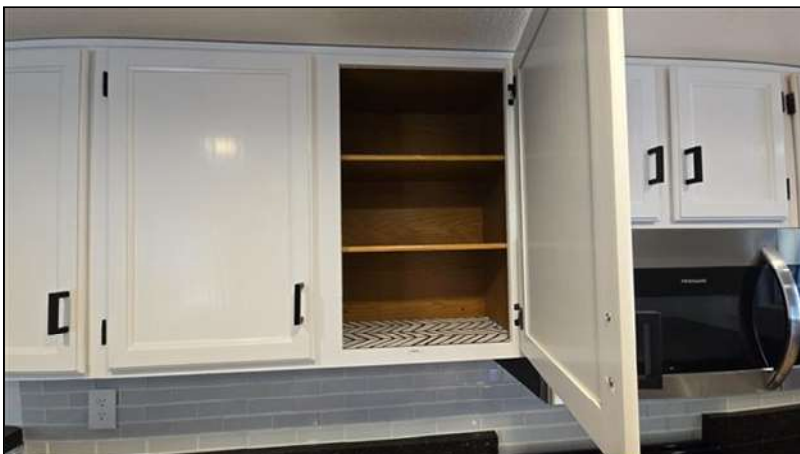
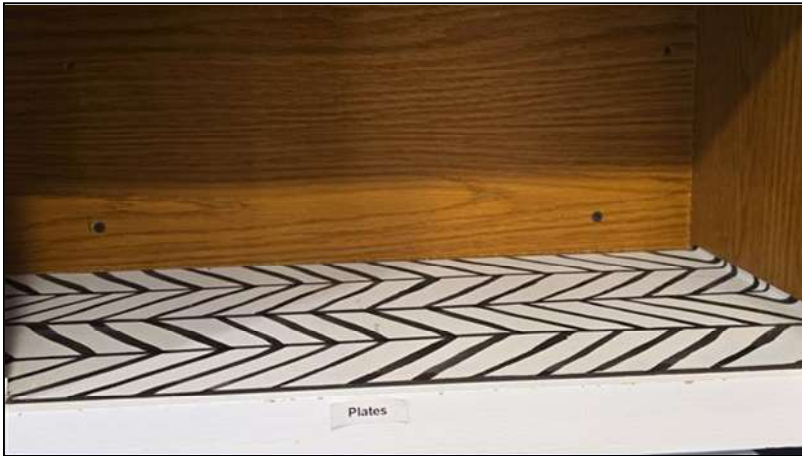
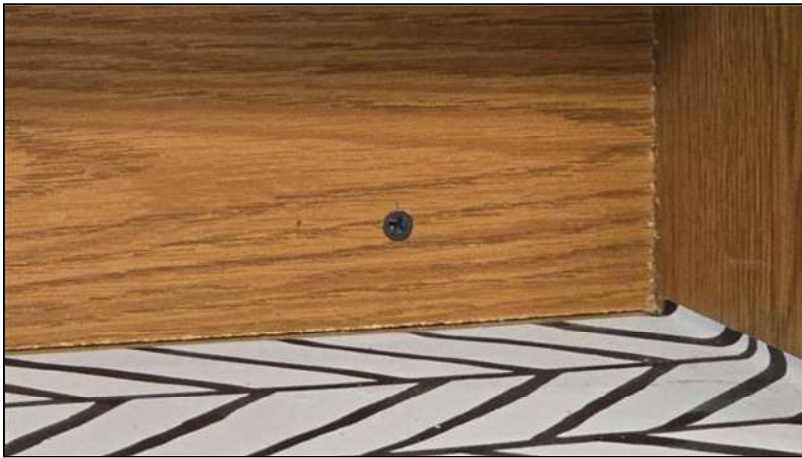
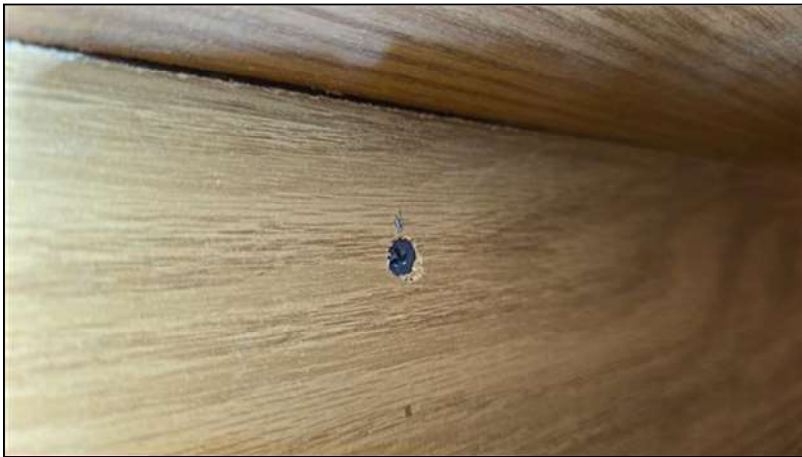
5.3 (3) Cabinet screws are incorrect. Cabinet specific screws that have a larger head are required to prevent screws from pulling through the cabinet back and the cabinet potentially falling off of wall. Recommend screws be replaced with cabinet screws designed for this use. Images are not all inclusive and only a representation of the types of repairs required.

Some of the screws are pulling through which makes repair of this more urgent.

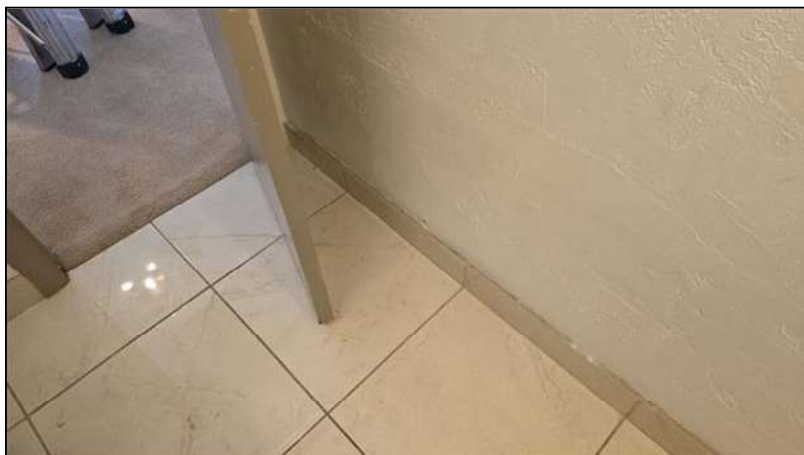
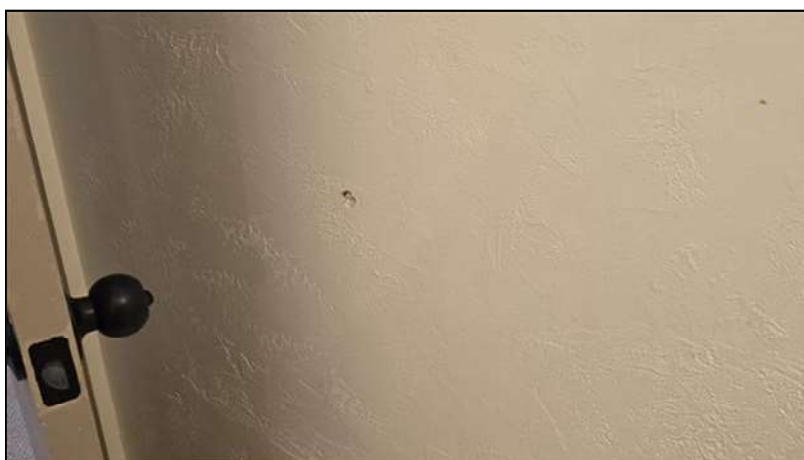
5.4 (1) One or more door stoppers were noted as missing throughout home. Replace as necessary.

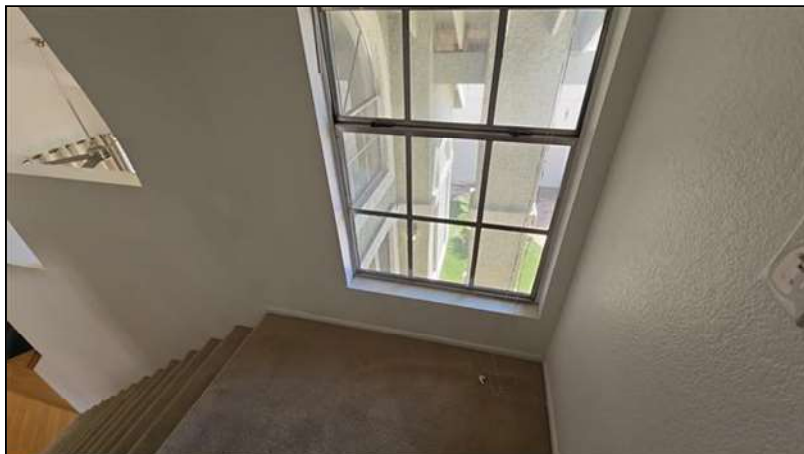
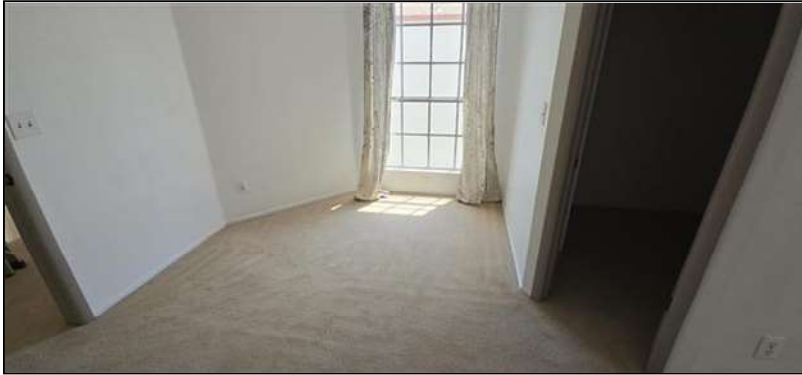
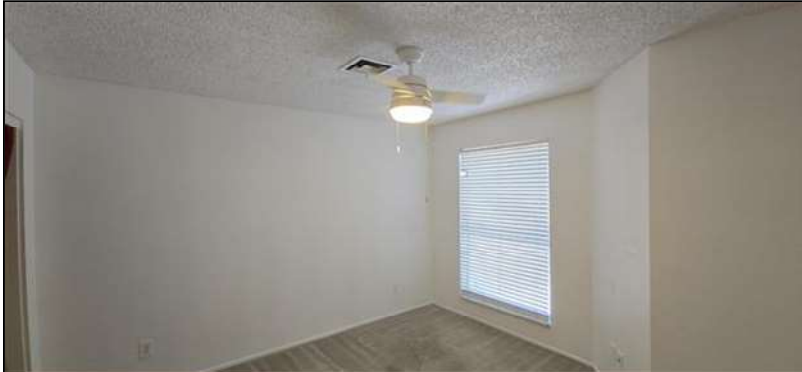
🟢 5.5 (1) Multiple windows are below 24" which is considered to be a safe height for second floor windows. This could be a safety concern for small children. Recommend repair or the addition of safety bars as necessary.

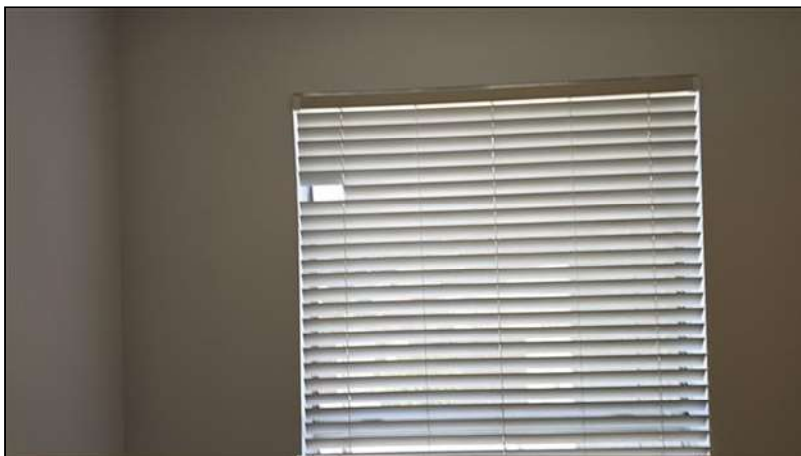
5.5 Guest bedroom

5.5 (4) Some window coverings are damaged. Repair as necessary. Images may not be all inclusive.

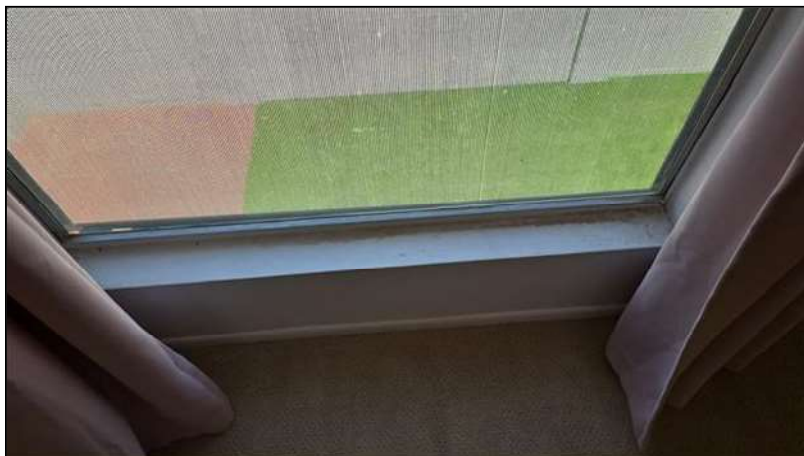
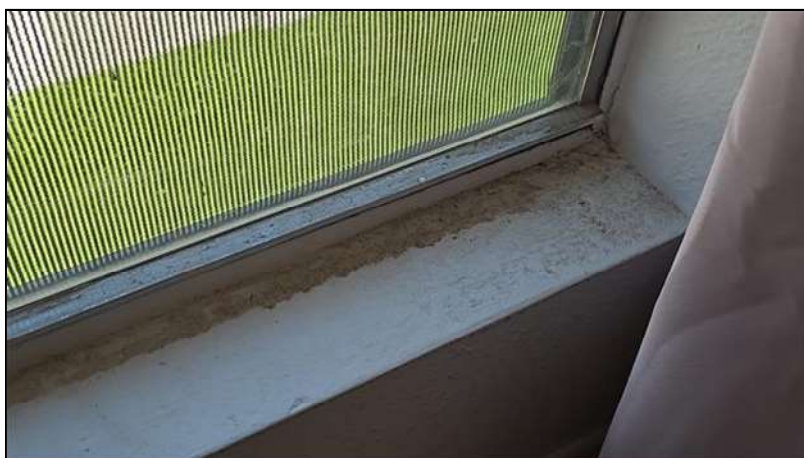
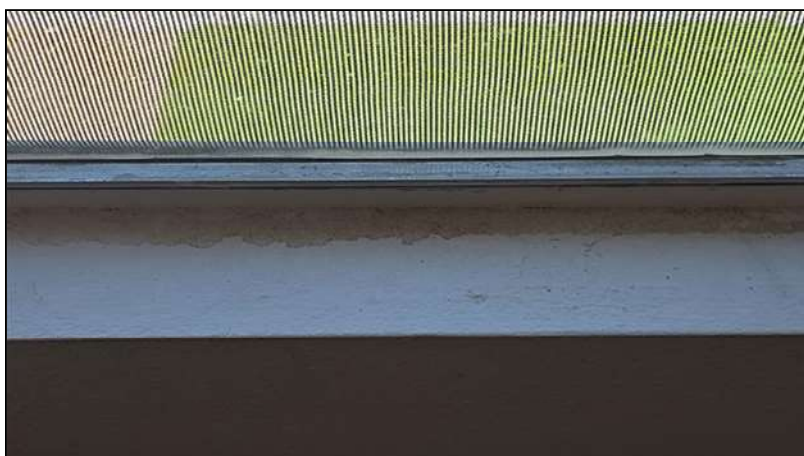
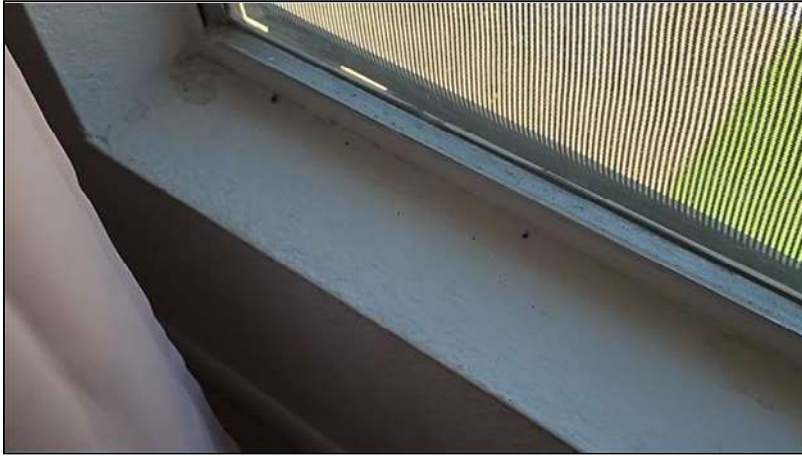
5.5 (6) Guest bedroom - minor moisture staining observed at the sill. This is not indicative of a typical window leak. Staining is most likely due to the window being left open during rain storms or the weep holes having blockage (if equipped). Recommend consulting with seller. Recommend weep holes are clear of blockage on windows to prevent frame from overflowing into the sill.

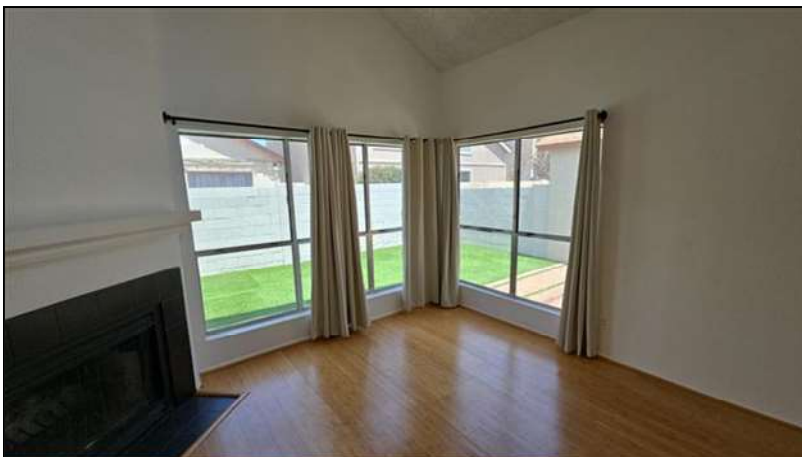
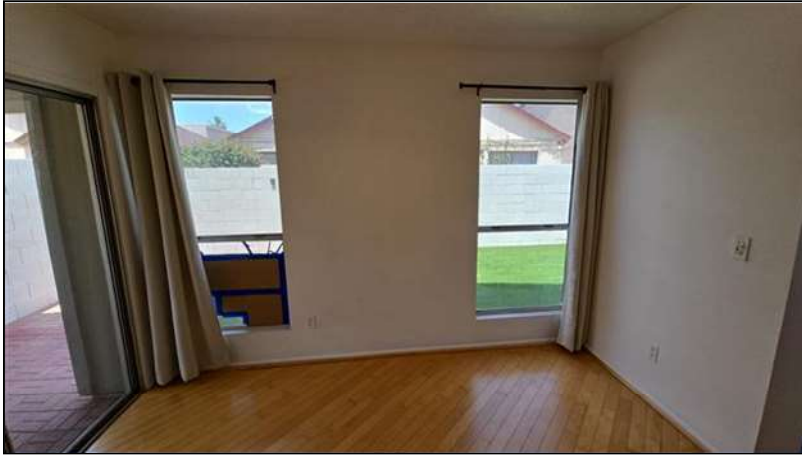
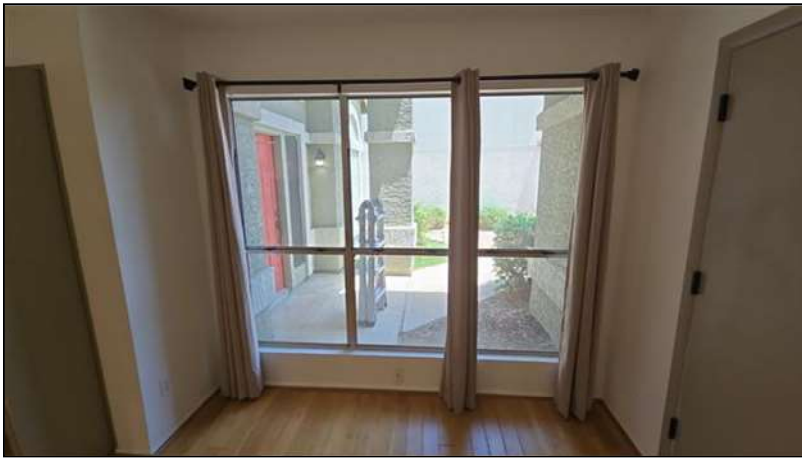
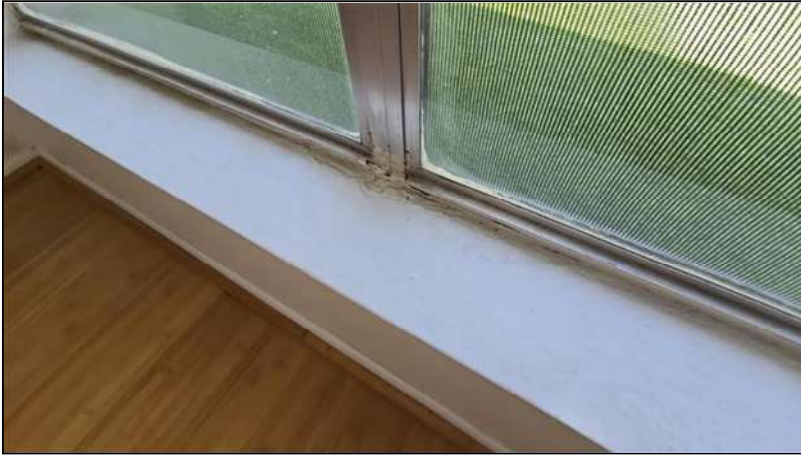
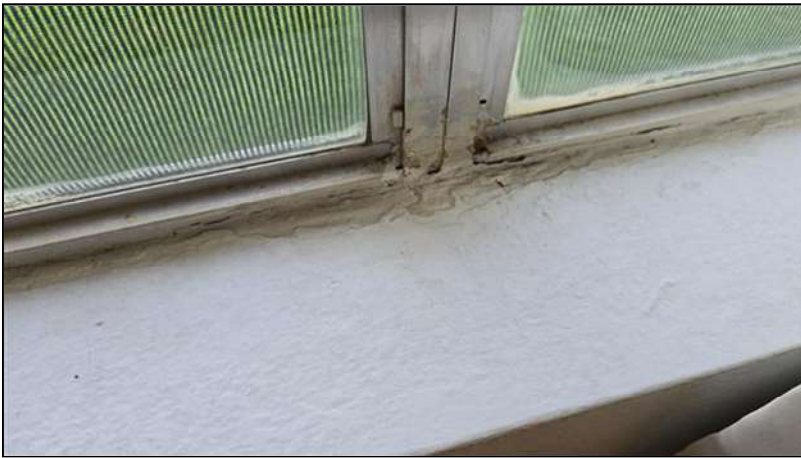
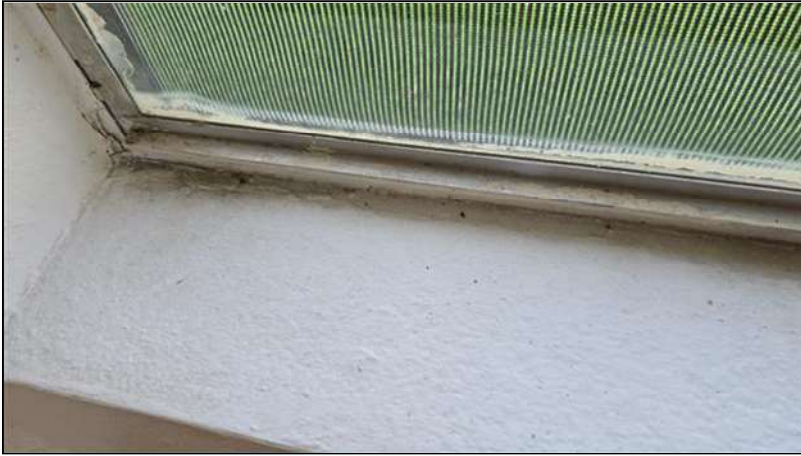
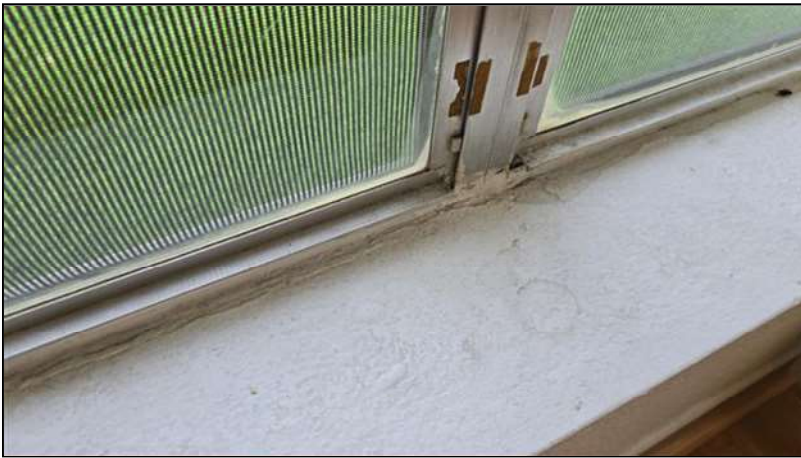
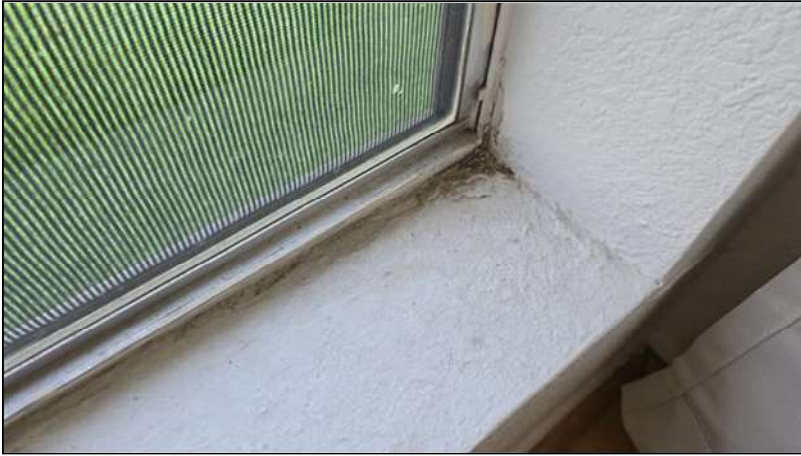
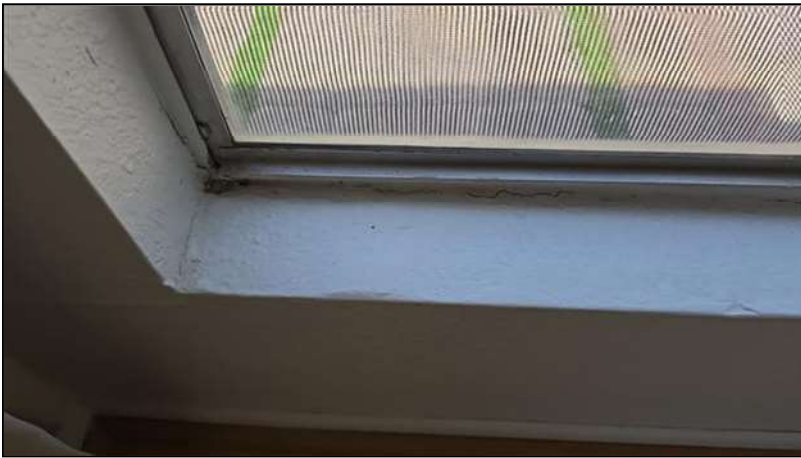
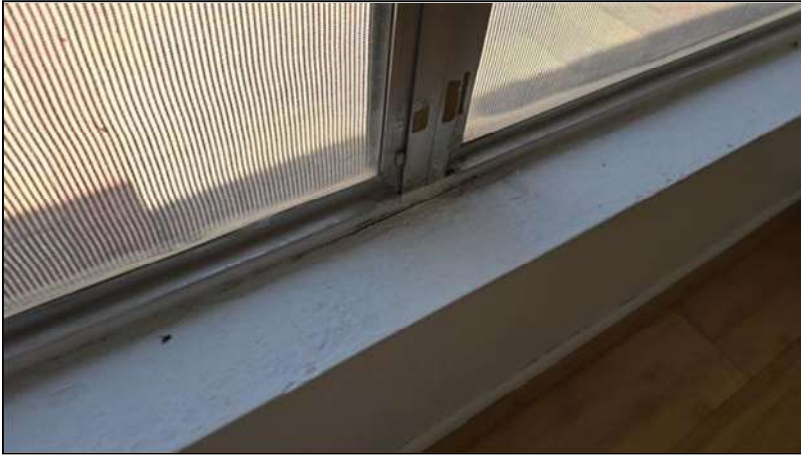
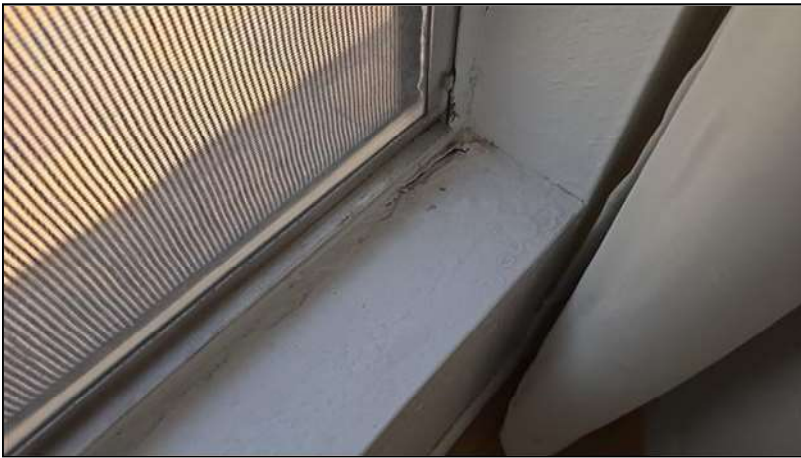
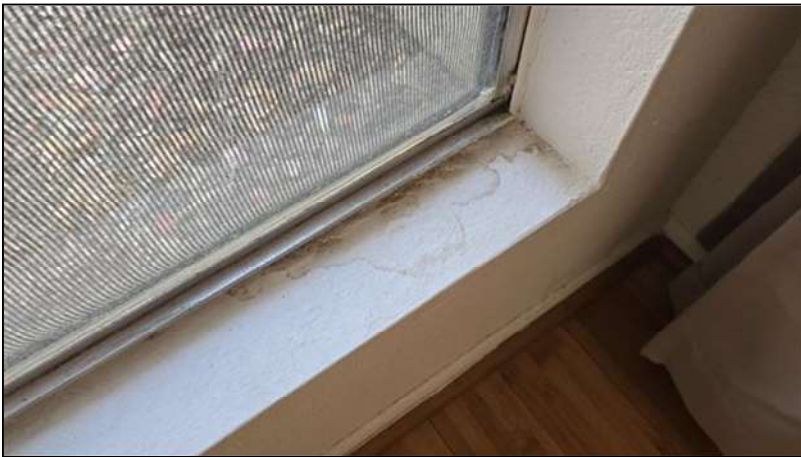
🟢 5.5 (8) The windows downstairs all have moisture staining/damage at the sills. This is not indicative of a typical window leak as the damage is across the entire sill. Damage is most likely due to the window being left open during rain storms or the weep holes having blockage (if equipped). Recommend consulting with seller. Recommend weep holes are clear of blockage on windows to prevent frame from overflowing into the sill.

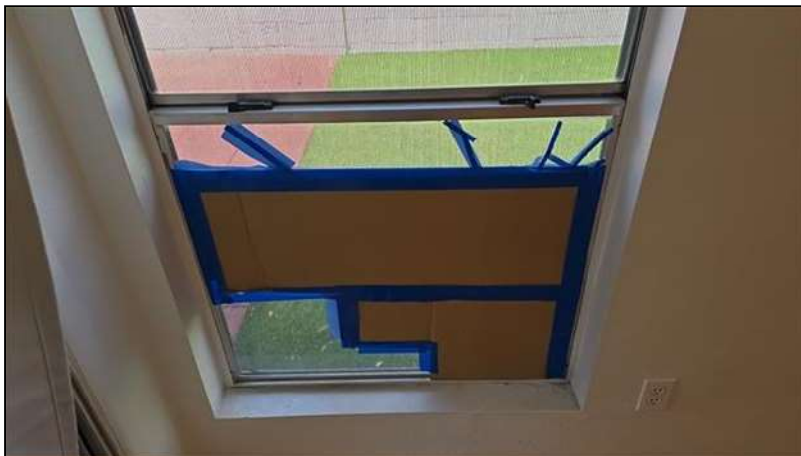
5.5 Nest to patio door

5.5 (9) The window is taped up with cardboard. The glass is shattered. Recommend repair. Due to the window being shattered the window was not opened. Recommend verifying window opens and closes properly when glass is replaced.

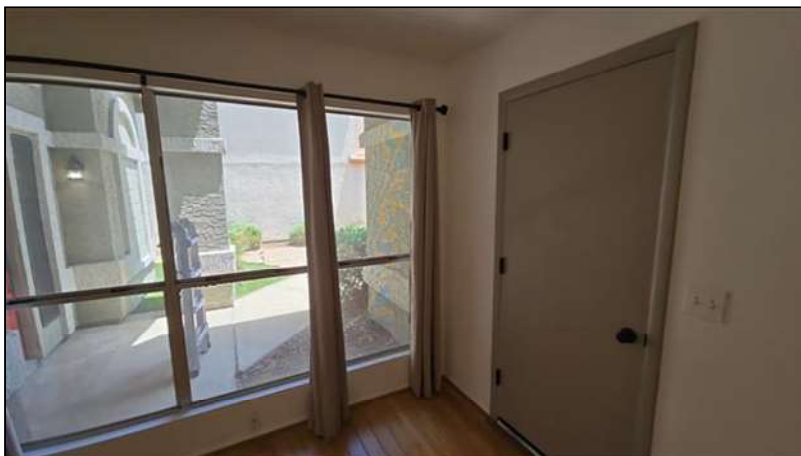
5.5 (10) Dining room - the window will not stay up without a prop. The window balancing assembly is missing or not functioning as intended. Recommend repair for full functionality.

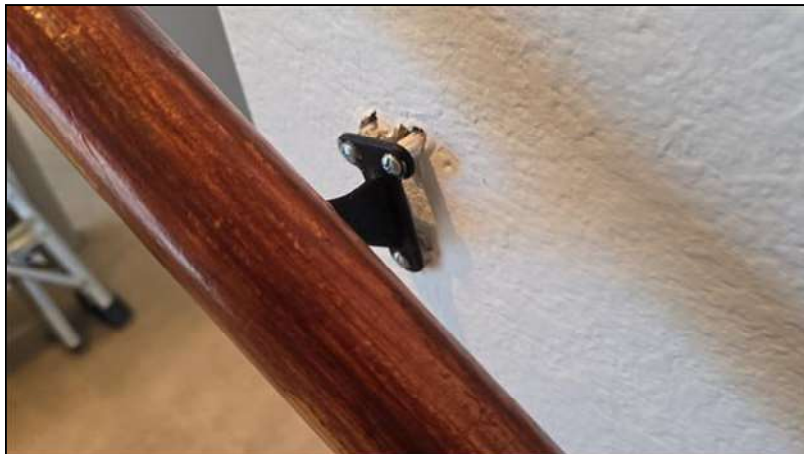
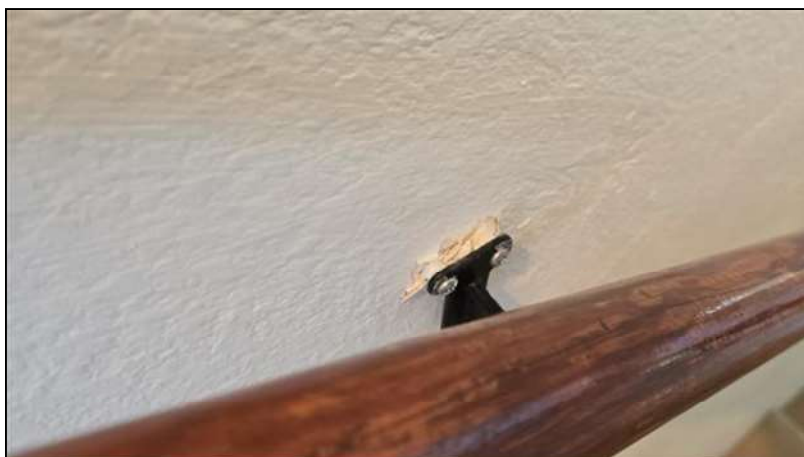
5.7 The railing mounts have pulled out of the wall in multiple locations. Railing is loose. Recommend repair for safety.

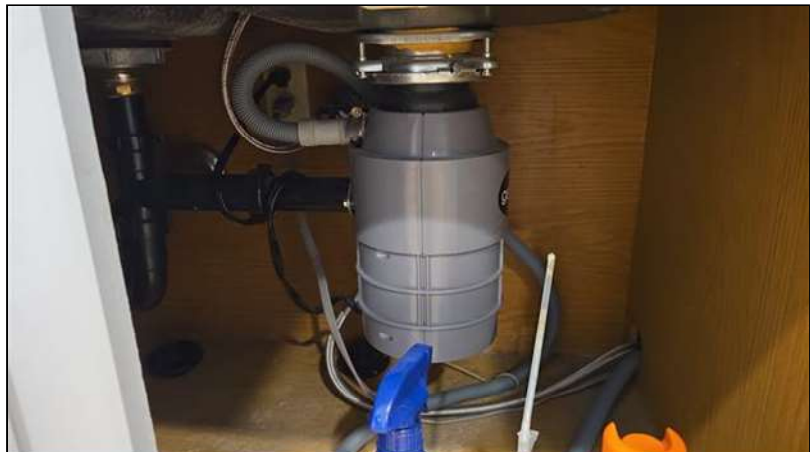
6.3 The garbage disposal vibrates excessively and could potentially fail in the near future. Excessive vibration can cause the shaft seal to fail and leak. Recommend replacement before failure.

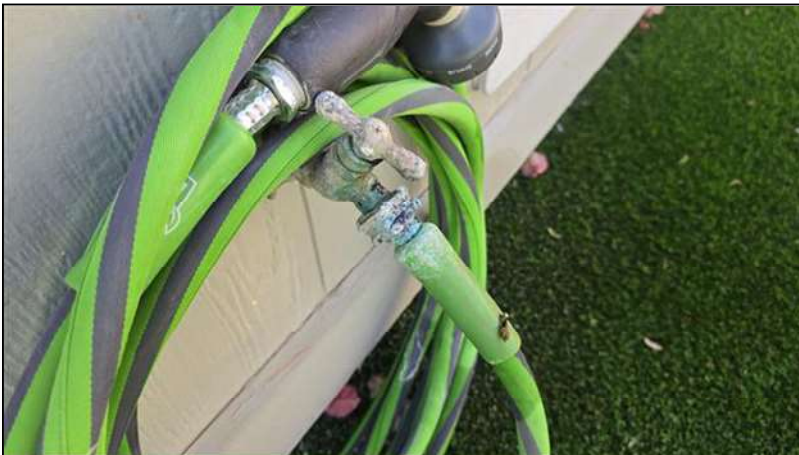
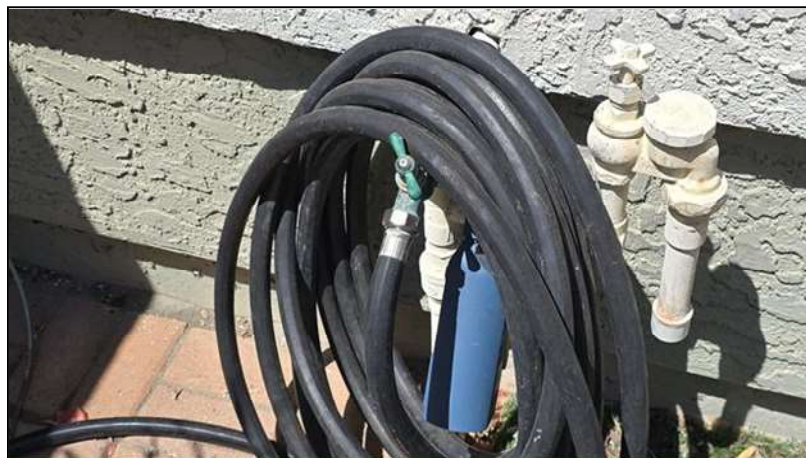
7.0 (3) Exterior - multiple faucets are missing anti-siphon type device. Anti-siphon devices prevent the backflow of water into potable water systems. These are inexpensive brass parts that can be purchased at the hardware store and screwed onto the faucet. Recommend installation of anti-siphon device for safety.

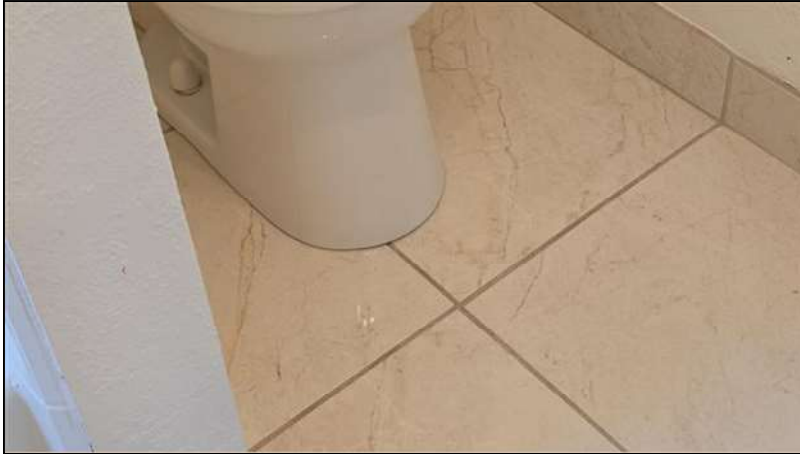
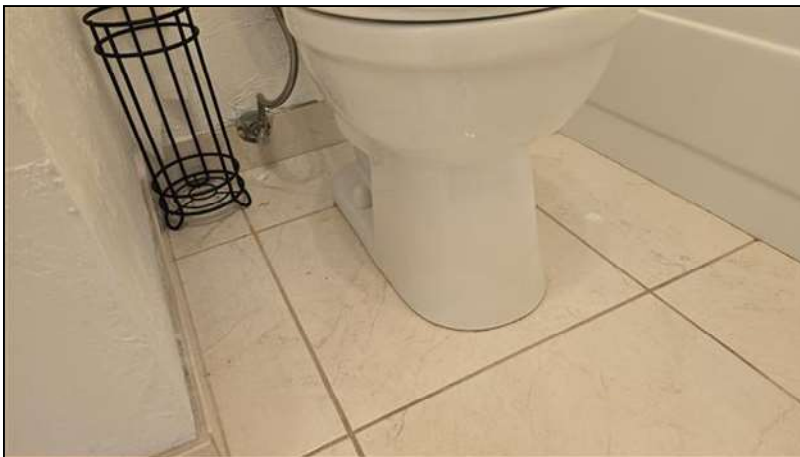
7.0 (6) Multiple toilets - the base caulking is missing. Recommend caulking area to prevent potential seepage and sewer smell..

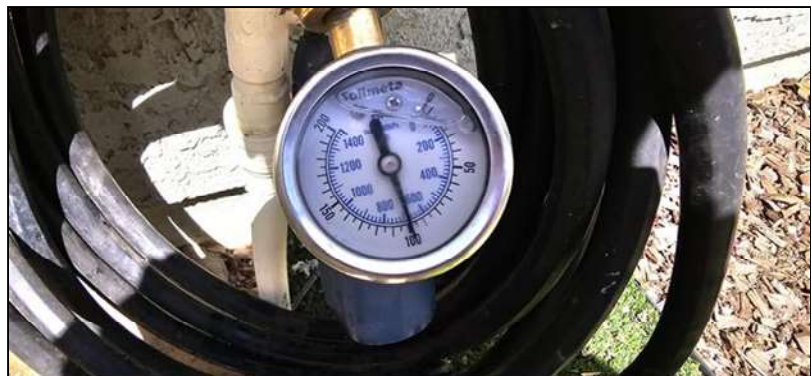
7.1 (2) Water supply - is over recommend 85PSI. Excessive water pressure could potentially cause damage to pipes, faucets and fixtures causing leaks at fittings, handles and other components. Recommend pressure be lowered to 85PSI or less. This will require the installation of a pressure regulator.

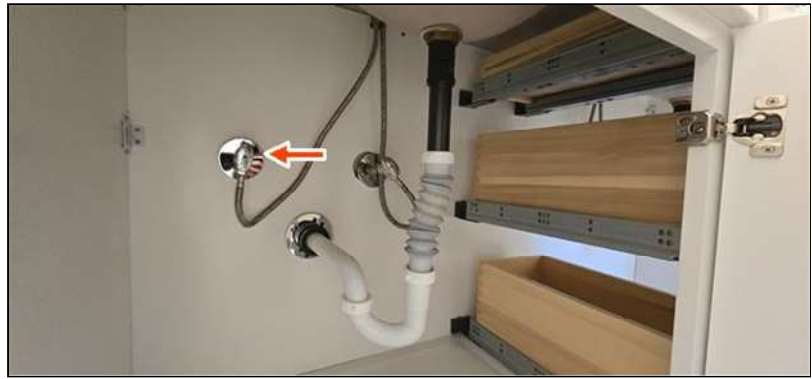
7.1 (3) Gate style supply valves are installed. These style valves are prone to leak when turned. Recommend monitoring valves for any leakage or corrosion forming which indicates failure. Recommend replacement with newer style 1/4 turn ball type valve.

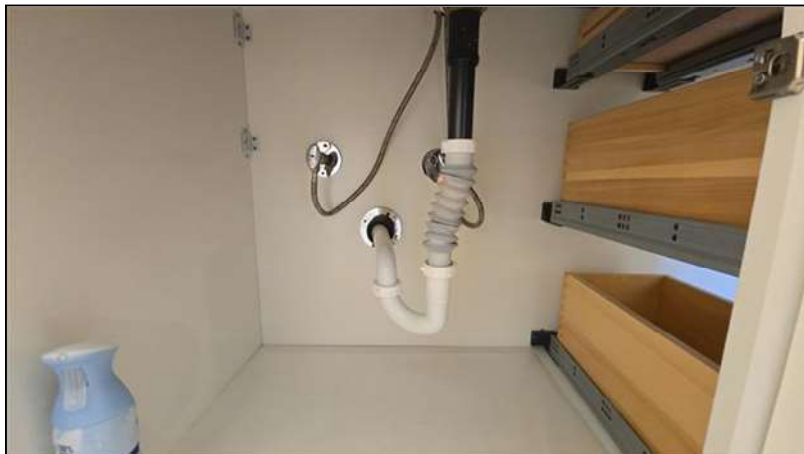
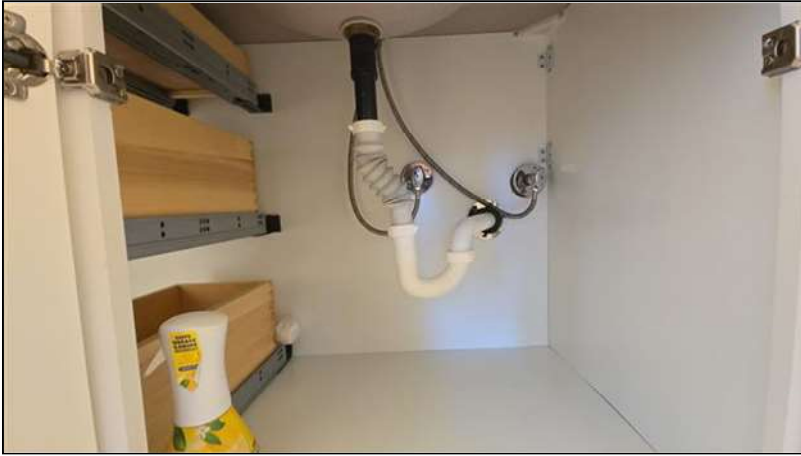
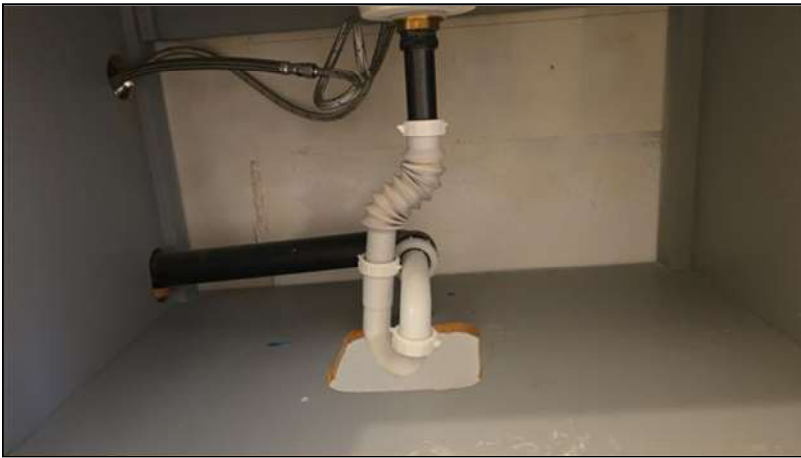
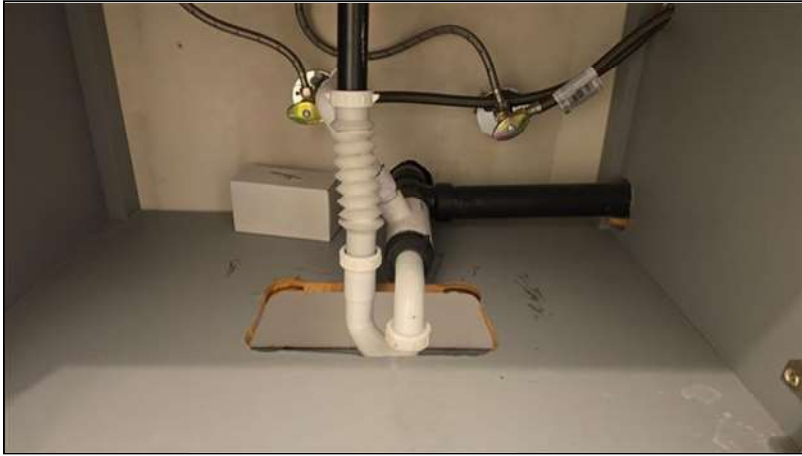
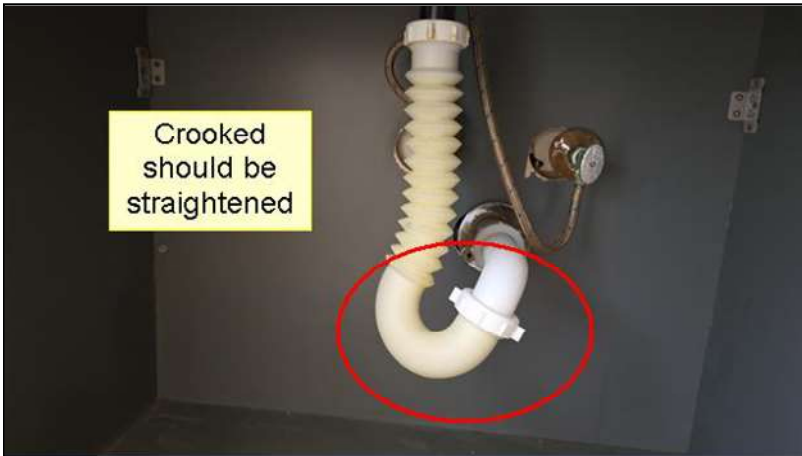
7.2 (2) Multiple locations - the plumbing drain has unconventional flexible drain pipe that could contribute to blockages. Repair as necessary.

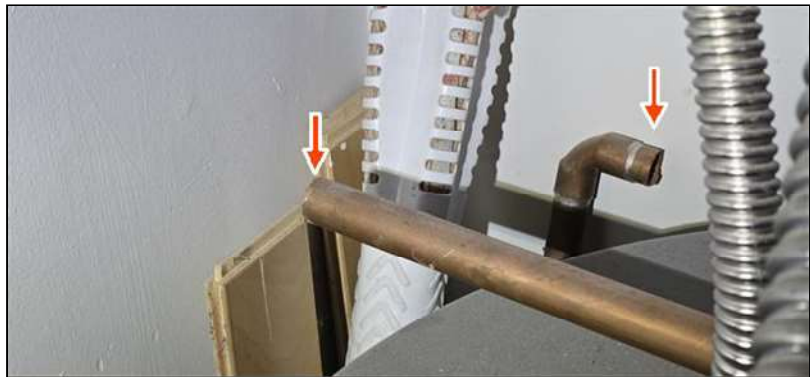
7.5 (2) The TPR (temperature pressure relief) valve on water heater should be 3/4 rigid type piping and extend within 6" of the floor or piped to the exterior for safety. Should TPR discharge it will be high pressure and temper tire water which can cause injury to persons. Piping has been cut and not reconnected. Recommend repair by a qualified plumber.

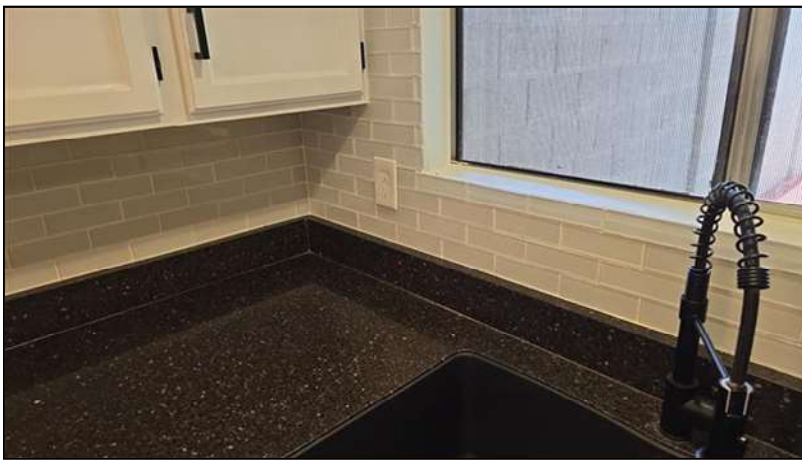
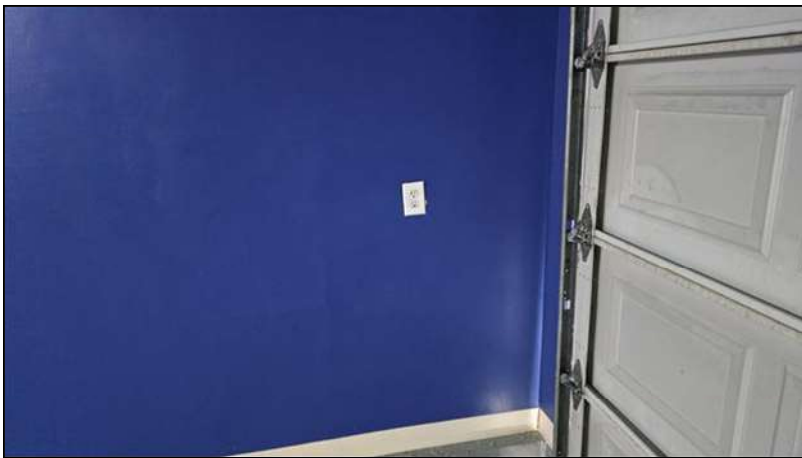
8.1 (2) Multiple outlets are loose in the wall. Recommend repair.
