Inspection Report

430 E Main St
Phoenix AZ 85024

Buy It Right Home Inspections LLC

Date: 5/15/2024	Time: 09:00 AM	Report ID: 20240515-430-E-Main-St
Property: 430 E Main St Phoenix AZ 85024	Customer: Joe Homebuyer	Real Estate Professional: Rhonda Carstensen My Home Group

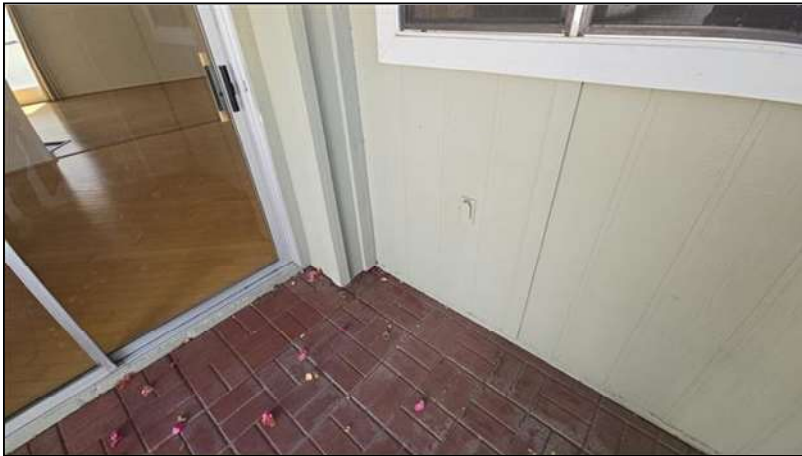
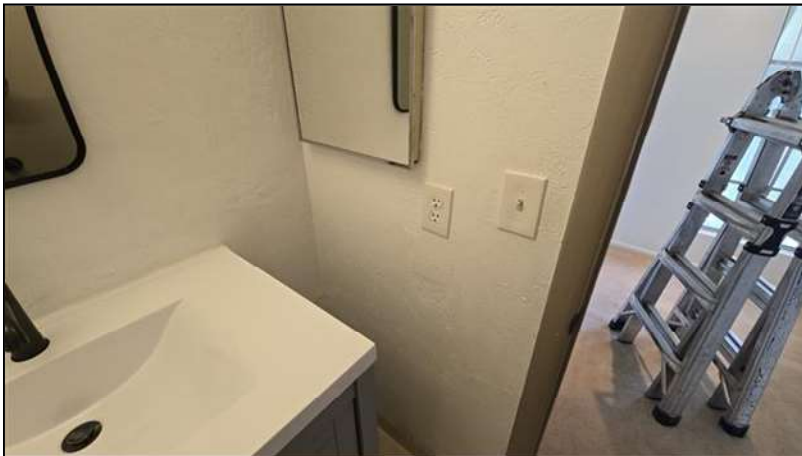
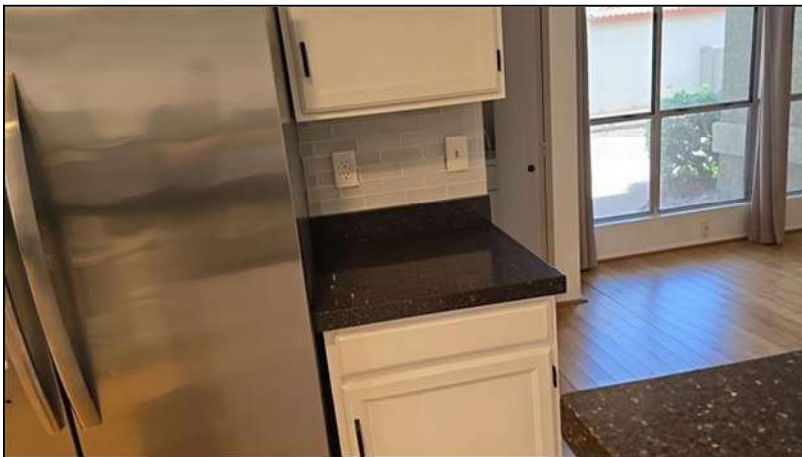
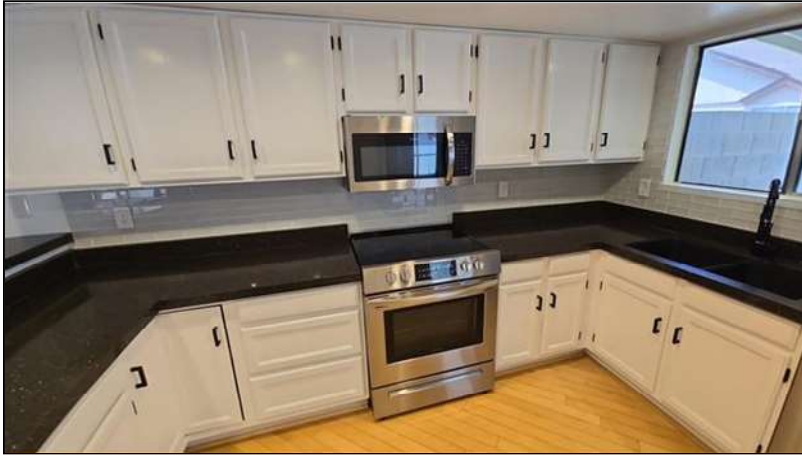
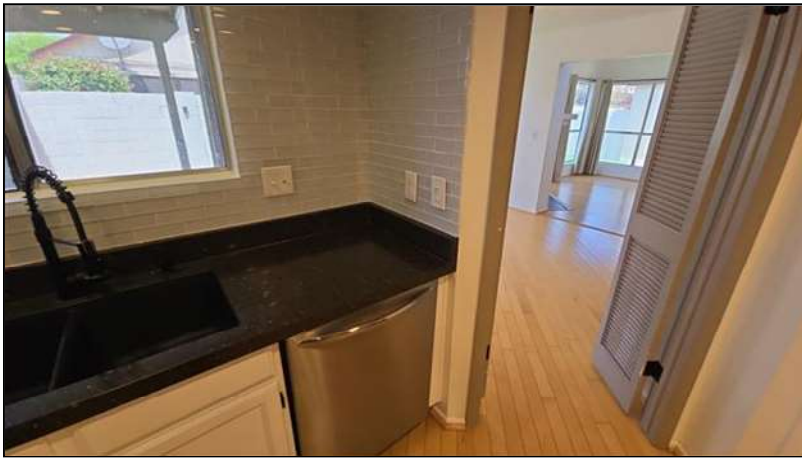
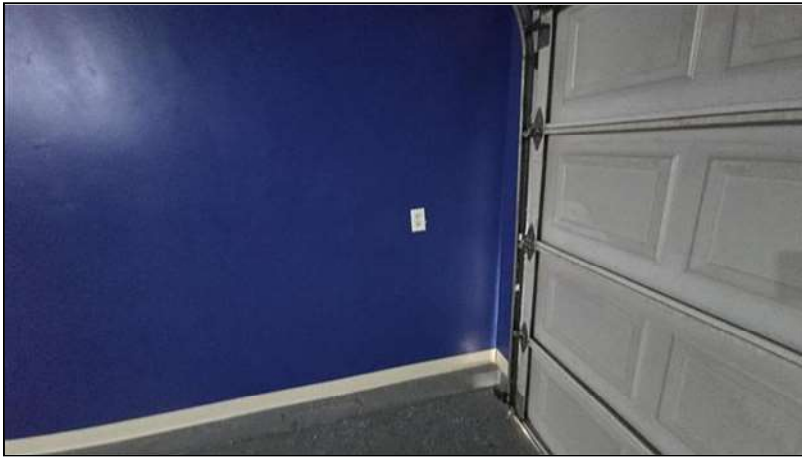
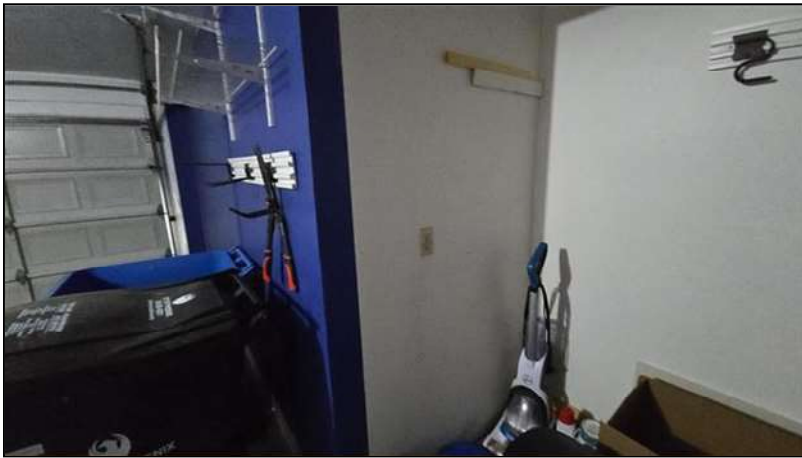
8.2 Several outlets were not GFCI protected. GFCI's are installed on all exterior outlets, garages, kitchens, laundries and any outlet withing 6' of water for safety. Recommend installation of GFCI's for safety. **Images may not be all inclusive, but are a representation of the locations requiring repair.**

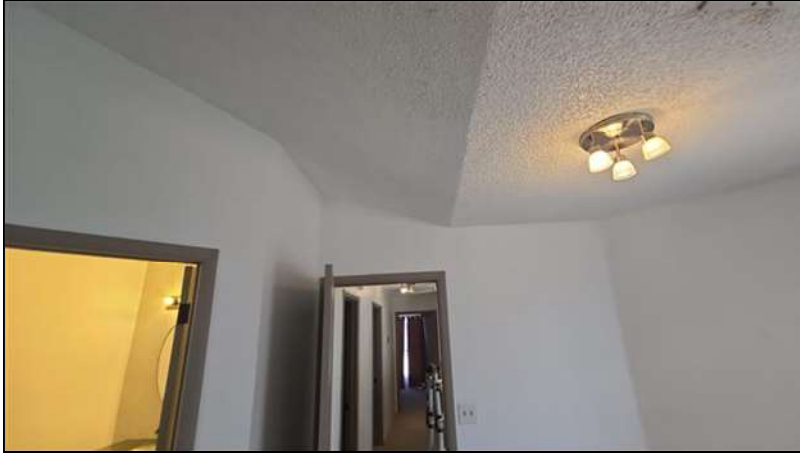
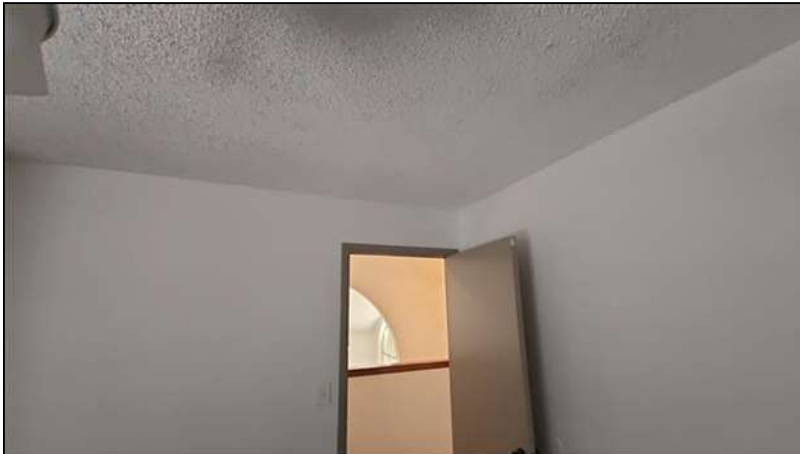
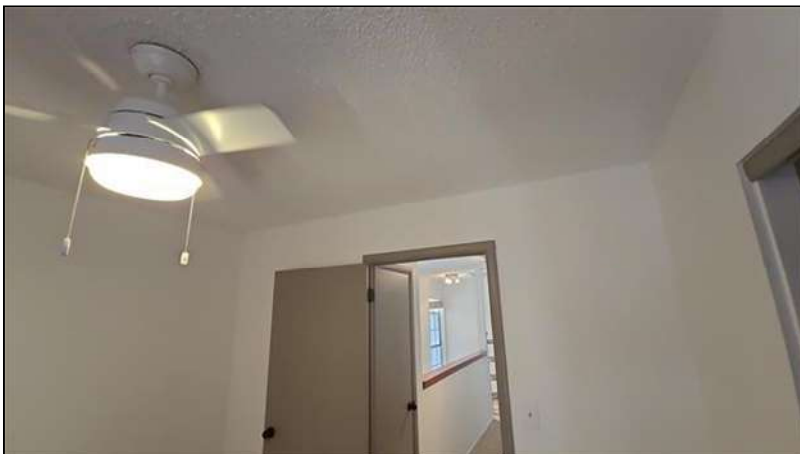
8.3 (2) It was noted that the smoke detectors were missing from all bedrooms. Recommend that smoke/carbon monoxide detectors be installed inside every sleeping area and outside each sleeping area and on every level of the home. Larger homes may require more detectors. **Images may not be all inclusive.**

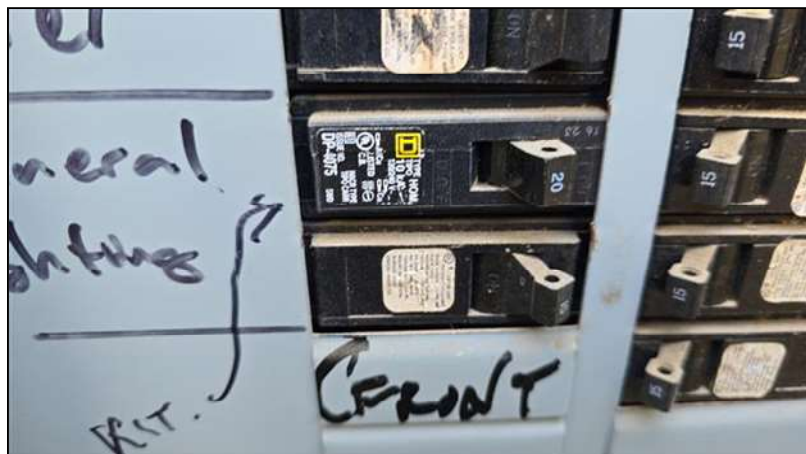
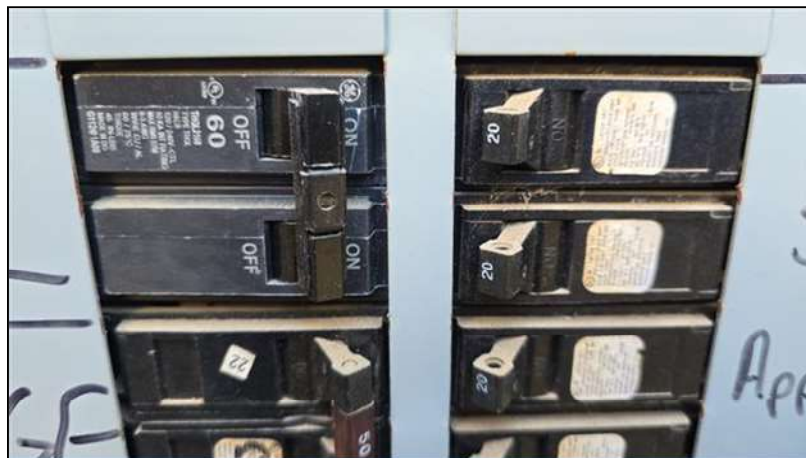
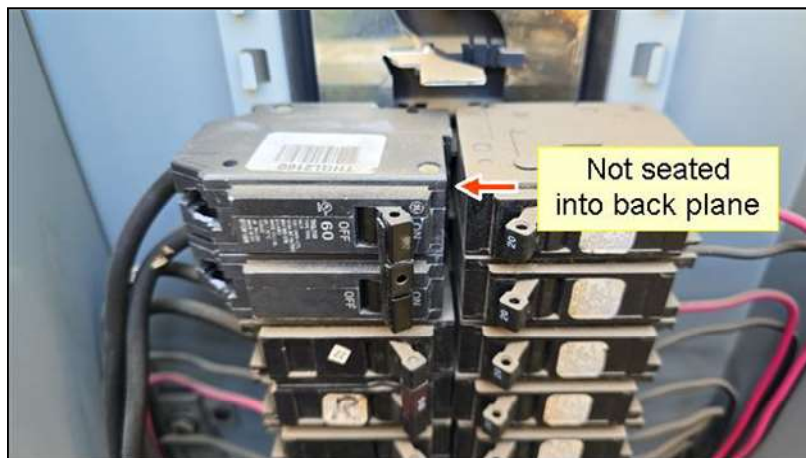
8.5 The breakers that are installed in the panel are mismatched. There is no label present in the panel to determine if this is acceptable. Incorrect breaker types can create a poor connection and overheating. Recommend consulting with a qualified electrician about correct breaker types for the panel.

The breaker is not fully seated. This is most likely due to the breaker not being compatible with the panel. This is a serious concern. Recommended repair by a qualified electrician.

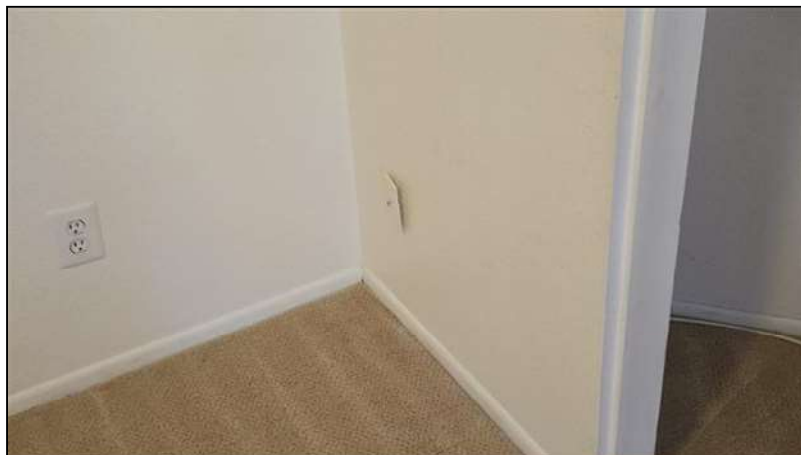
8.8 (2) The low voltage outlet is not secure. Recommend repair.

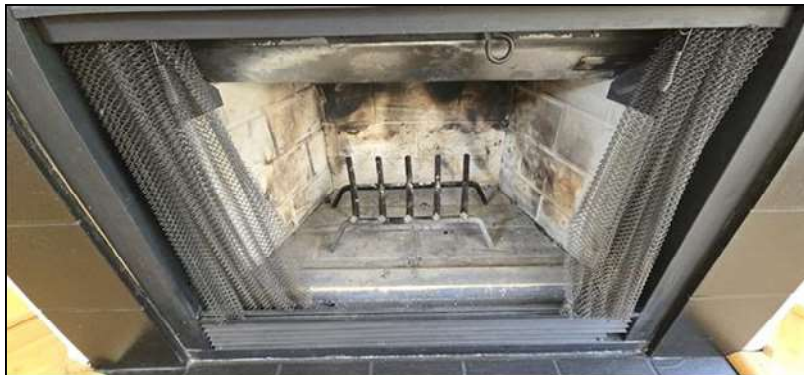
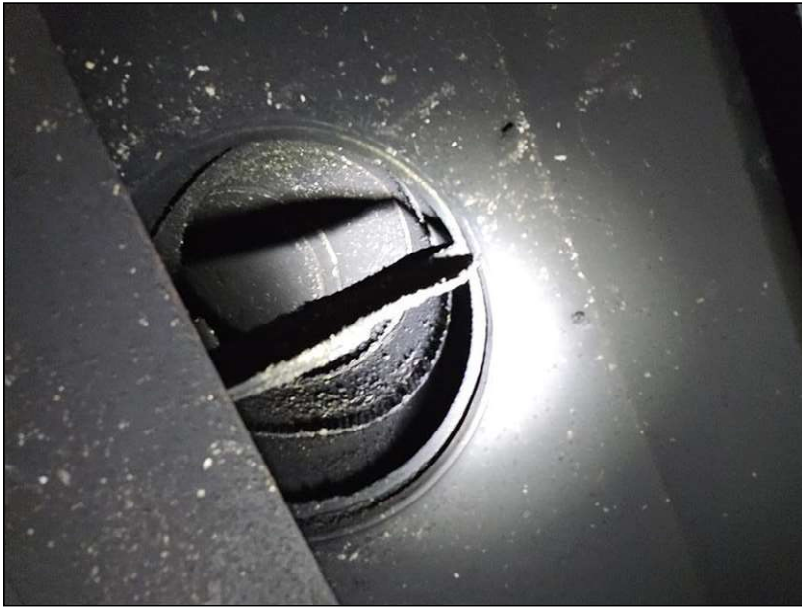
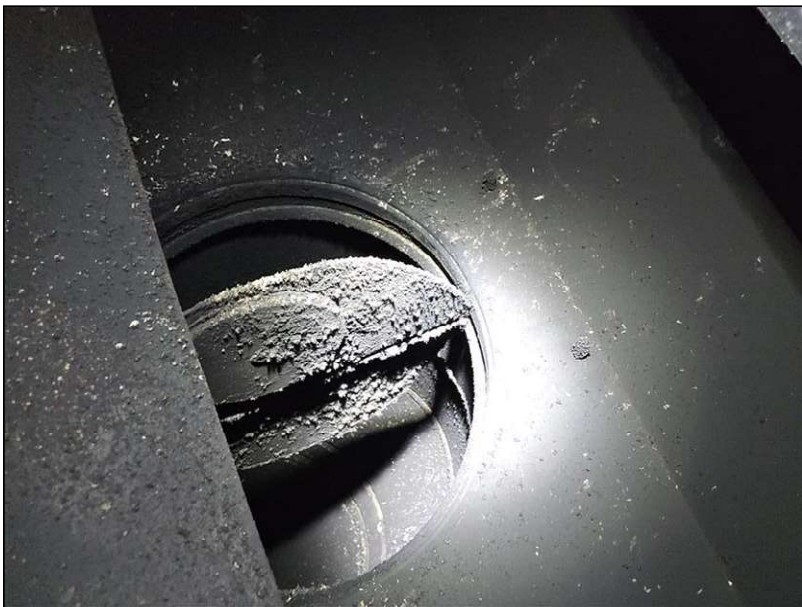
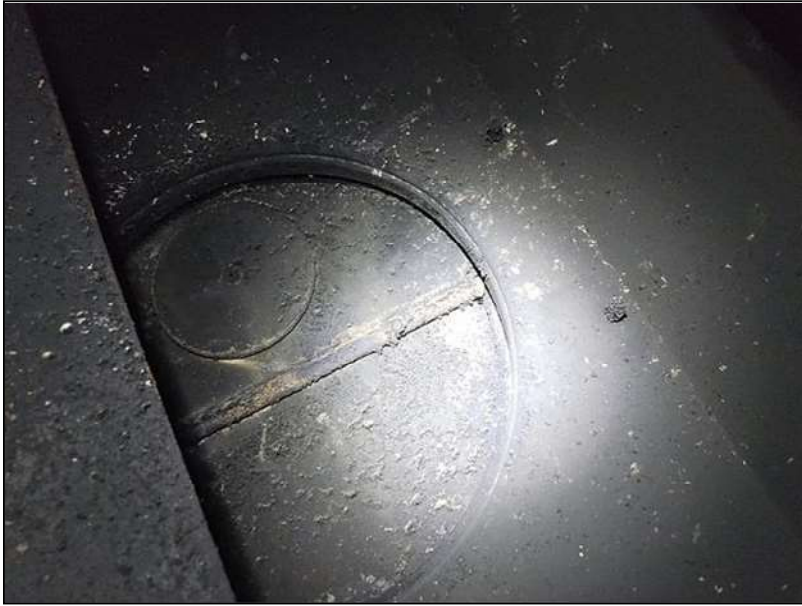
Creosote build-up observed in chimney. Excessive creosote buildup can be a fire hazard. Recommend cleaning and inspect for safety by a level II chimney sweep.

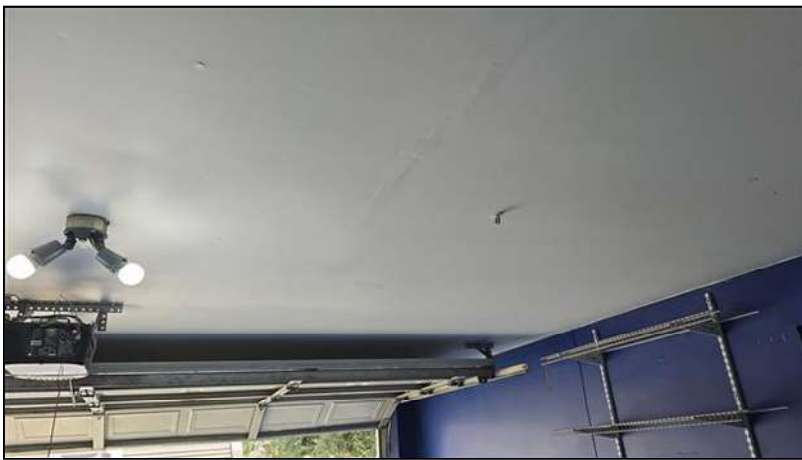
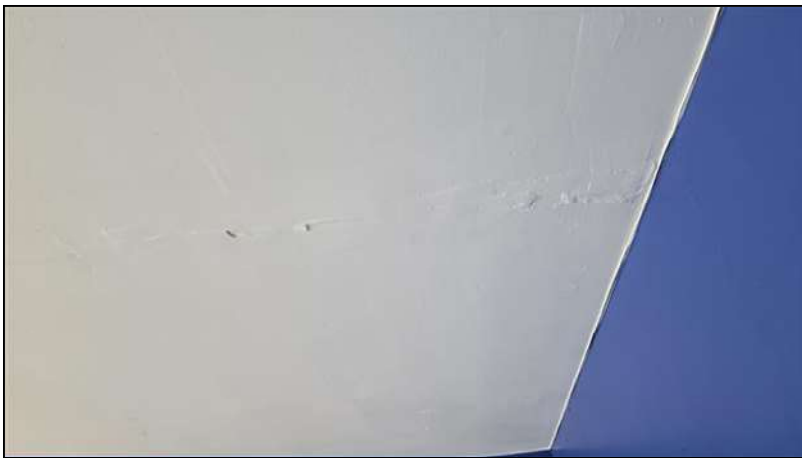
10.2 Common cracking observed in ceiling drywall. Recommend repair.

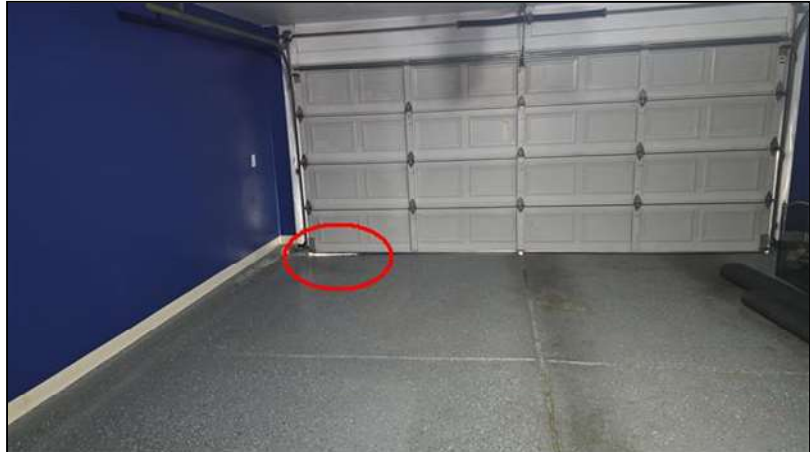
10.4 (2) The door does not fully seal at the foundation. This is most likely due to the concrete not being level. Recommend repair to prevent moisture and pest intrusion.

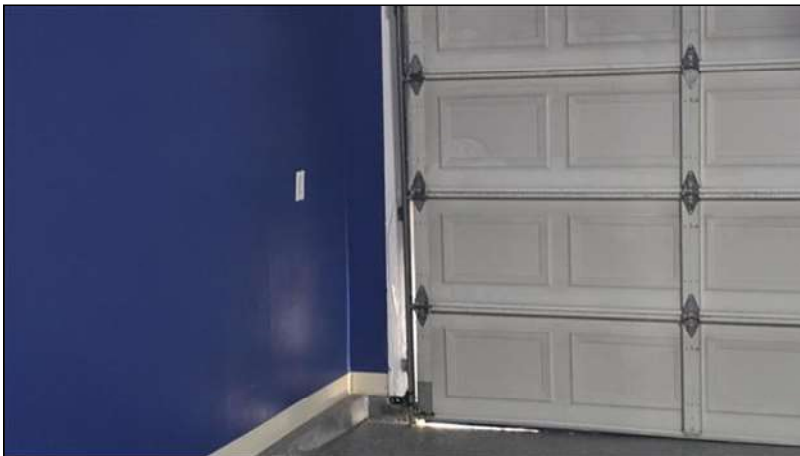
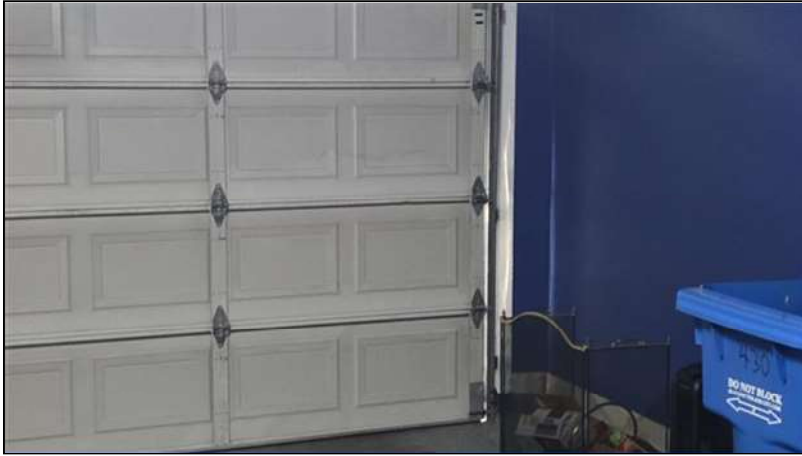
10.4 (3) The garage door reveals daylight. Recommend adjustment by a qualified garage door repair technician.

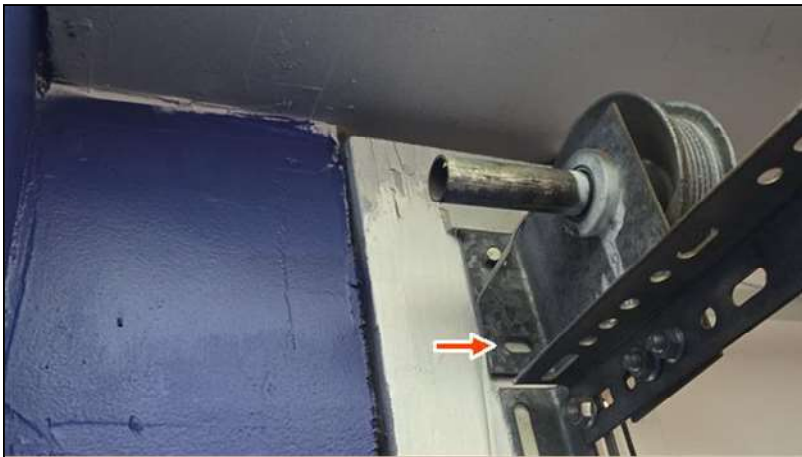
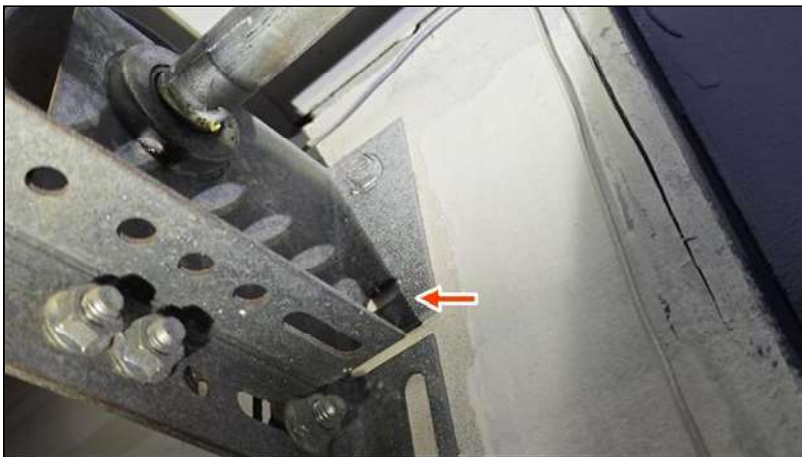
10.4 (4) Bolts are missing from the garage door mounting. Recommend all hardware be installed per the manufacturers installation instructions.

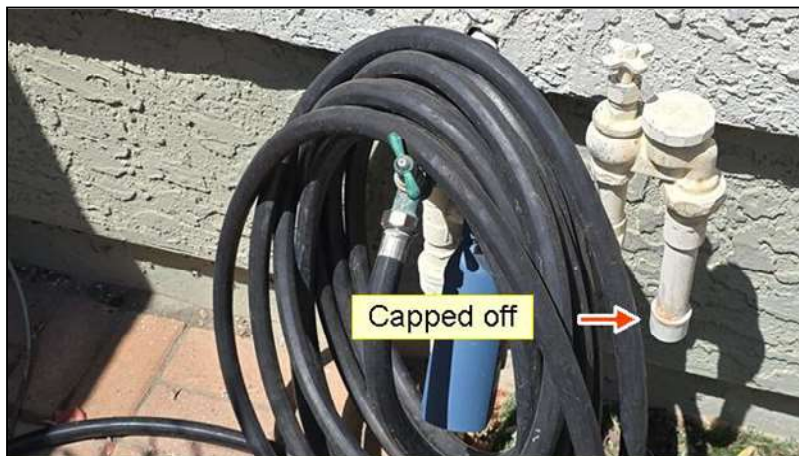
11.0 There is no sprinkler/drip system installed.
